ALERT SERVICE BULLETIN

UH-1H-16-14 24 March 2016

**GOODRICH EXTERNAL HOIST** SUBJECT:

**HELICOPTERS AFFECTED:** ALL UH-1H with Goodrich 44316 Series Hoist

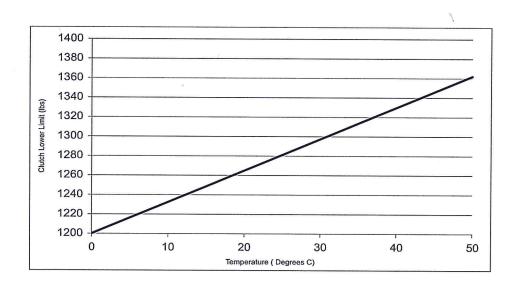
Figure 1. Lower limit for the 600 lb capacity hoists

TABLE 2. Lower Load Limit, 600 lb hoists

- (i) If the test results indicate a value above the allowable limits per Table 1, record the results, inform Goodrich and the TC holder, and continue operations.
- (j) If the test results indicate a value below the acceptable lower limit per Table 1, obtain a return authorization for the failed hoist using the standard RMA process through Goodrich at the address listed below. Send results of testing to Goodrich.

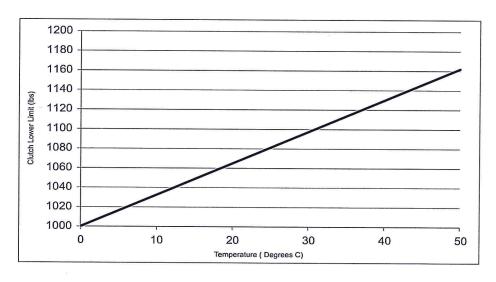
Figure 2. Lower limit for the 500 lb capacity hoists

TABLE 3.	Lower	Load	Limit.	500	lh	hoists
IADLE 3.	LOWEI	Luau	LIIIIII,	อบบ	ID	HOISIS
