ALERT SERVICE BULLETIN

ASB UH-1H-23-22

MODEL AFFECTED: UH-1H

SUBJECT: TENSION ROD ASSEMBLY P/N 205-030-249-009 OR 205-030-249-013, INSPECTION OF.

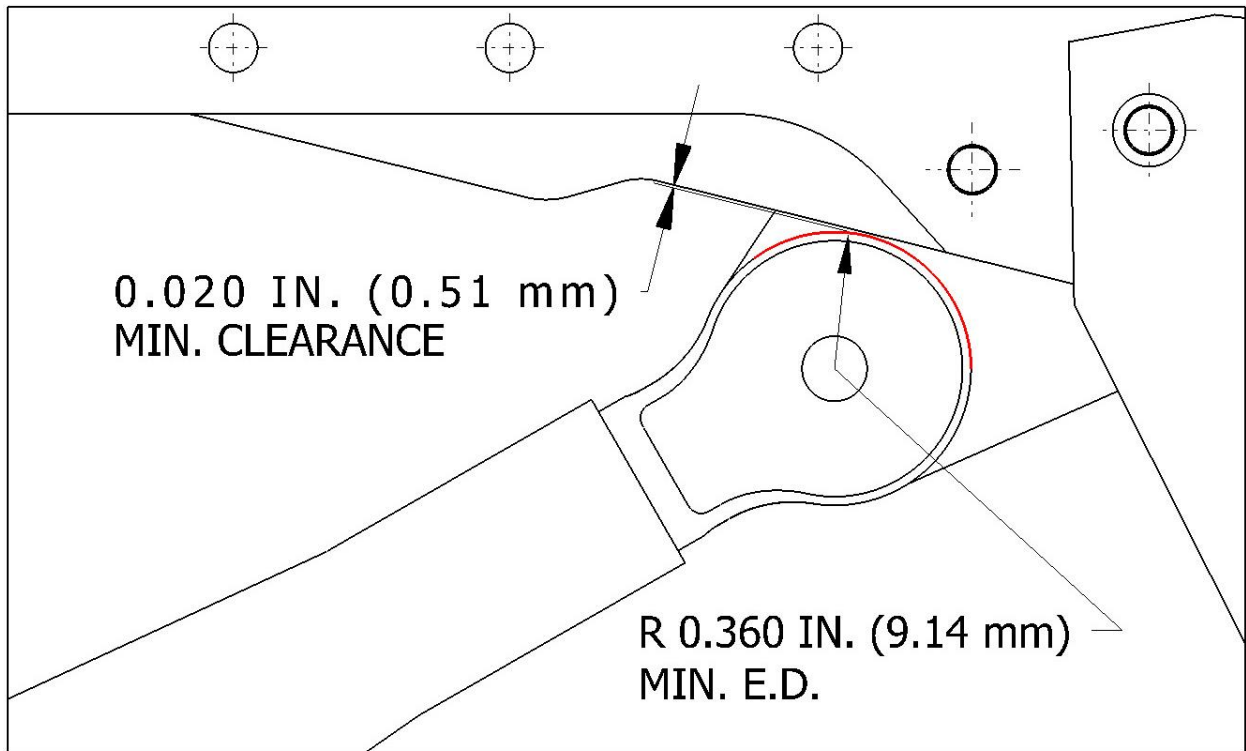
FIGURE 1. Inspection requirements.

2. Inspect the forward end (upper attachment location) of the tension rod assembly as follows:
 - a. Inspect the outboard side of the tension rod assembly rod end for a possible over trimmed condition. Minimum acceptable radius dimension measured from the bolt hole center is 0.360-inch (9.14 mm) edge distance (E.D.) (Figure 1). Removal of the attachment bolt may be required to perform this measurement. Record findings. During reinstallation of hardware, if required, tighten the nuts IAW appropriate instructions. [QA]

- b. Check for fouling or low clearance conditions between the rod end and the structure (cap, web, angle). Minimum acceptable clearance is 0.020-inch (0.51 mm) (Figure 1). Record findings.

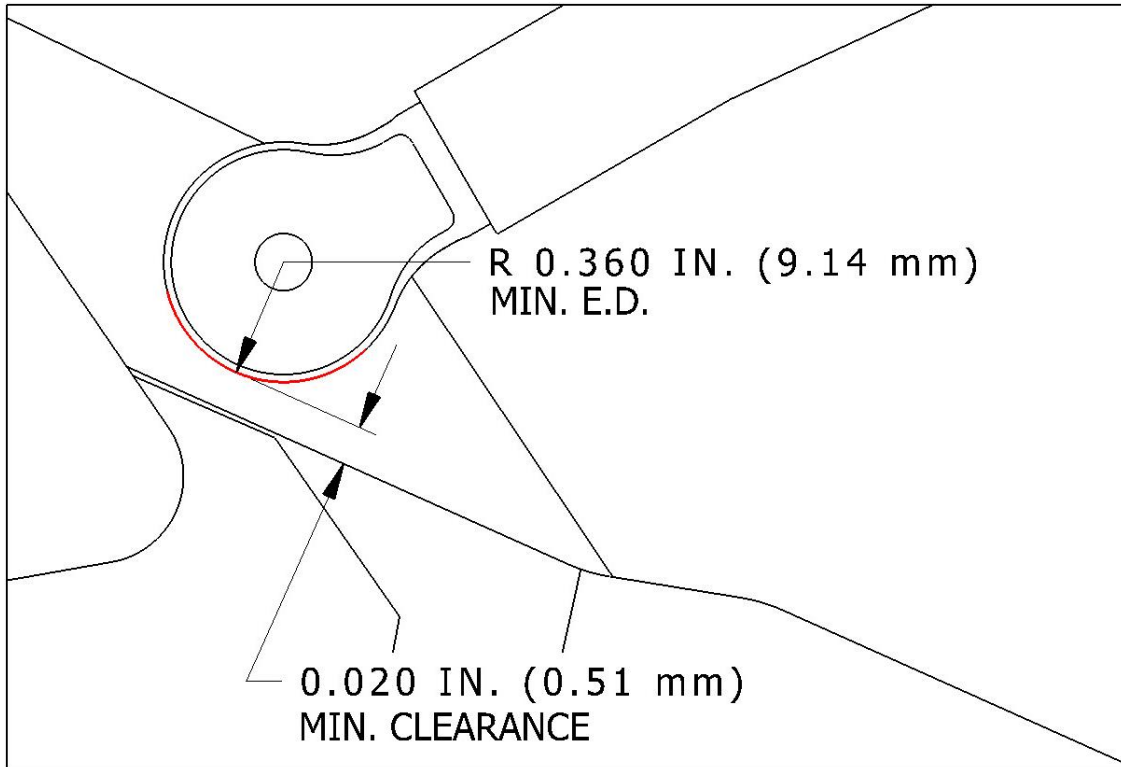
FIGURE 2. Inspection requirements

3. Inspect the aft end (lower attachment location) of the tension rod assembly as follows:
 - a. Inspect both sides of the tension rod assembly rod end for a possible over trimmed condition. Minimum acceptable radius dimension measured from the bolt hole center is 0.360-inch (9.14 mm) edge distance (E.D.) (Figure 2 and 3). Removal of the attachment bolt may be required to perform this measurement. Record findings. During reinstallation of hardware, if required, tighten the nuts IAW appropriate instructions. [QA]

- b. Check for fouling or low clearance conditions between the rod end and the structure (cap, web) on the outboard side and the fillet radius on the inboard side of the fitting. Minimum acceptable clearance is 0.020-inch (0.51 mm) (Figures 2 and 3). Record findings.
