ALERT SERVICE BULLETIN ASB UH-1H-II-23-XX

MODEL AFFECTED: UH-1H-II

SUBJECT: TENSION ROD ASSEMBLY P/N 205-030-249-009 OR 205-030-249-013, INSPECTION OF.

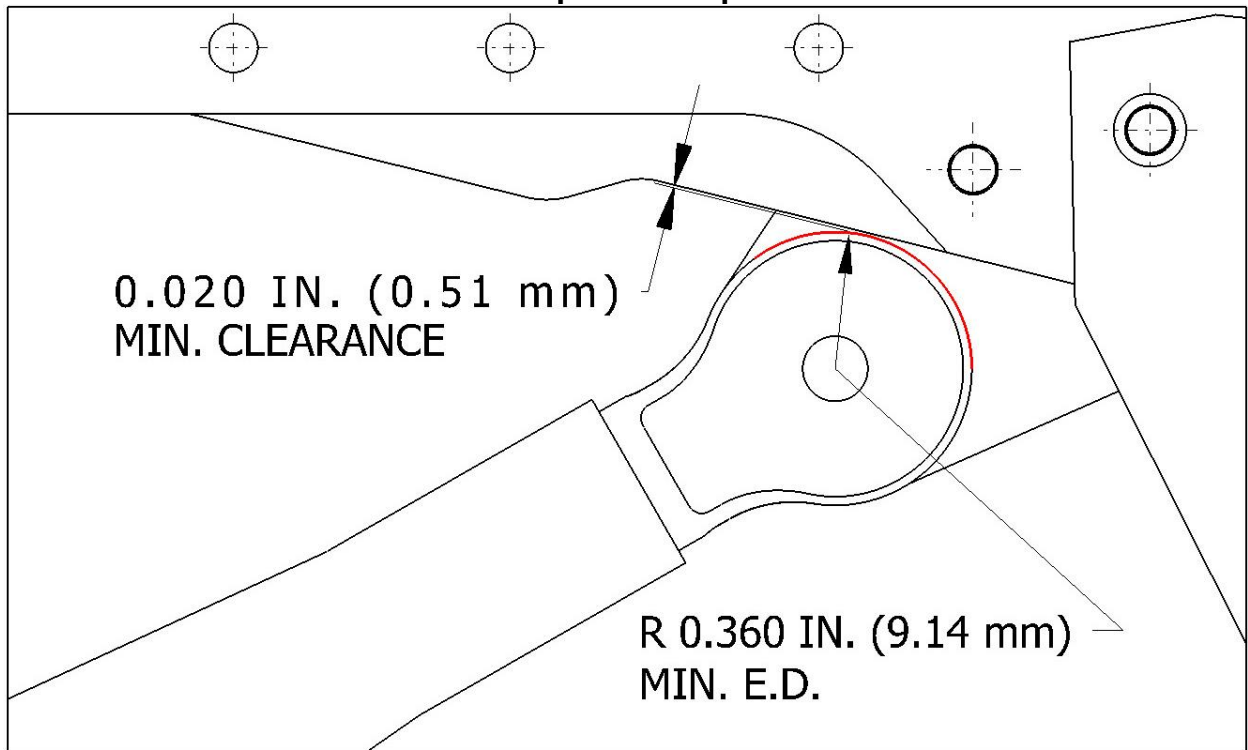
FIGURE 1. Inspection requirements.

2. Inspect the forward end (upper attachment location) of the tension rod assembly as follows:
 - a. Inspect the outboard side of the tension rod assembly rod end for a possible over trimmed condition. Minimum acceptable radius dimension measured from the bolt

hole center is 0.360-inch (9.14 mm) edge distance (E.D.) (Figure 1). Removal of the attachment bolt may be required to perform this measurement. Record findings. During reinstallation of hardware, if required, tighten the nuts IAW appropriate instructions.

- b. Check for fouling or low clearance conditions between the rod end and the structure (cap, web, angle). Minimum acceptable clearance is 0.020-inch (0.51 mm) (Figure 1). Record findings.

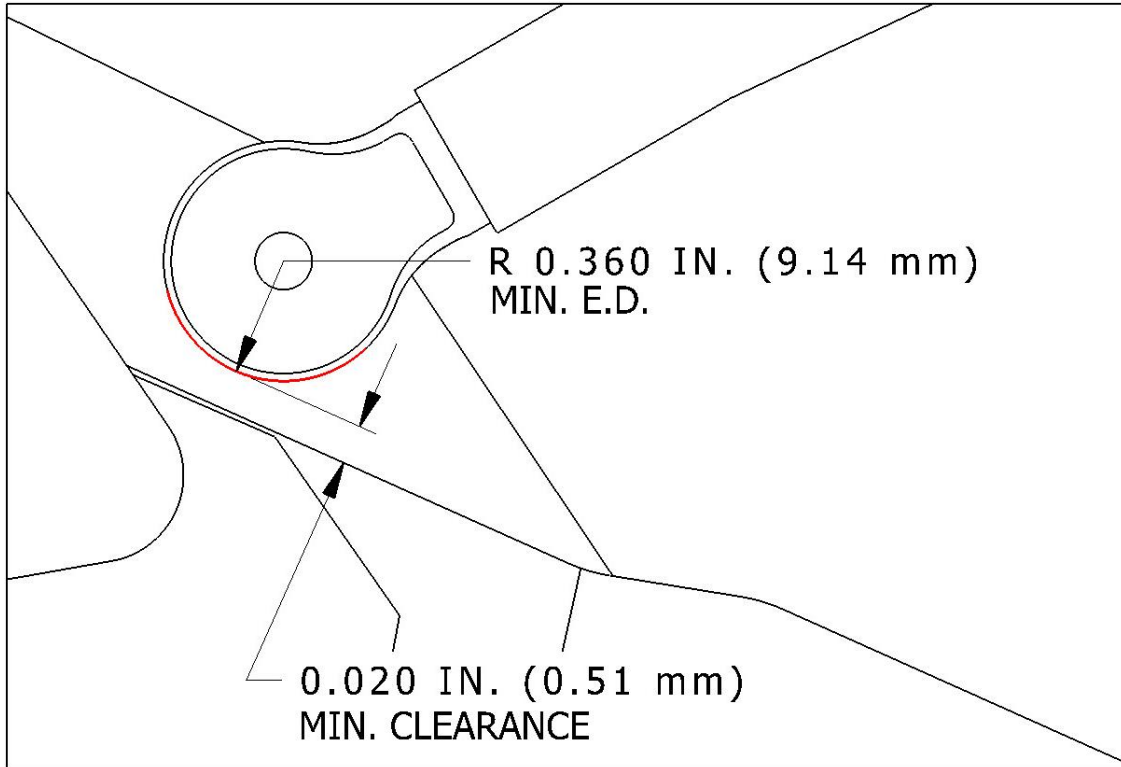
FIGURE 2. Inspection requirements

3. Inspect the aft end (lower attachment location) of the tension rod assembly as follows:
 - a. Inspect both sides of the tension rod assembly rod end for a possible over trimmed condition. Minimum acceptable radius dimension measured from the bolt hole center is 0.360-inch (9.14 mm) edge distance (E.D.) (Figure 2 and 3). Removal of the attachment bolt may be required to perform this measurement. Record findings. During reinstallation of hardware, if required, tighten the nuts IAW appropriate instructions.

- b. Check for fouling or low clearance conditions between the rod end and the structure (cap, web) on the outboard side and the fillet radius on the inboard side of the fitting. Minimum acceptable clearance is 0.020-inch (0.51 mm) (Figures 2 and 3). Record findings.

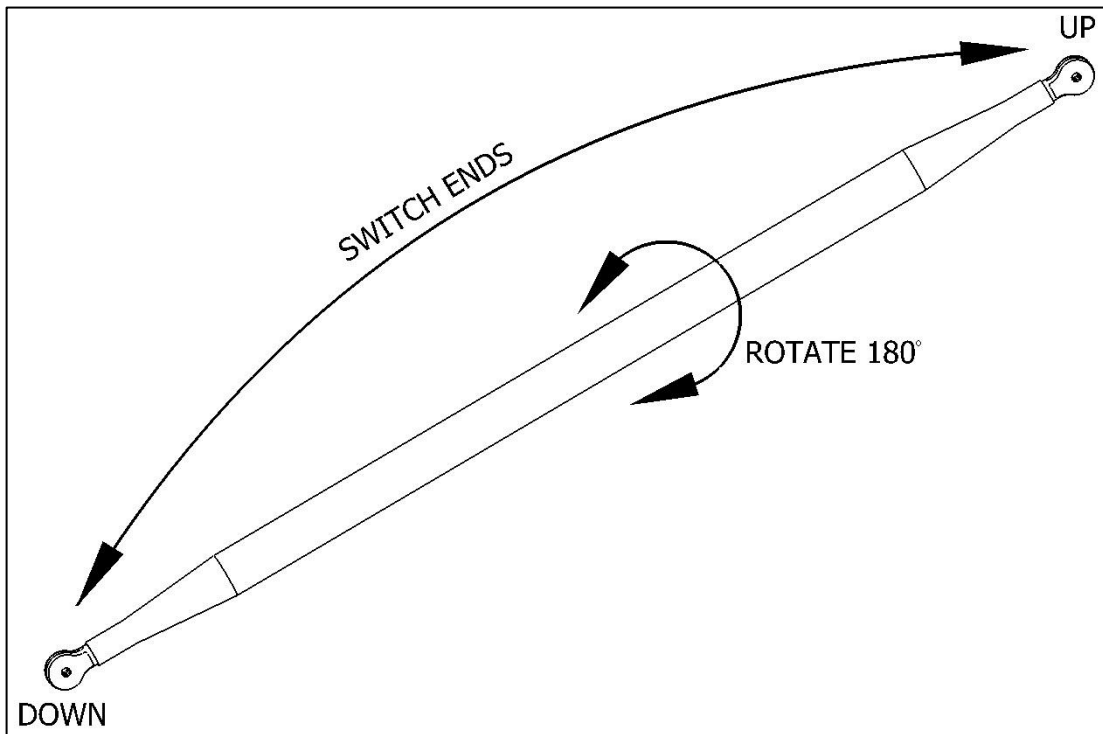
FIGURE 4. Tension rod assembly proper installation verification.

1. If a fouling or a low clearance condition exists, the tension rod assembly may have been incorrectly installed. Prior to trimming the rod ends, remove the tension rod

assembly (step 1.a.) and try different orientations by rotating and/or switching ends to obtain the best possible fit (Figure 4). If proper clearance dimensions as defined in PART I cannot be met, proceed with step 3.

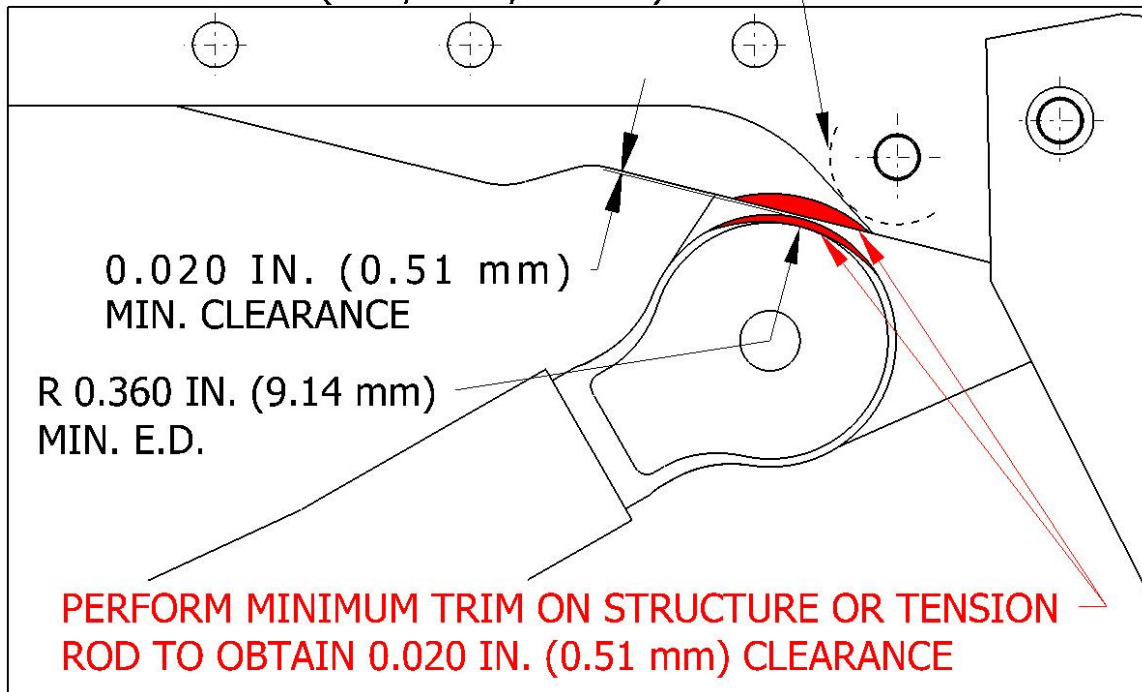
FIGURE 5. Rework requirements
KEEP 0.280 IN. (7.11 mm) MIN. E.D.
FOR FASTENERS (CAP, WEB, ANGLE)

3. Temporarily reinstall tension rod assembly. Mark the minimum material removal required on the affected rod end and/or structure attachment points to obtain the required clearance. (Figure 5 for the upper bolt. Figures 6 and 7 for the lower bolt.)
4. Remove the tension rod assembly (step 1.a.).
5. Trim and deburr previously marked material on the affected rod end and/or structure attachment fitting. Ensure the inspection criteria defined in **PART I** are respected (Figures 1, 2, and 3).
6. Apply chemical film and one coat of epoxy polyamide primer to the reworked area.
7. Install the tension rod assembly (step 2.a.).
8. Make an entry in the helicopter logbook and historical service records indicating compliance with this Alert Service Bulletin.
