ALERT SERVICE BULLETIN ASB UH-1H-II-24-36

MODEL AFFECTED: UH-1H-II

SUBJECT: MAIN BEAM CAP ANGLE, P/N 205-830-036-119,
INSPECTION OF.

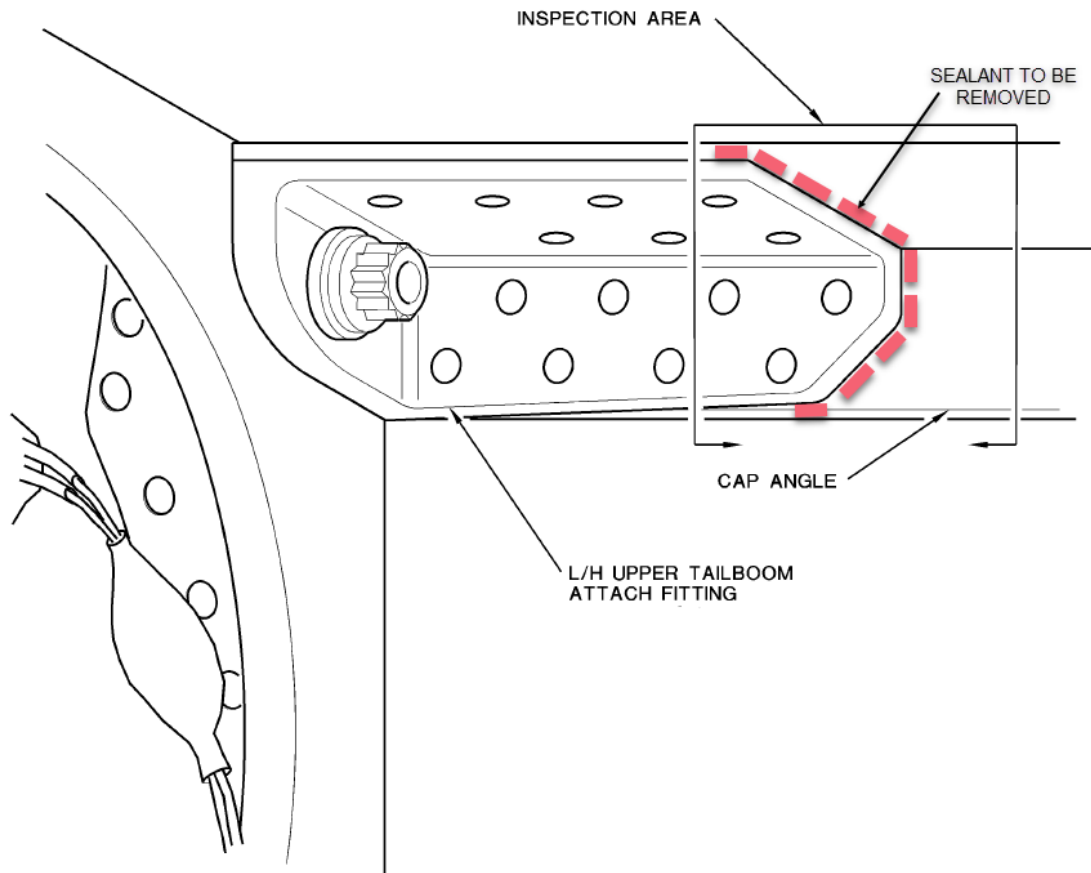
Figure1. Fuselage Tailboom Attachment Inspection.

Bell has investigated reports of fractured tailboom attachment main beam cap angles. Some were found during routine inspection and some during Special Inspections. The investigation indicates that the Special Inspection intervals established for the model helicopters with this cap configuration is not adequate to detect all cracks before possible fracturing of the cap angle. Since the risk of cracking/fracture remains on the 205-830-036-119 cap angle, this ASB introduces a recurring 25 Hour Tailboom Attachment Inspection. Special Inspections publications will be revised to include this 25 Hours Tailboom Attachment Inspection.

2. Remove sealant from edge of fitting (Refer to Figure 1).
3. Inspect the cap angle area shown in Figure 1 with a 10x magnifying glass and bright light.
4. If a crack is found, replace the cap angle before further flight. If no cracks are found, continue with Step 5.
5. Touch up primer and paint, if damaged during sealant removal, and allow to dry. Do not reapply sealant.
6. Ensure work areas are clean and secure. [QA]
7. Make an entry in the helicopter logbook and historical service records indicating findings and compliance with this Alert Service Bulletin.
