INFORMATION LETTER

204-20-26

20 August 2020

SUBJECT: MAIN TRANSMISSION SUPPORT CASE MOUNTS, NEW INSPECTION REQUIREMENTS.

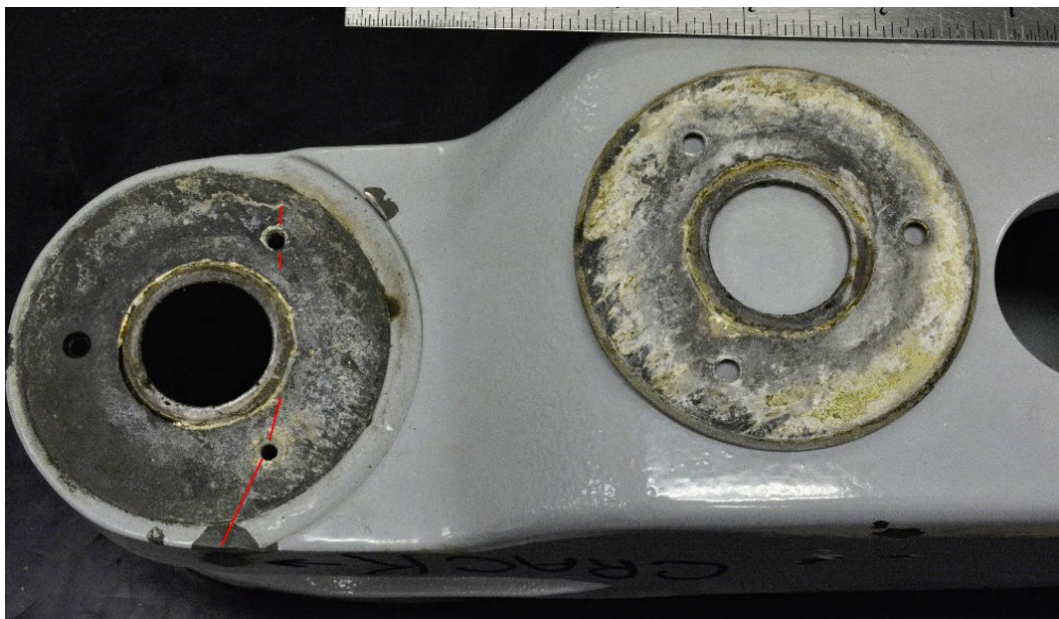
Bell occasionally receives reports of main transmission support cases found cracked at one of the lateral mounts. Cracking is usually caused by excessive corrosion of the surface under the washer and originates from a washer attachment screw threaded hole. Cracking can occur at the upper or lower surfaces of the lateral mount. The pictures on Page 2 show an example of a case found cracked during routine maintenance. To mitigate the risk of cracking due to corrosion, this Information Letter (IL) informs owners/operators of a new support case inspection requirement that has been incorporated in the Maintenance Manual (MM).

At the interval specified by the latest manual revision, the washers installed on the upper and lower surfaces of the support case lateral mounts must be removed to inspect the area in accordance with the latest criteria. The Component Repair & Overhaul Manual (CR&O) has also been revised to include washer removal and installation instructions as well as corrosion damage limits for the affected area.
