## **INFORMATION LETTER**

**204-20-26**

**SUBJECT: MAIN TRANSMISSION SUPPORT CASE MOUNTS, NEW INSPECTION REQUIREMENTS.**

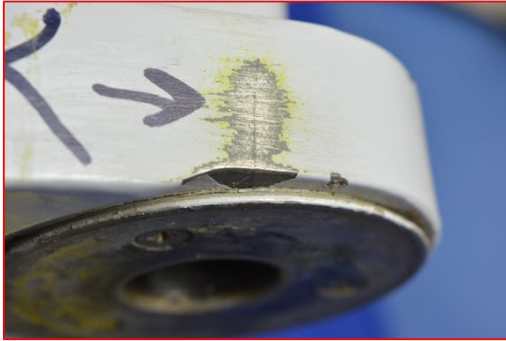
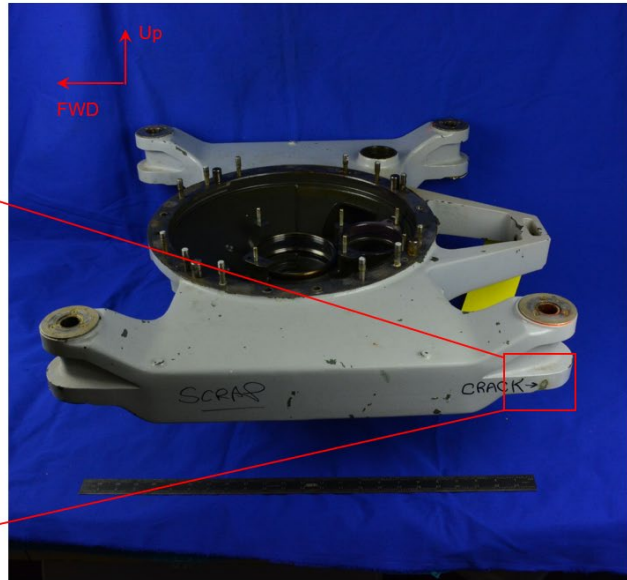
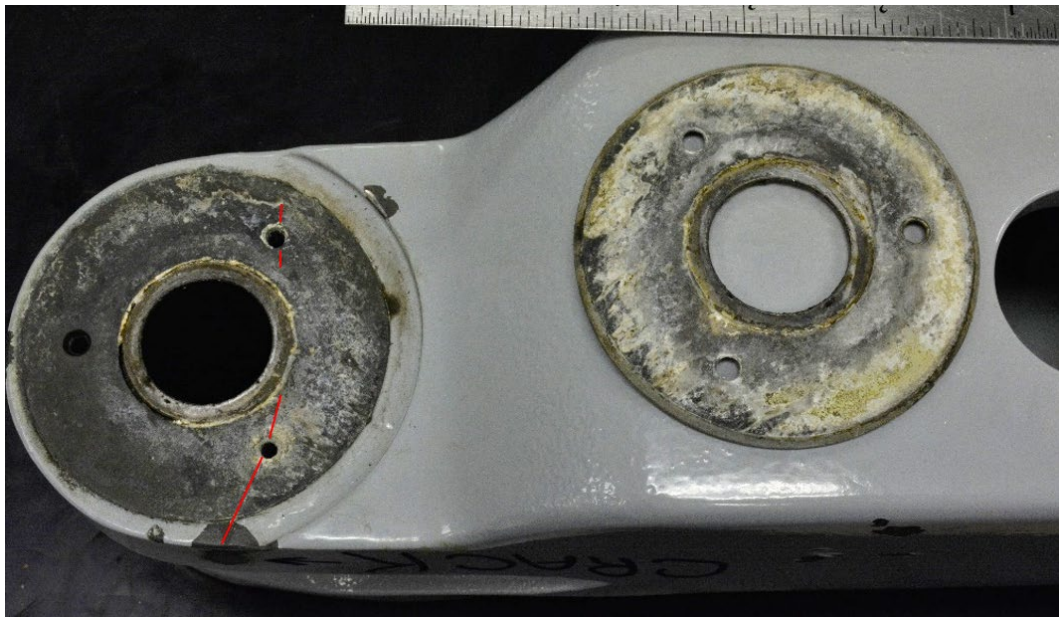
Bell occasionally receives reports of main transmission support cases found cracked at one of the lateral mounts. Cracking is usually caused by excessive corrosion of the surface under the washer and originates from a washer attachment screw threaded hole. Cracking can occur at the upper or lower surfaces of the lateral mount. The pictures on Page 2 show an example of a case found cracked during routine maintenance. To mitigate the risk of cracking due to corrosion, this Information Letter (IL) informs owners/operators of a new support case inspection requirement that has been incorporated in the Maintenance Manual (MM).

At the interval specified by the latest manual revision, the washers installed on the upper and lower surfaces of the support case lateral mounts must be removed to inspect the area in accordance with the latest criteria. The Component Repair & Overhaul Manual (CR&O) has also been revised to include washer removal and installation instructions as well as corrosion damage limits for the affected area.
