INFORMATION LETTER

407-20-120
29 October 2020

SUBJECT: MAIN ROTOR BLADE TRAILING EDGE VOIDS/GAPS

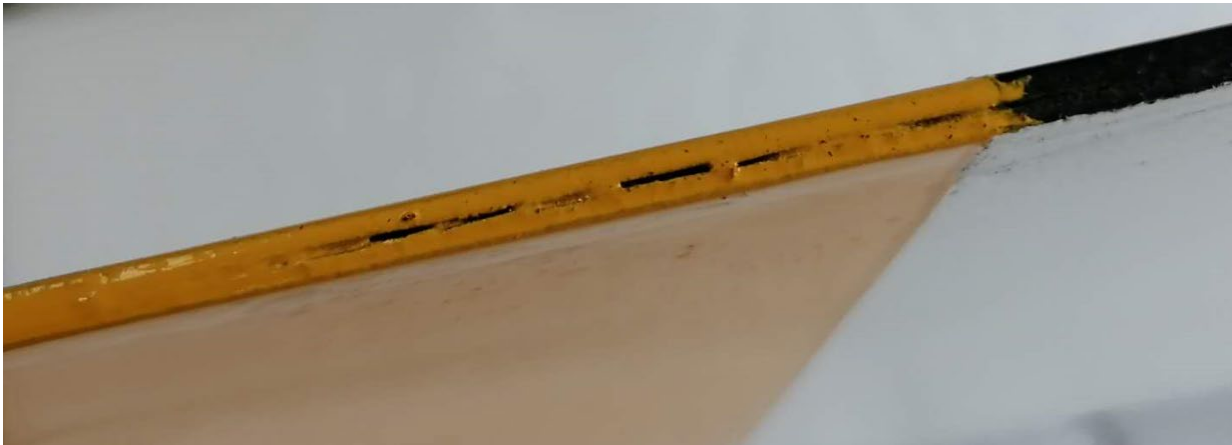
The purpose of this Information Letter (IL) is to inform owners/operators of possible voids or gaps that may be found on the trailing edge area of some main rotor blades 407-015-001-137 that have been delivered. A complete stock purge of the Bell inventory has been accomplished, therefore no new main rotor blade deliveries following the release date of this letter should have these defects.

If voids or gaps are found on the trailing edge area during scheduled/periodic inspections, they can be repaired in accordance with the 407-MM Maintenance Manual [DMC-407-A-62-10-00-10A-685A-A](#).
