## INFORMATION LETTER

**505-20-12**  
7 October 2020

**TO: All owners and operators of Model 505 helicopters**

**SUBJECT: FORWARD TAIL ROTOR DRIVESHAFT CORROSION**

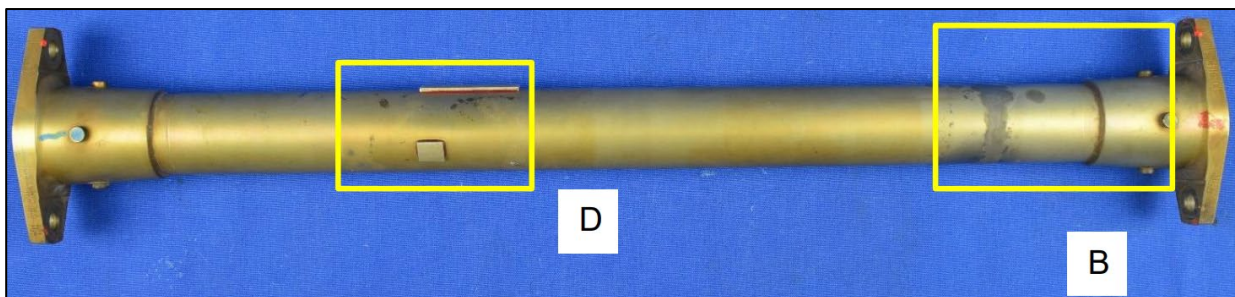
Bell has received reports of forward tail rotor driveshafts 406-040-315-119 having similar surface discoloration patterns as shown below. Our investigation revealed that the residue from an engine cleaning solution is most likely the cause. The appearance of the discoloration on the shaft is consistent with fluid dripping and flowing around the tube. The chromate conversion and cadmium plating protective coatings were no longer present within these discolored areas.

This information letter is to advise owner/operators that the use of cleaning products for other tasks, engine washing in this example, could have an adverse effect on other components such as the driveshaft in this case. It is important to perform a thorough rinse and wipe the driveshaft clean of any engine wash solution residue after its use.

Refer to BHT-ALL-SPM chapter 5, for the applicable best practices' procedure for cleaning metal surfaces. Chapter 3 provides instructions for corrosion control and protective covering/coatings treatments.
