**OPERATION SAFETY NOTICE**

**206-19-42**

**SUBJECT: ROLLS-ROYCE M250 ENGINES - MAINTENANCE WARNING - EXTERNAL LINES**

## MAINTENANCE WARNING - EXTERNAL LINES

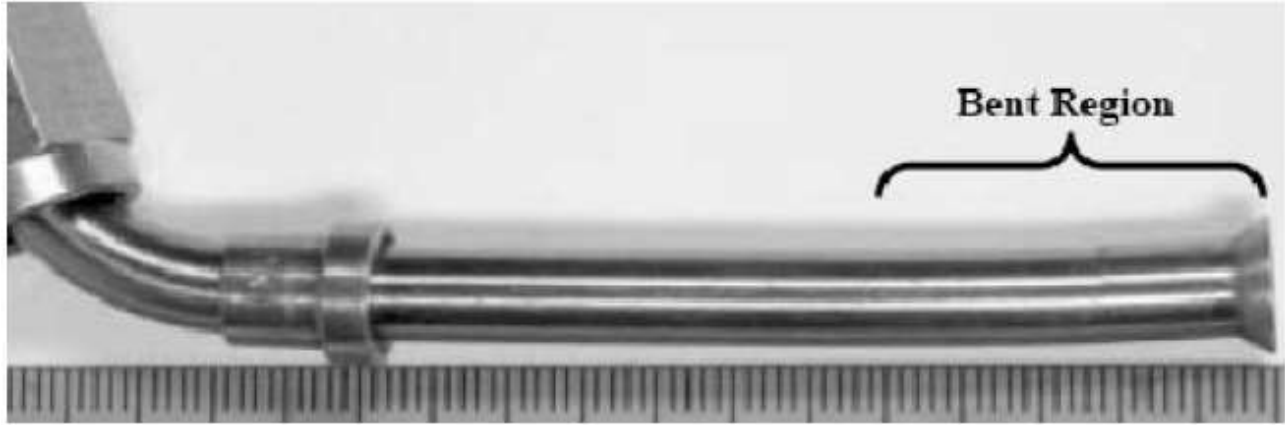
- A. The tube is bent in an area that is not a principal bend, a region that should be straight. See [Figure 1](#).
- B. Severe fretting was found under the ferrule sleeve caused by misalignment of the tube to fitting joint. See [Figure 2](#).
- C. The flared tube was found cracked 270° circumferentially in the area of ferrule fretting. The crack and fretting were likely caused by misalignment of the tube to fitting joint. See [Figure 3](#).

Tube Assembly, P/N 6890581  
FIG. 1

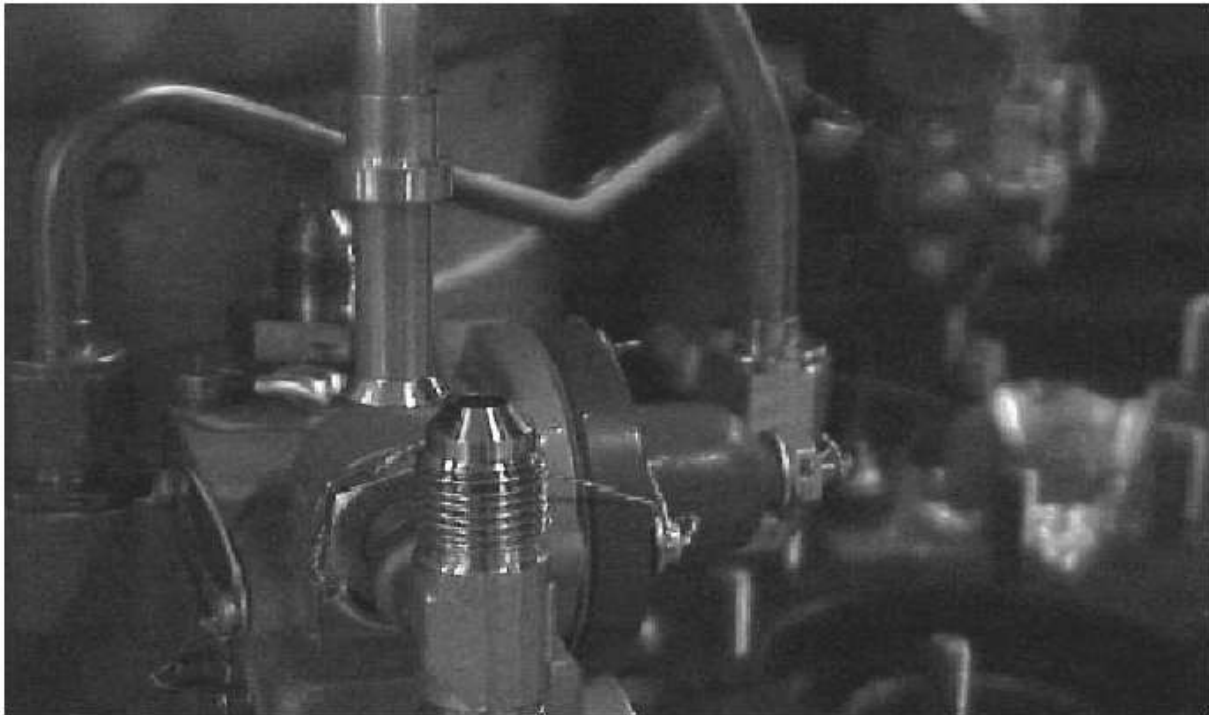
Misaligned Tube  
FIG. 5

- C. Always use a torque reaction wrench when tightening tube assembly B-nuts.
- D. Tube assemblies must fit and be aligned with the mating flare tube fittings to the degree that at both ends of the assembly, the flares shall be uniformly seated in a free state on the cones of the mating fittings. The fitting shall be without distortions or stretching of the tube assembly, and to the degree that the nuts can be fully engaged up to the final one-half turn with light finger pressure. See [Figures 5](#) and [6](#).

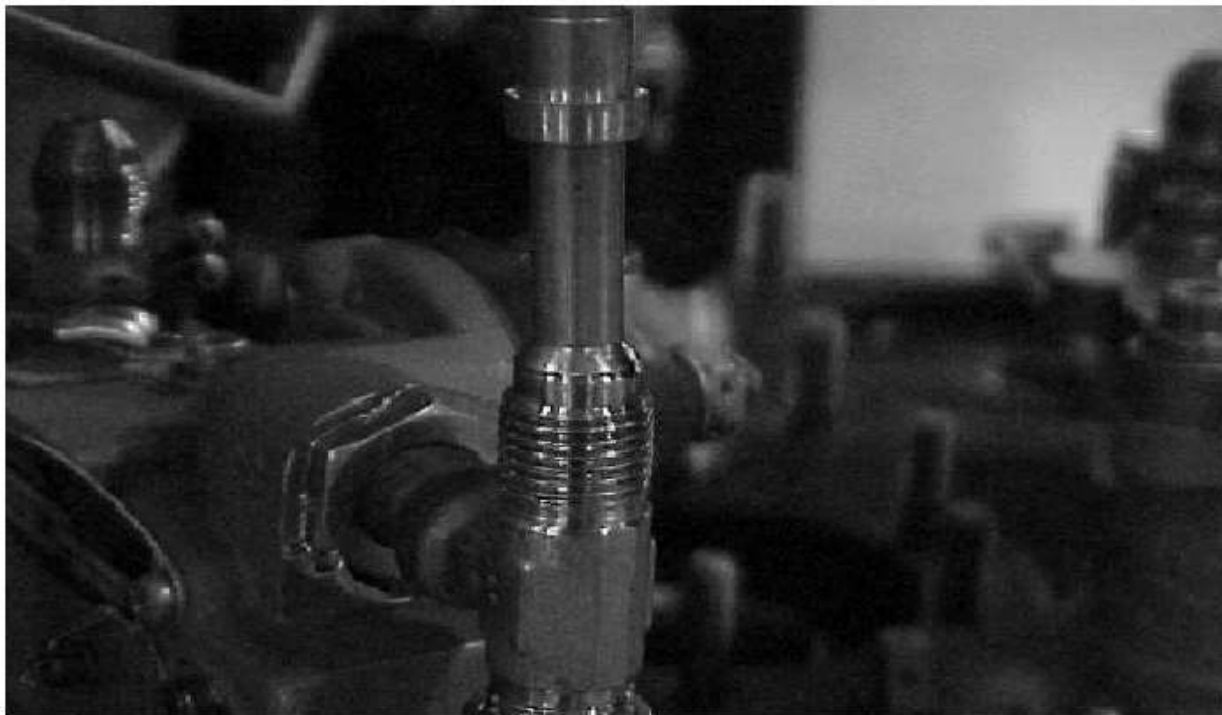
Properly Aligned Tube  
FIG. 6

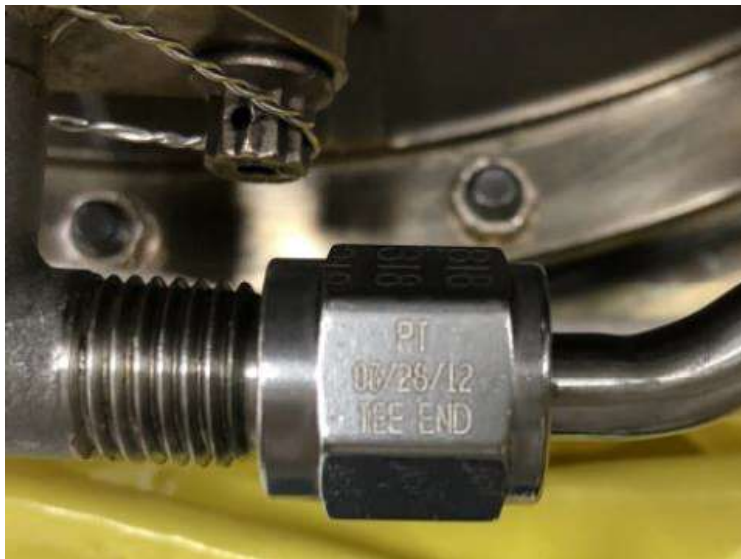
23037410 and 23038235 Series IV Pressure Oil Tubes  
FIG. 12

- 23051141 and 23054628 Series II Scroll-to-Pc filter (Figure 15)
- 23037410 and 23038235 Series IV pressure oil tube from #6/7 bearing tee to the #8 bearing fitting (Figure 12)
- 23064620 Series IV anti-ice solenoid-to-actuator (Figure 17).

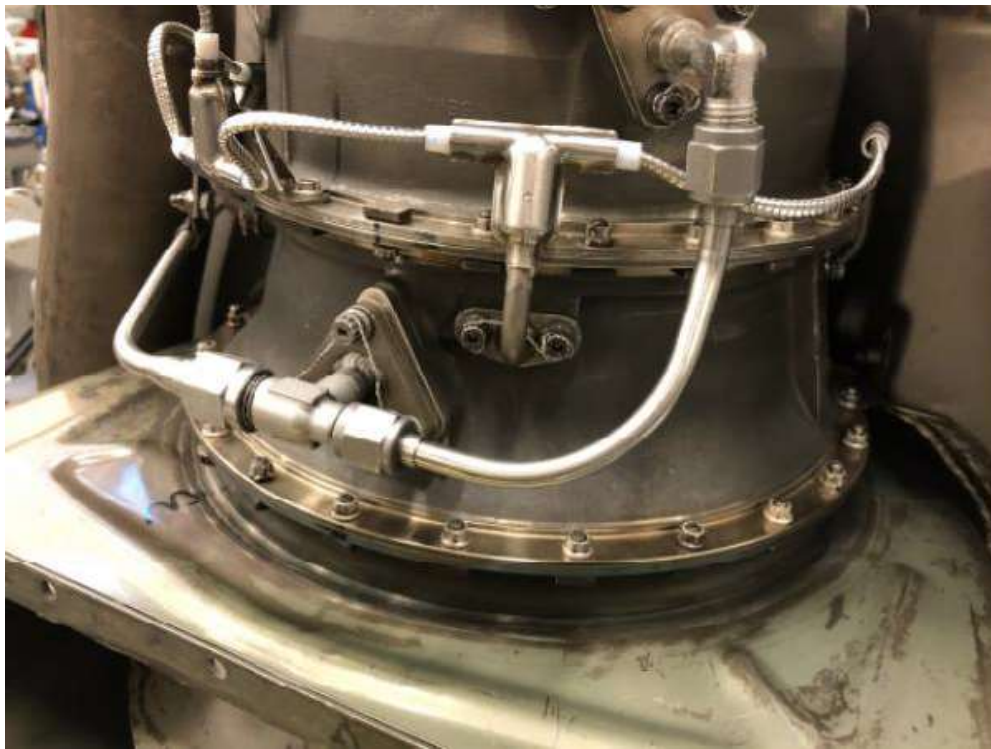
Incorrect Installation  
FIG. 12B

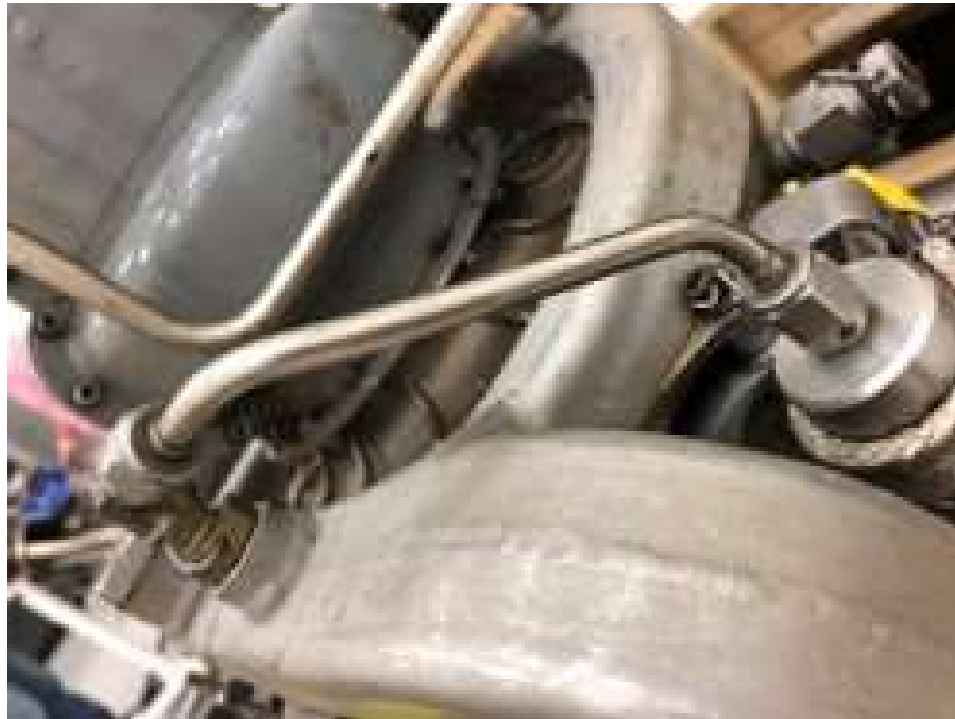
23054628 Series II Scroll to Pc Filter - Incorrect Orientation  
FIG. 15A
