**OPERATIONS SAFETY NOTICE**

**OSN 206L-08-46****TO: ALL MODEL 206L, 206L-1, 206L-3 and 206L-4 OWNERS/OPERATORS****SUBJECT: CYCLIC CONTROLS SYSTEM RIGGING**

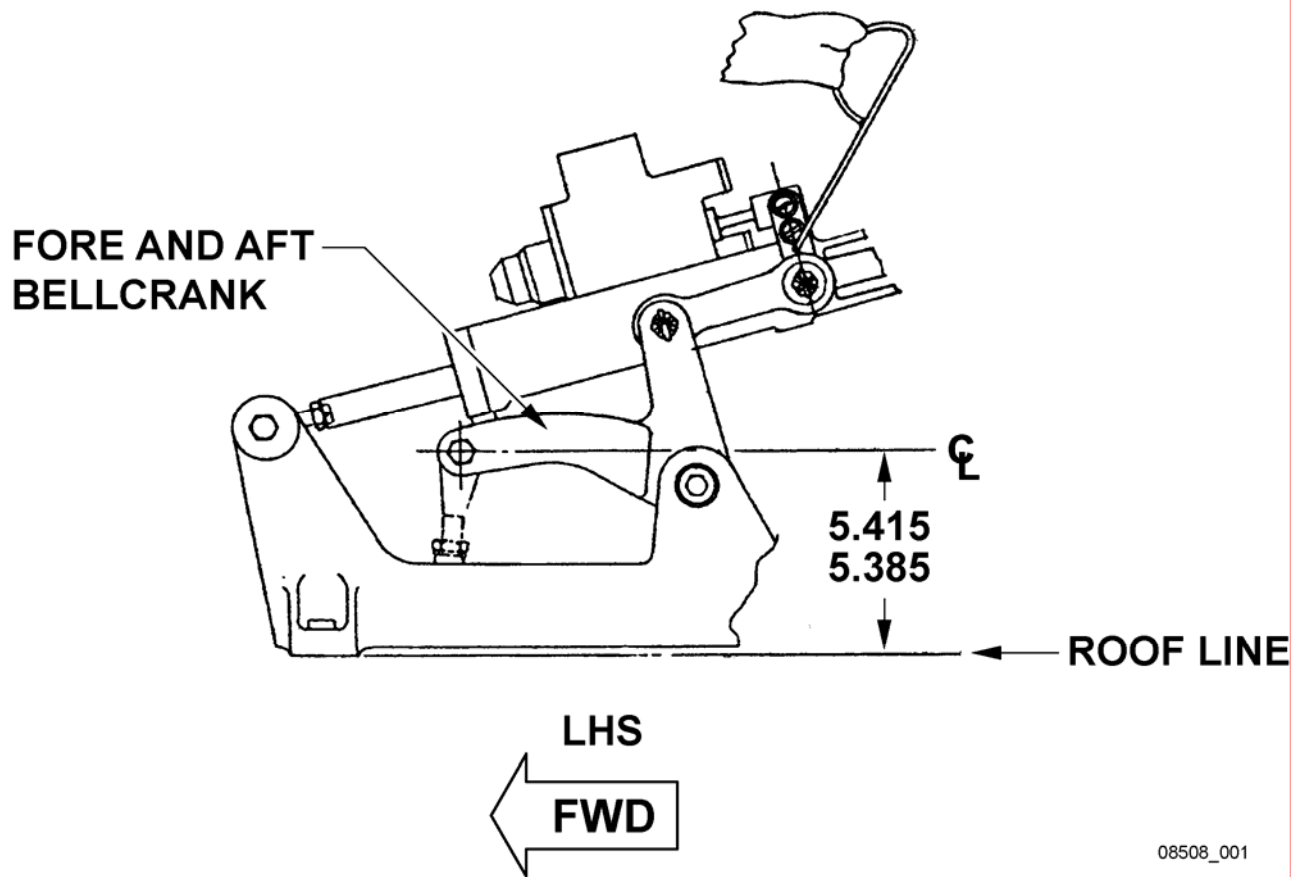
Figure 1. Fore and Aft cyclic rigging dimension.

A Model 206L-4 operator has reported a ground incident where a helicopter was damaged as a result of incorrect rigging of the cyclic control system. Damage occurred when the rotating swashplate outer ring contacted the collective lever. No personnel injuries were sustained.

Investigation has revealed that component contact can occur with the collective in full down position and the cyclic full forward if the dimension shown in Figure 1 is not within the maintenance manual limits.

This Operations Safety Notice is issued to place emphasis on the importance of the rigging dimensions given in the maintenance manual.

In addition, maintenance personnel are reminded to perform a clearance check after accomplishment of flight controls rigging. A verification for sufficient clearance between the swashplate outer ring and the collective lever shall be part of the clearance check.
