OPERATION SAFETY NOTICE

206L-14-50  
21 October 2014

**SUBJECT: HIGH ALTITUDE TAIL ROTOR (HATR) KIT, MAINTENANCE PRACTICES**

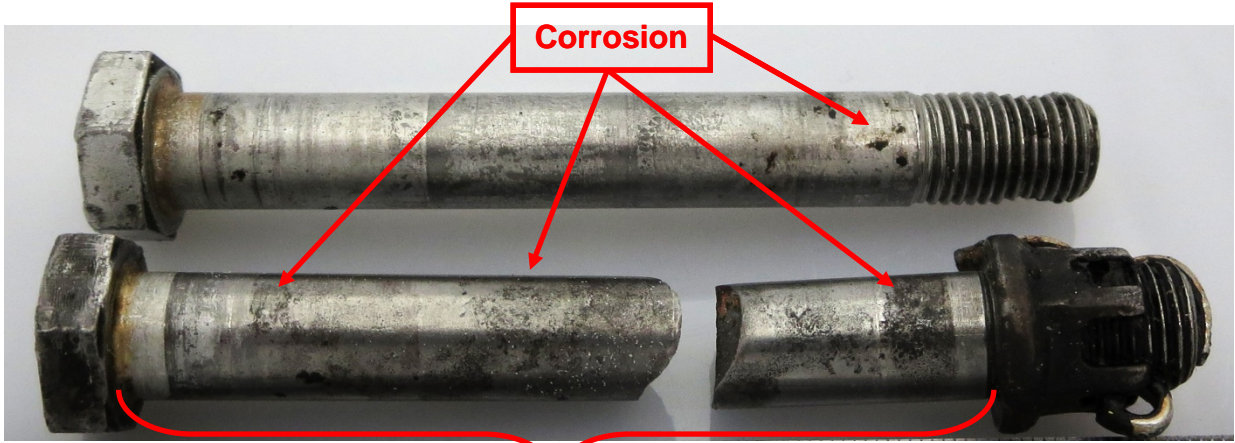
Parts from two of the incidents were returned back to Bell Helicopter Textron for root cause investigation, and the findings indicated several areas of concern related to maintenance practices. All the returned bolts had missing Cadmium plating. One of the cracked bolts was found with pitting corrosion, from which the fatigue crack propagated. The crack occurred in two distinct phases, meaning the crack was already existent prior to the final failure. The bolt had been removed and re-used in that cracked condition. The second cracked bolt showed fretting and corrosion on the bolt, which also led to a fatigue crack initiating from that location.

**Missing Cadmium plating**

This OSN is published to heighten customer's awareness to the importance of the corrosion protection that is applied to components and hardware. When applicable, the use of published procedures to add or repair damaged or missing corrosion protective material should be followed (refer to the Information Letter GEN-03-89, the Corrosion Control Guide (CSSD-PSE-87-001), and the Standard Practice Manual (BHT-ALL-SPM)). We also want to highlight the importance of following all installation procedures preventing "shanking" of bolts and assuring proper torque applications to the installed hardware.

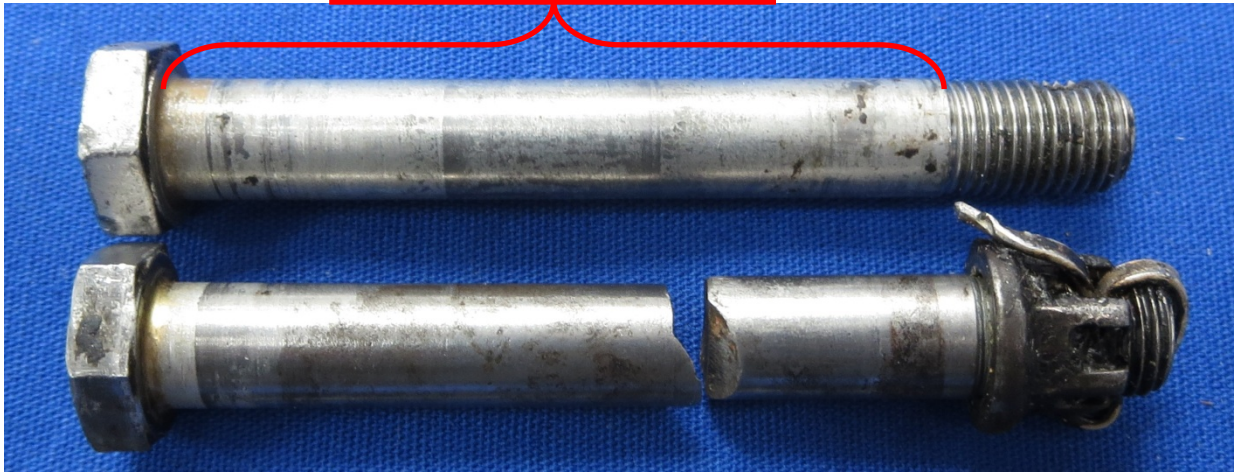
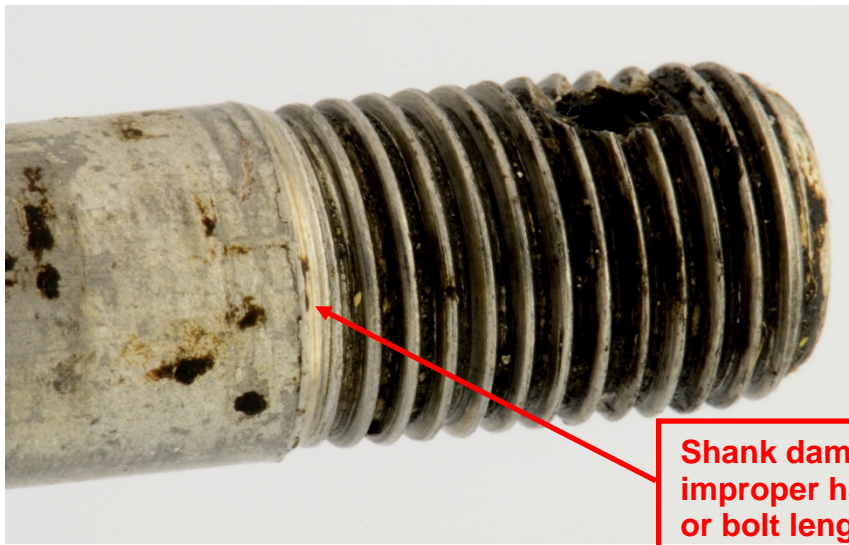
**FIGURE 1 – High Altitude Tail Rotor Blade Retention Bolts**

One of the bolts showed that there was deformation to the shank of the bolt indicating that an improper stack up of washers and/or bolt lengths was used during the installation.

**Shank damage due to improper hardware stack-up or bolt length**
