**OPERATION SAFETY NOTICE**

**206L-19-54**

**SUBJECT: ROLLS-ROYCE M250 ENGINES - MAINTENANCE WARNING - EXTERNAL LINES**

## MAINTENANCE WARNING - EXTERNAL LINES

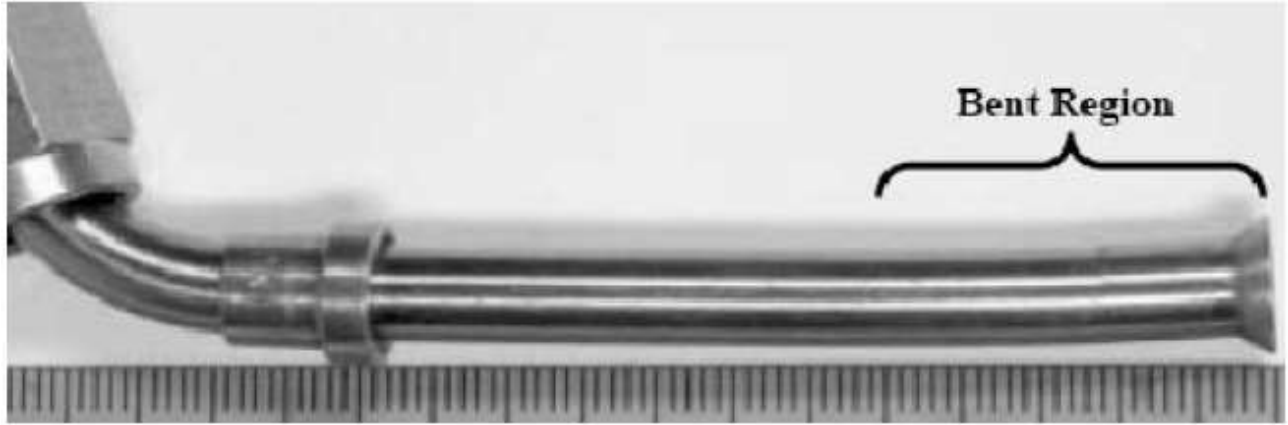
Tube Assembly, P/N 6890581  
FIG. 1

- A. The tube is bent in an area that is not a principal bend, a region that should be straight. See [Figure 1](#).
- B. Severe fretting was found under the ferrule sleeve caused by misalignment of the tube to fitting joint. See [Figure 2](#).
- C. The flared tube was found cracked 270° circumferentially in the area of ferrule fretting. The crack and fretting were likely caused by misalignment of the tube to fitting joint. See [Figure 3](#).

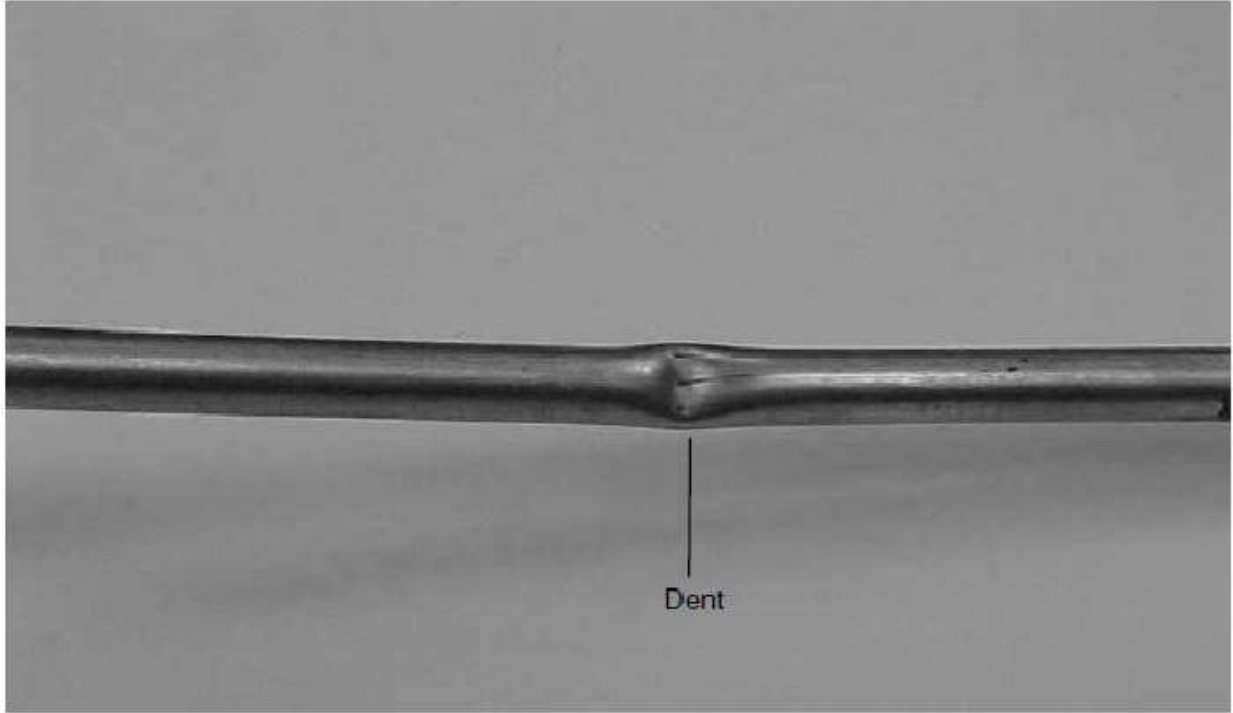
Tube Assembly, P/N 23033896  
FIG. 4

P/N 23033896 tube assembly was removed from a Model C20R Series engine. Photographs were taken of the deformations in the tube assembly and are indicated in [Figure 4](#). The following discrepancies were noted during the examination of the tube assembly:

- A. The deformations were caused by attempting to use Model C20R Series single engine designated clamping on a multi-engine configuration tube.
- B. The previously mentioned clamp hid the large dent. Only removal of the tube assembly allowed discovery of the extent of damage to the tube.

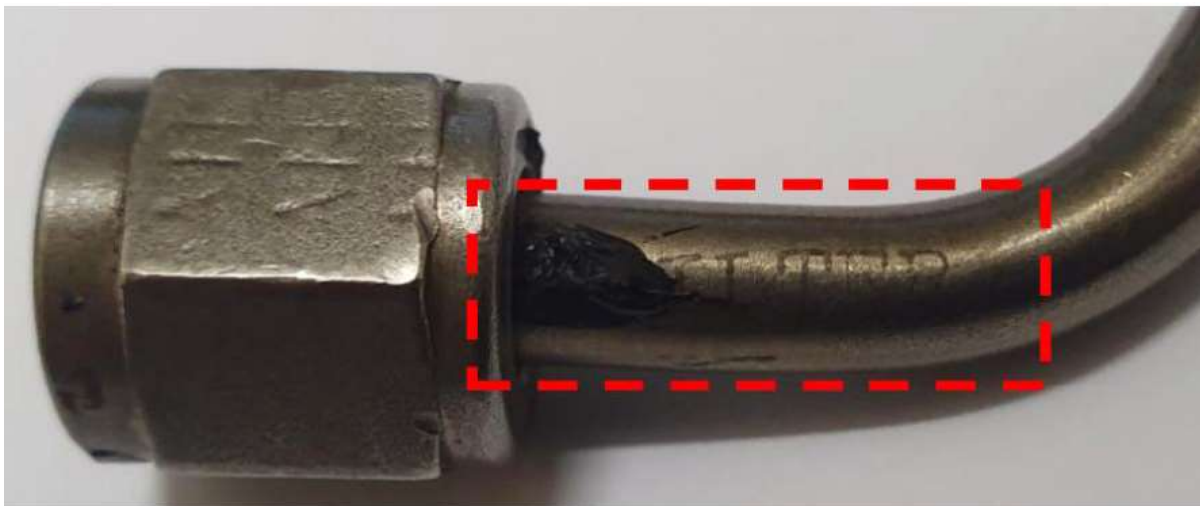
Orientation Mark  
FIG. 9

P/N 23051141 tube assembly was removed from a C20J engine after experiencing an in-flight power loss, followed by a hard landing. Photographs were taken of the tube while installed and after being removed as shown in [figures 9](#) through [11](#). The following discrepancies were noted during the examination of the tube assembly:

- A. The tube was corroded at both ends near and underneath the ferrules.
- B. The tube was installed backwards. The word "FILTER" is etched on the tube to indicate the end that should be adjacent to the Pc filter when installed.
- C. The separation between the tube's fracture surface and the B-nut attached to the filter indicates the tube was under stress due to misalignment.
- D. This aircraft had spent several years in a coastal environment, which likely contributed to the corrosion seen on the tube.

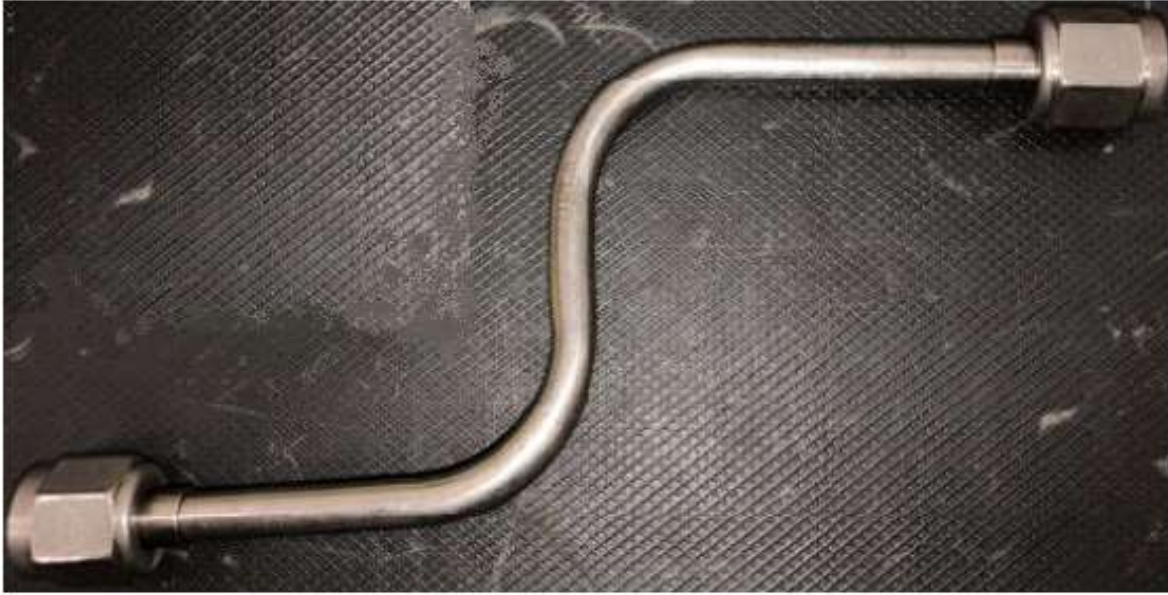
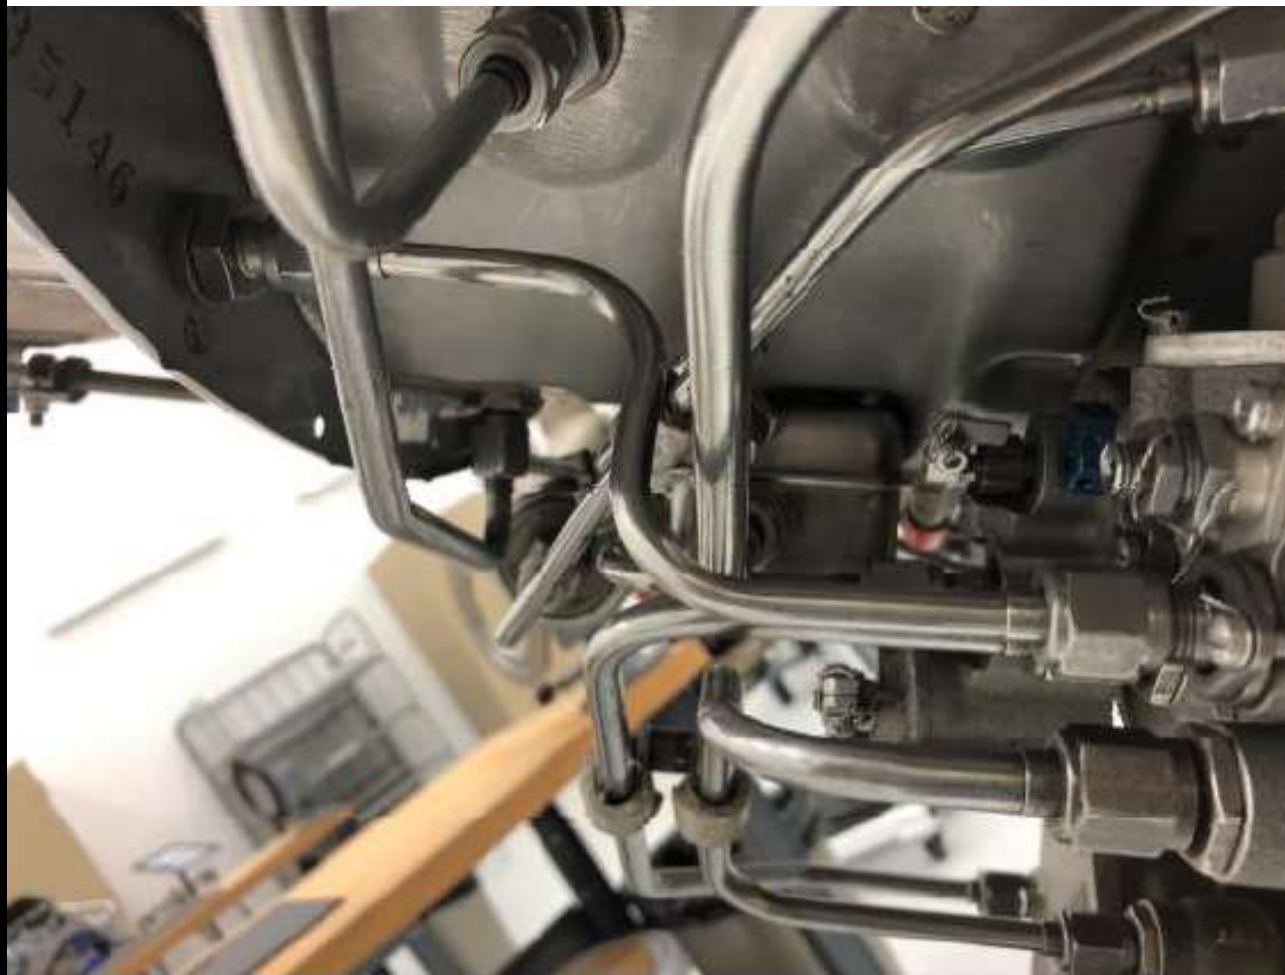
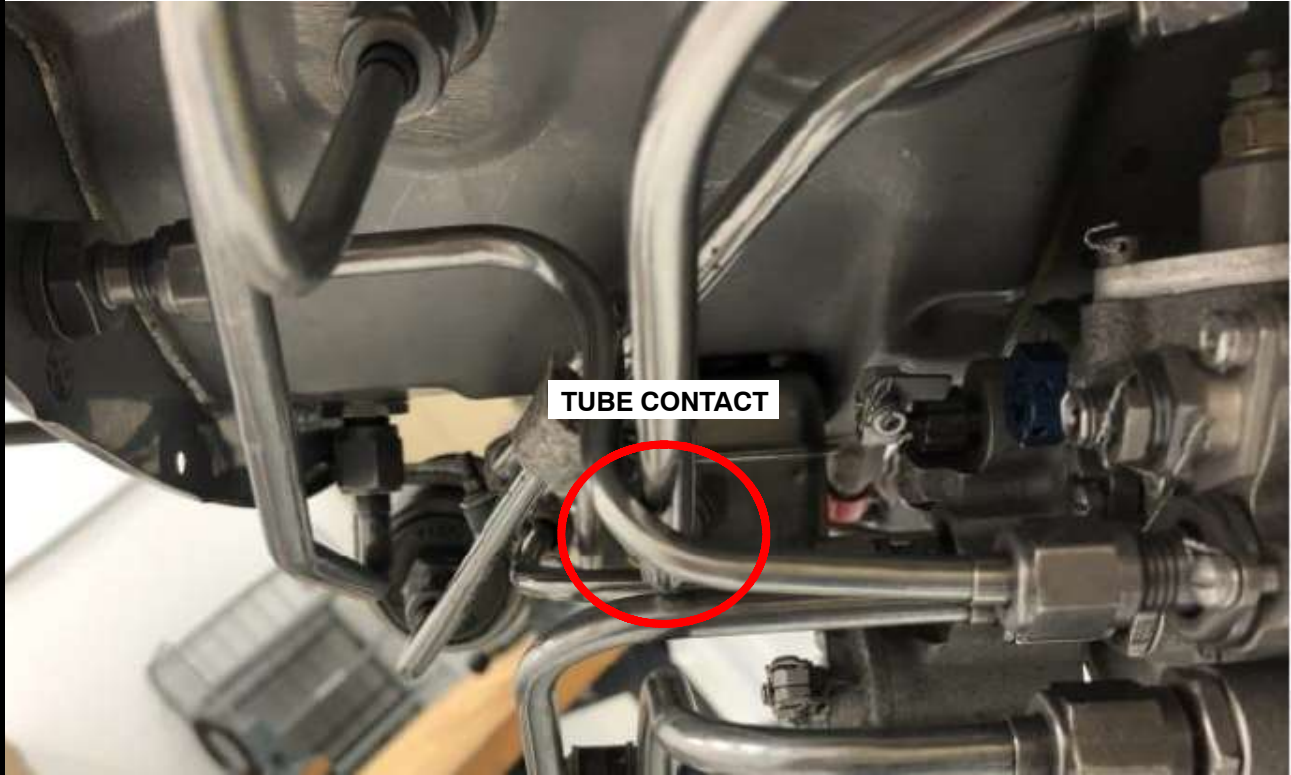
6844169 FCU to Fire Shield Series II  
FIG. 13

Two tubes can fit either way, but one way results in contact with another tube. In this case, one must ensure that the orientation with the largest clearance from other tubes is selected. These tubes are:

- 6844169 Series II FCU-to-fire shield (Figure 13)
- 6890580 Series III/IV FCU-to-fire shield (Figure 14).
