OPERATION SAFETY NOTICE

205-15-47
205B-15-18
212-15-51
412-15-42
412CF-15-14

SUBJECT: TAIL ROTOR CONTROL TUBE 212-001-055-101 FOUND CRACKED.

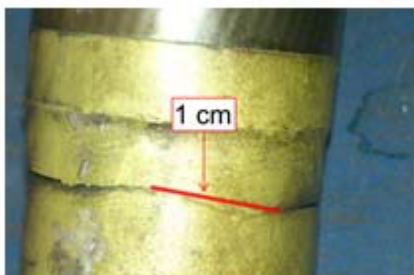
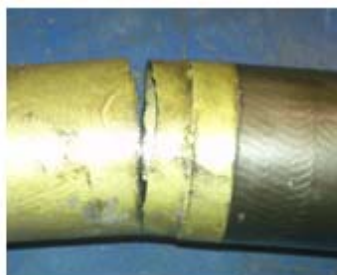
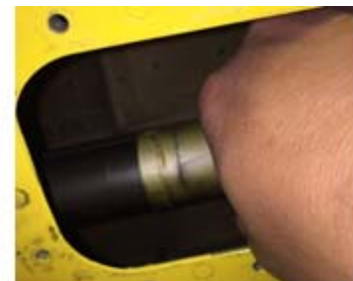
Bell Helicopter is currently investigating a tail rotor flight control tube 212-001-055-101 found cracked during the scheduled inspection. The circumferential fracture was located at approximately 20 inches (50.8 cm) from the clevis bolt holes at the lower end of the tube.

The purpose of this OSN is to emphasize the importance of performing the scheduled inspections as recommended by the applicable Maintenance Manual. Thorough visual inspection of flight control tubes, bellcranks, and associated bearings is critical. During inspections, ensure smooth operation of tail rotor controls through full travel range and that no binding is present.
