OPERATION SAFETY NOTICE

407-19-23

**SUBJECT: ROLLS-ROYCE M250 ENGINES - MAINTENANCE WARNING -
EXTERNAL LINES**

MAINTENANCE WARNING - EXTERNAL LINES

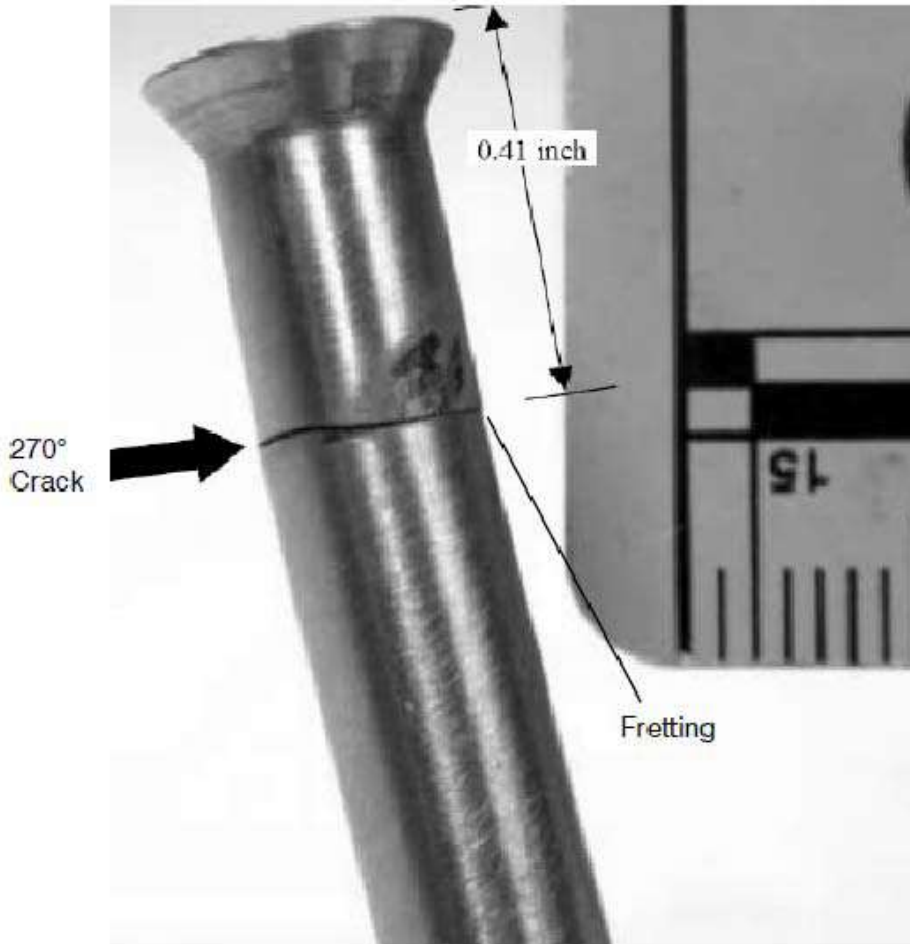
- A. The tube is bent in an area that is not a principal bend, a region that should be straight. See [Figure 1](#).
- B. Severe fretting was found under the ferrule sleeve caused by misalignment of the tube to fitting joint. See [Figure 2](#).
- C. The flared tube was found cracked 270° circumferentially in the area of ferrule fretting. The crack and fretting were likely caused by misalignment of the tube to fitting joint. See [Figure 3](#).

Tube Assembly, P/N 6890581
FIG. 2

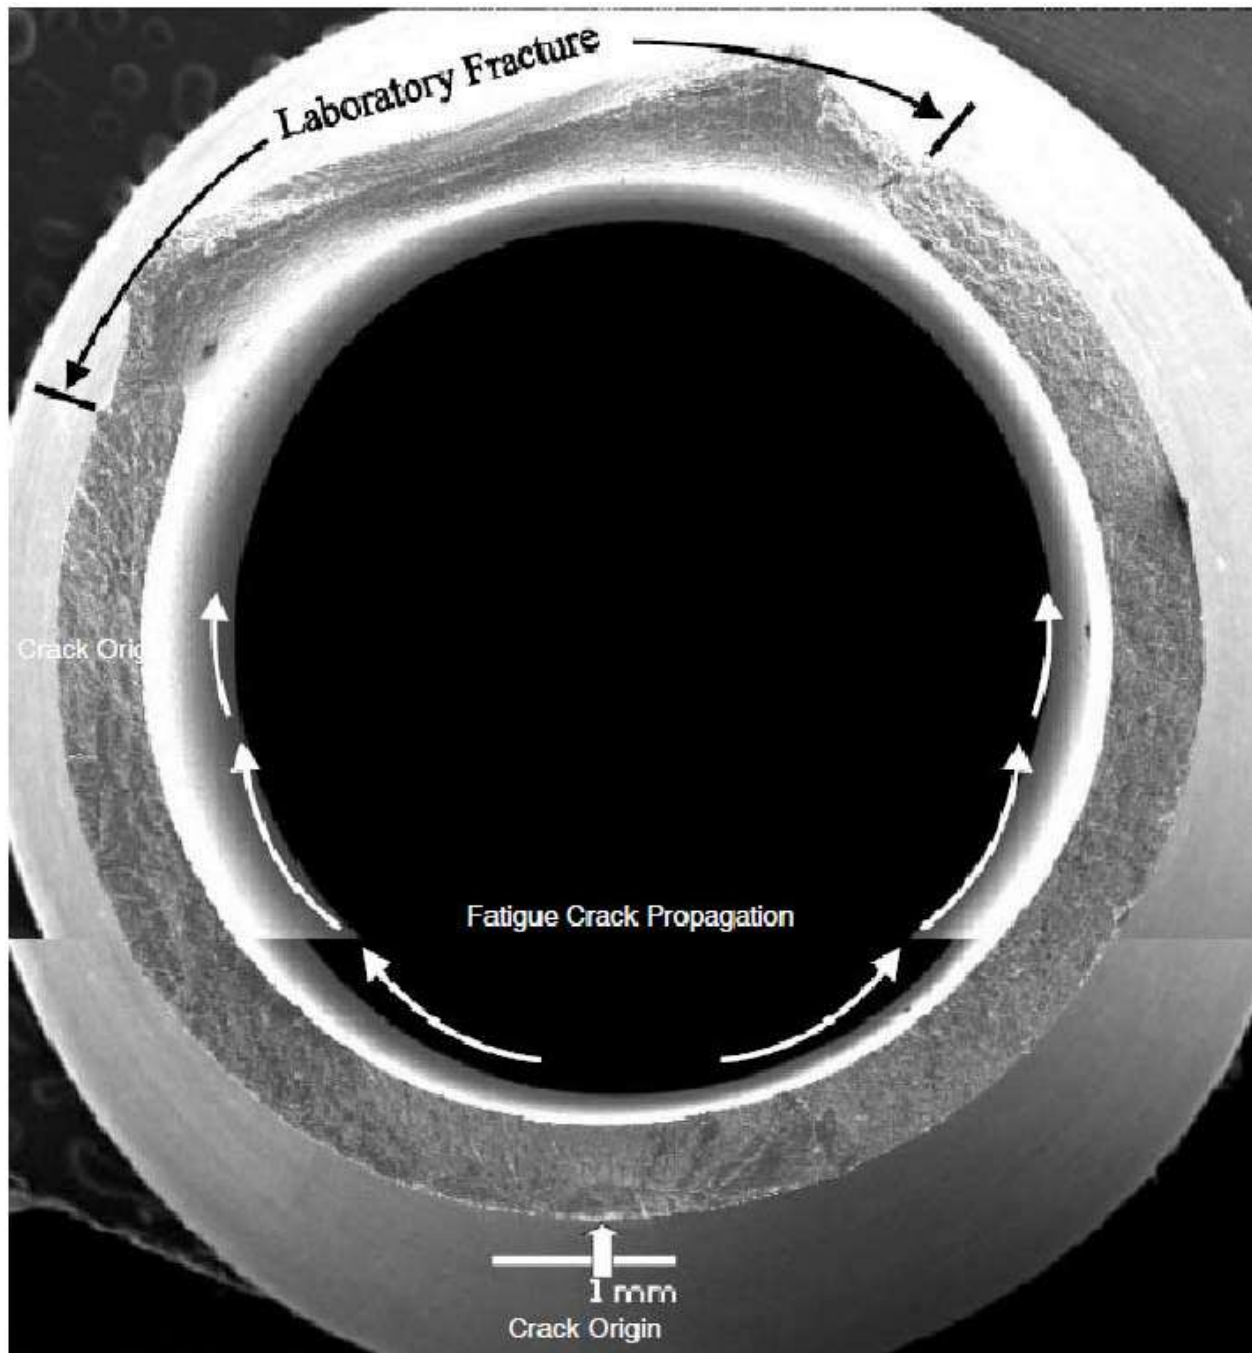
Tube Assembly, P/N 6890581 Surface of Fracture

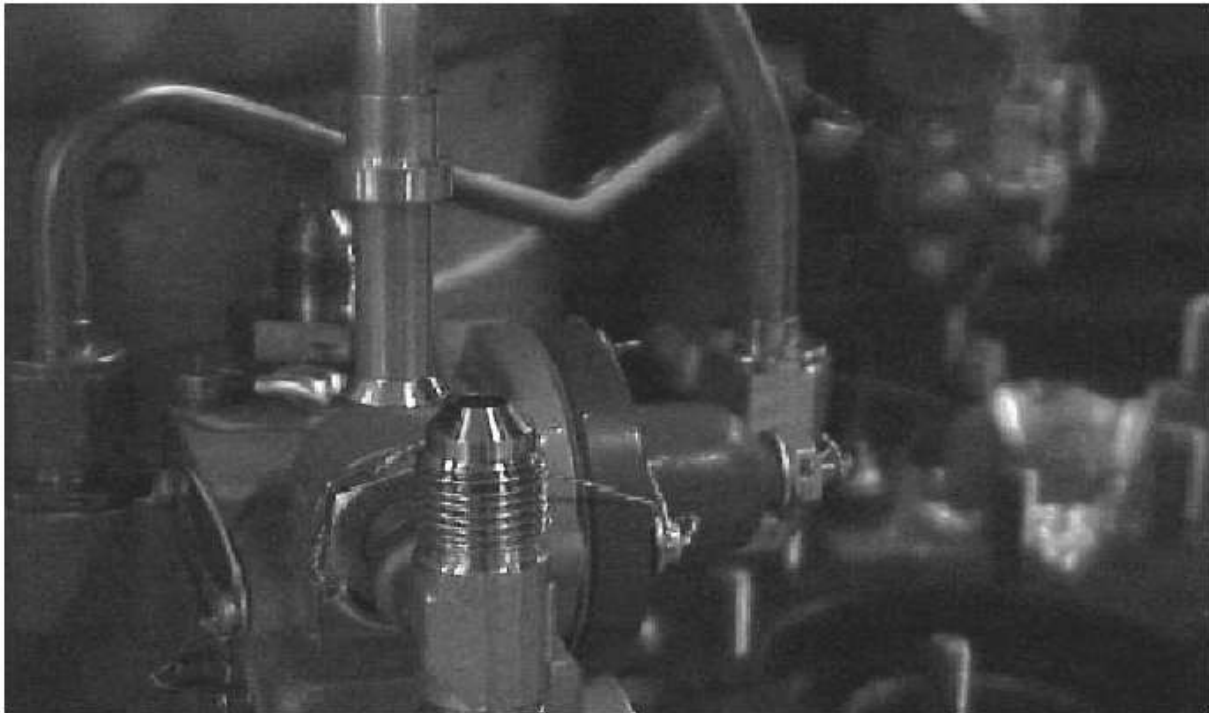
Misaligned Tube
FIG. 5

- C. Always use a torque reaction wrench when tightening tube assembly B-nuts.
- D. Tube assemblies must fit and be aligned with the mating flare tube fittings to the degree that at both ends of the assembly, the flares shall be uniformly seated in a free state on the cones of the mating fittings. The fitting shall be without distortions or stretching of the tube assembly, and to the degree that the nuts can be fully engaged up to the final one-half turn with light finger pressure. See [Figures 5](#) and [6](#).

- E. In the event that a tube does not align with the mating fittings, re-position the mating fittings to the degree that proper alignment may be attached. Final tightening of these fitting lock nuts must be accomplished before the tube assembly is torqued.

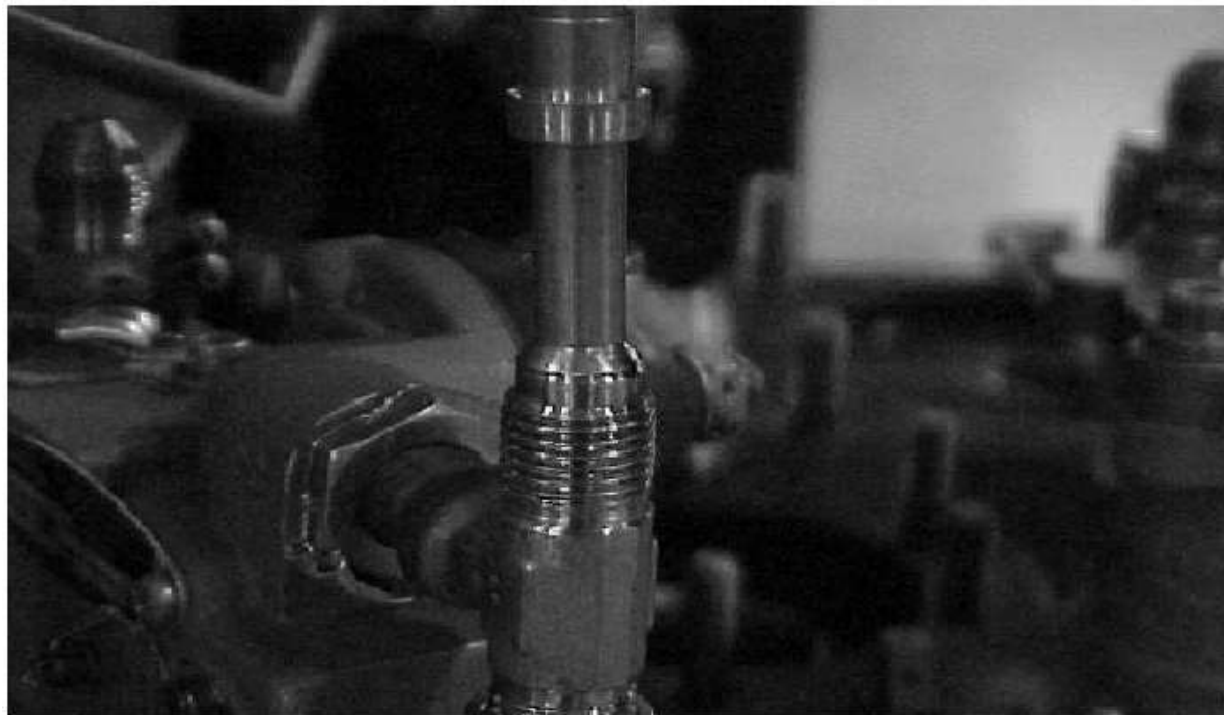
Properly Aligned Tube
FIG. 6

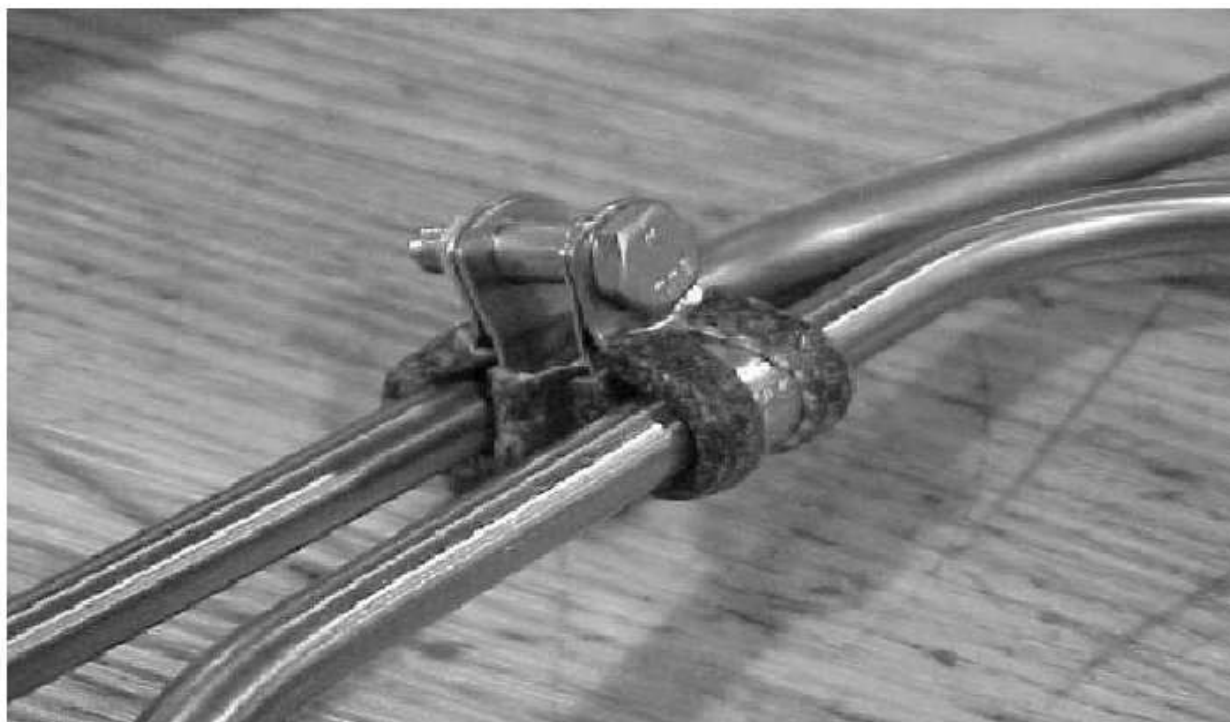
Correct Cushion Material
FIG. 7

- L. Clamp the tube assemblies as shown in the appropriate Illustrated Parts Catalogs and/or Commercial Engine Bulletins.
- M. Do not install unauthorized clamps, hardware, fittings, chafe material, etc., on the engine tube assemblies. See [Figure 7](#) for a correct cushion material example.

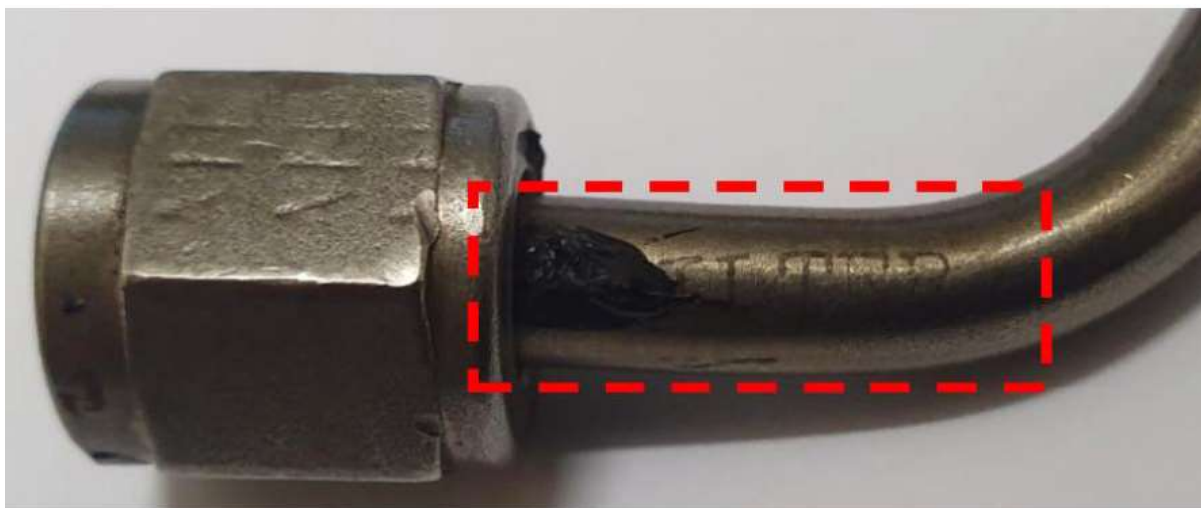
P/N 23051141 tube assembly was removed from a C20J engine after experiencing an in-flight power loss, followed by a hard landing. Photographs were taken of the tube while installed and after being removed as shown in [figures 9](#) through [11](#). The following discrepancies were noted during the examination of the tube assembly:

- A. The tube was corroded at both ends near and underneath the ferrules.
- B. The tube was installed backwards. The word "FILTER" is etched on the tube to indicate the end that should be adjacent to the Pc filter when installed.
- C. The separation between the tube's fracture surface and the B-nut attached to the filter indicates the tube was under stress due to misalignment.
- D. This aircraft had spent several years in a coastal environment, which likely contributed to the corrosion seen on the tube.

Orientation Mark
FIG. 9

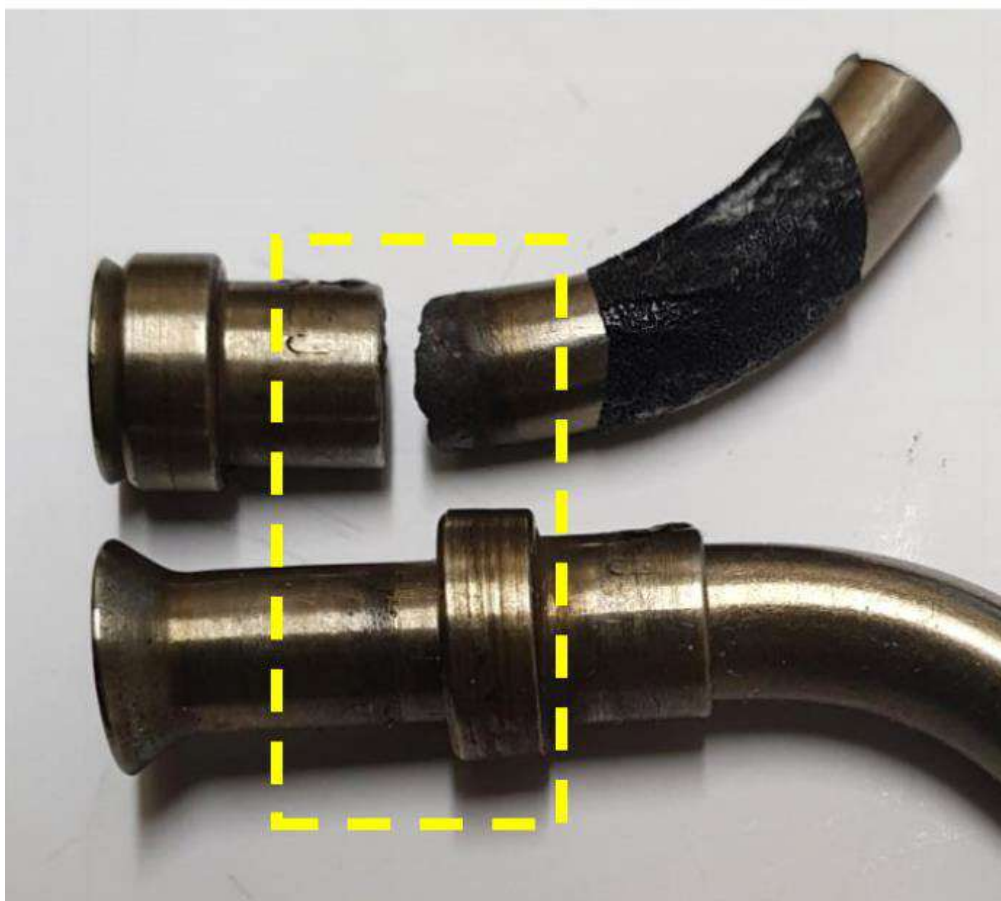
Broken Tubing Showing Corrosion on Tube Under Ferrule
FIG. 10

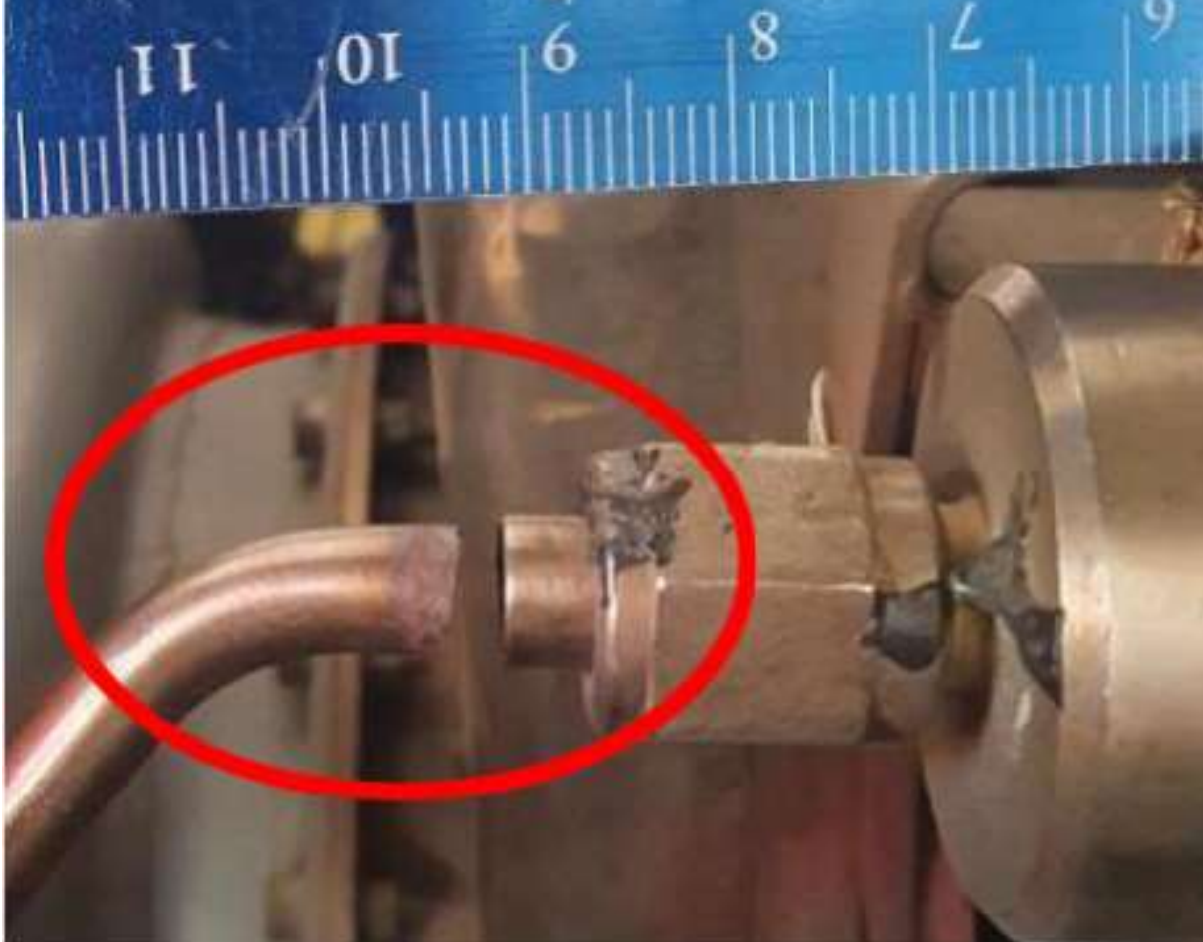
Broken Tubing with Gap Indicative of Misalignment
FIG. 11

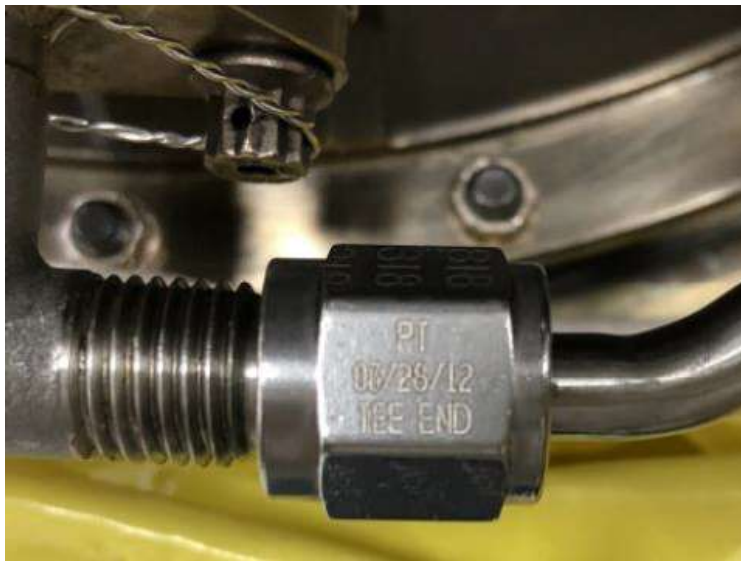
23037410 and 23038235 Series IV Pressure Oil Tubes
FIG. 12

R. Ensure proper orientation of tubes during installation. Several tubes are marked either on the tube itself or the B-Nut to indicate proper orientation. These include:

- 23051141 and 23054628 Series II Scroll-to-Pc filter (Figure 15)
- 23037410 and 23038235 Series IV pressure oil tube from #6/7 bearing tee to the #8 bearing fitting (Figure 12)
- 23064620 Series IV anti-ice solenoid-to-actuator (Figure 17).

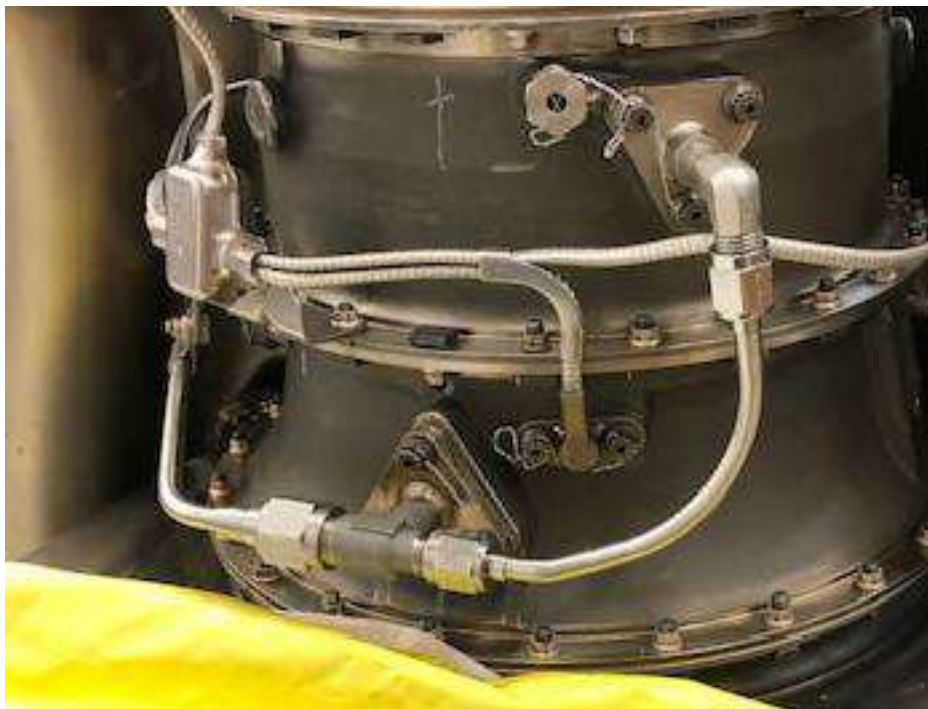
Correct Installation
FIG. 12A

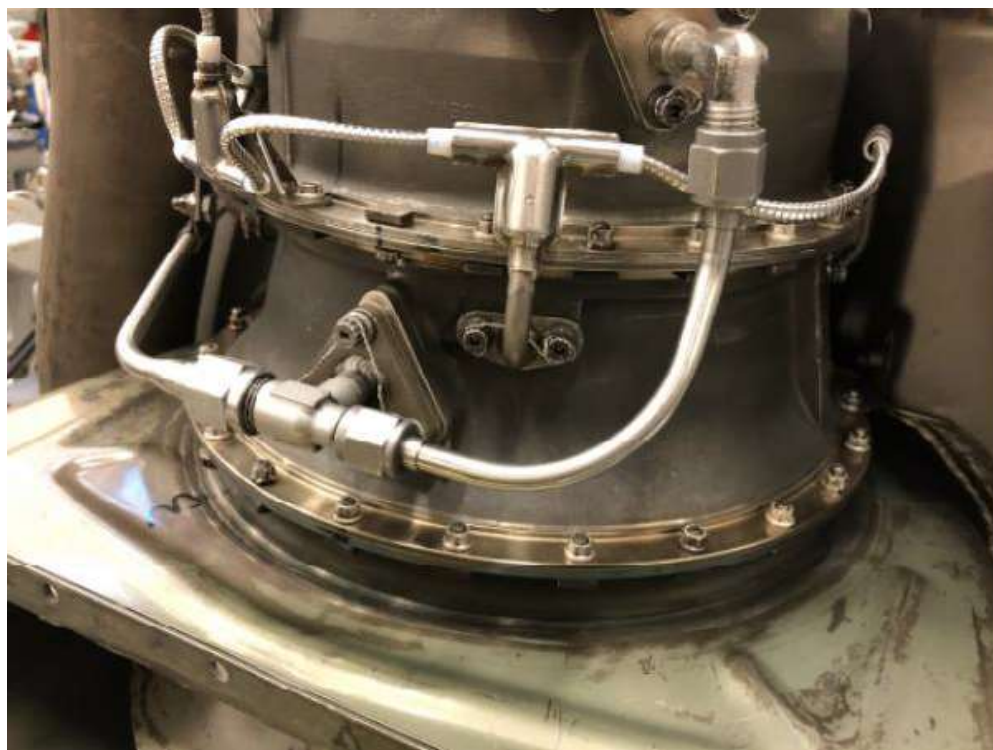
Incorrect Installation
FIG. 12B

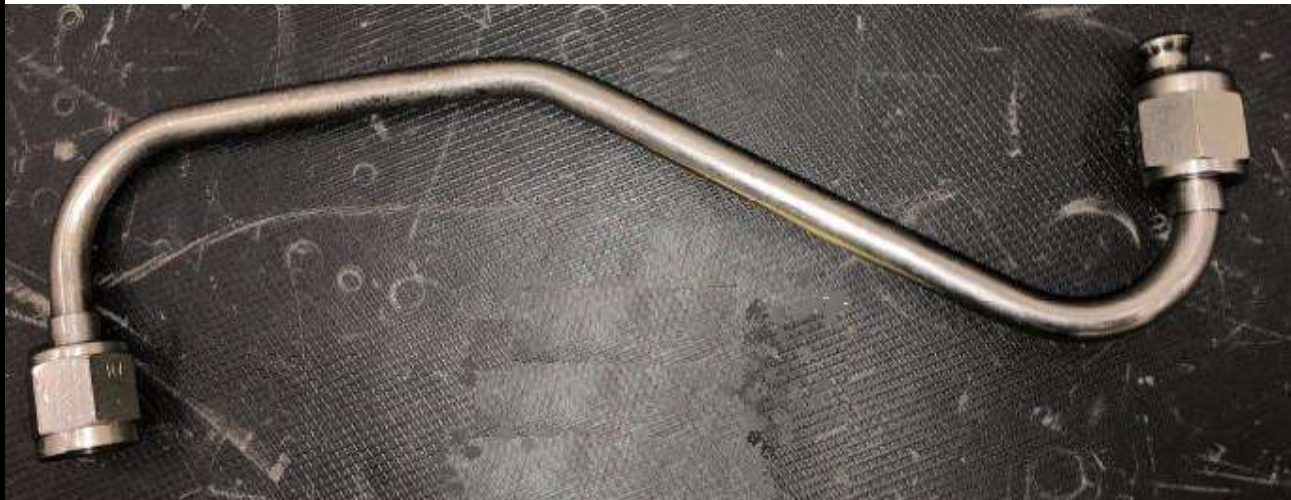
6890580 FCU to Fire Shield Series II
FIG. 14

Two tubes can fit either way, but one way results in contact with another tube. In this case, one must ensure that the orientation with the largest clearance from other tubes is selected. These tubes are:

- 6844169 Series II FCU-to-fire shield (Figure 13)
- 6890580 Series III/IV FCU-to-fire shield (Figure 14).

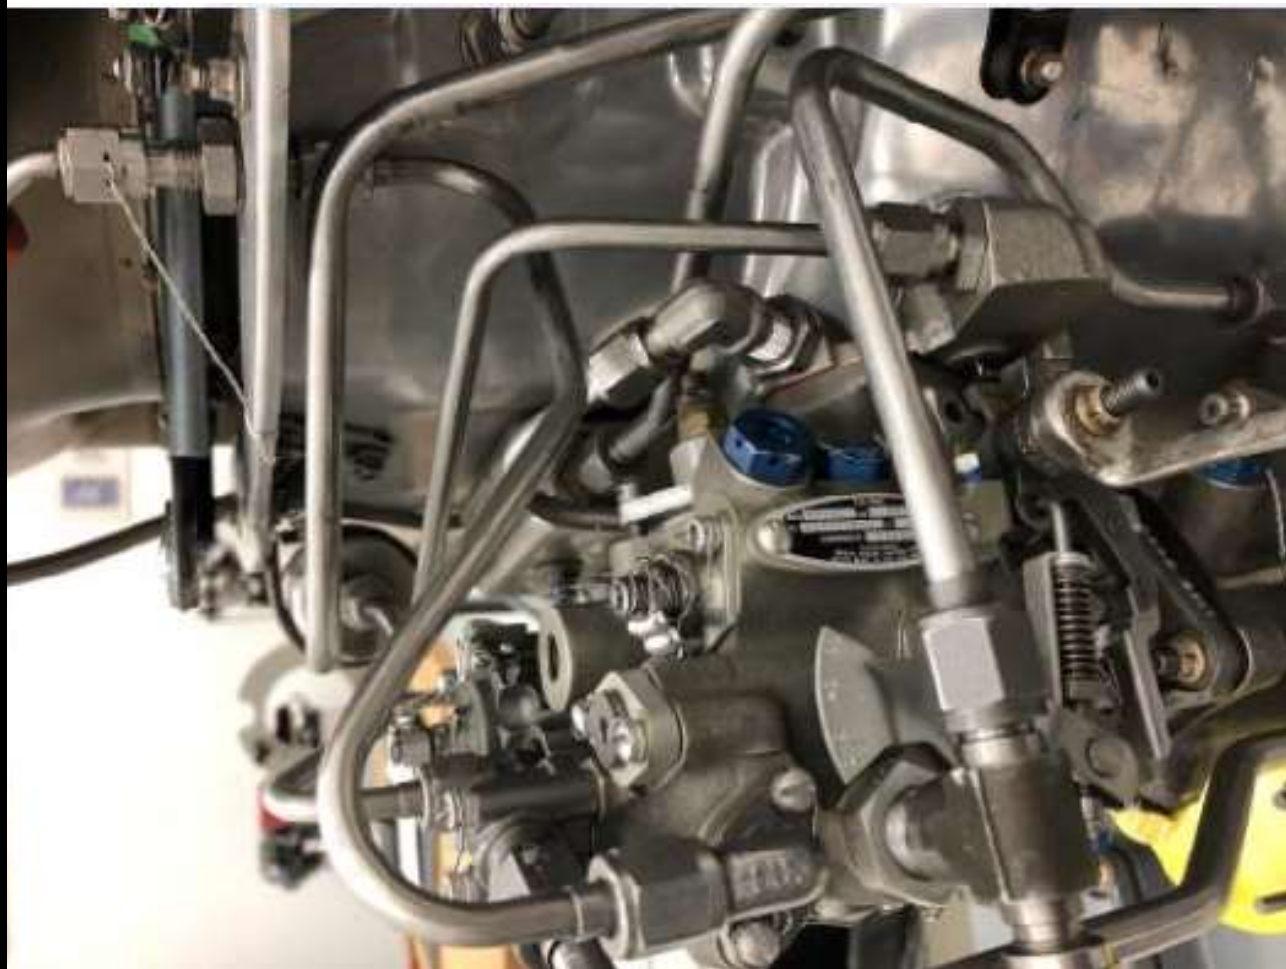
Correct Installation
FIG. 14A

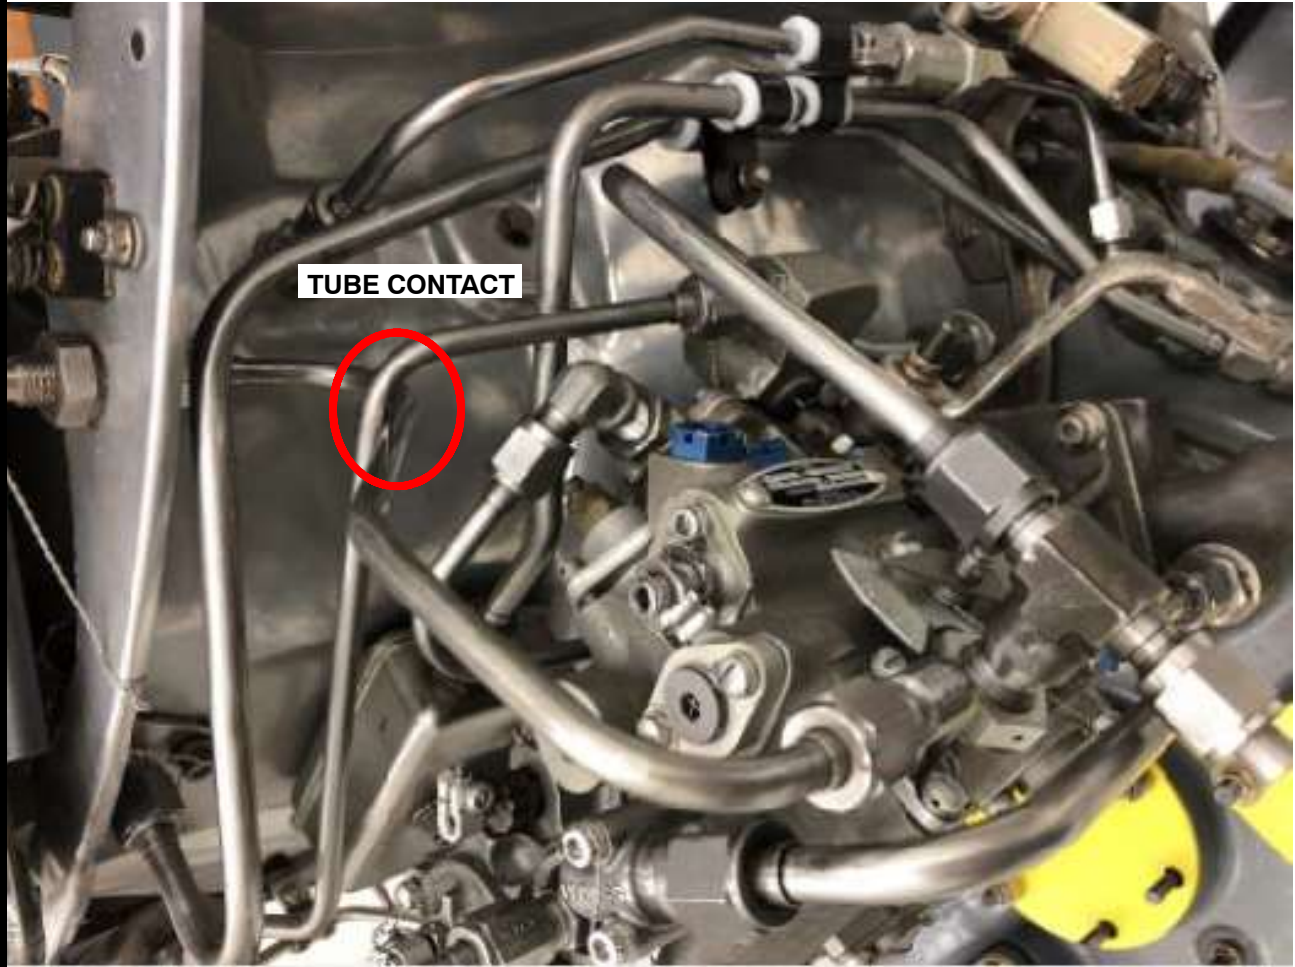
Incorrect Installation
FIG. 14B

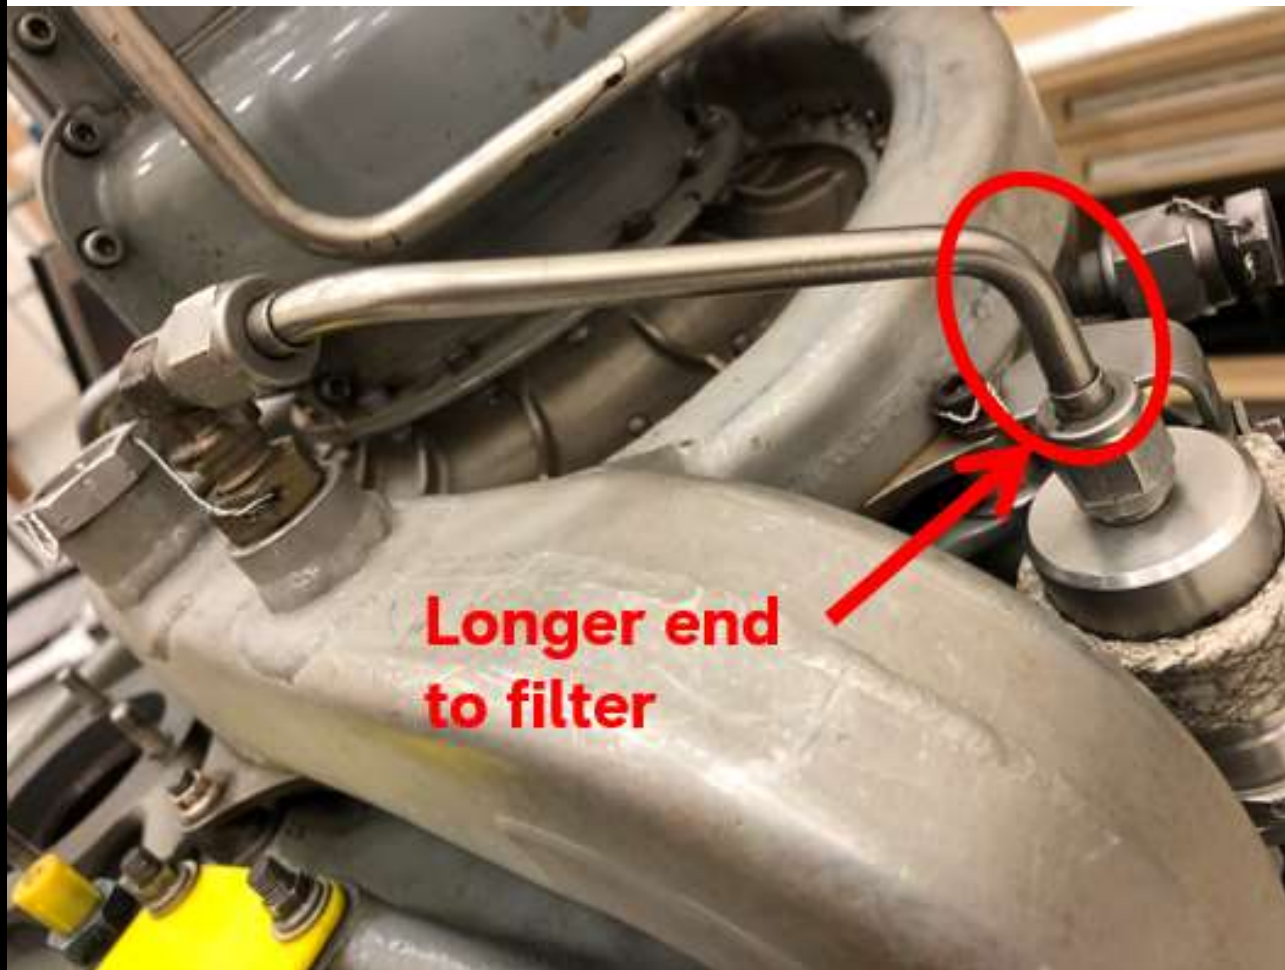
23054628 Series II Scroll to Pc Filter - Correct Orientation
FIG. 15

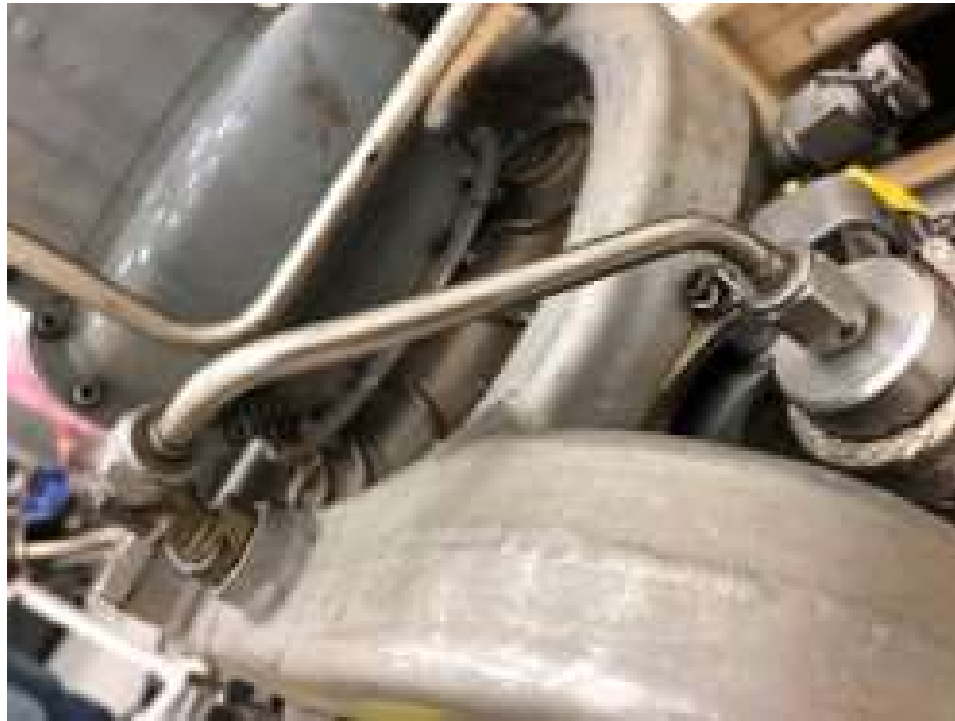
23054628 Series II Scroll to Pc Filter - Incorrect Orientation
FIG. 15A

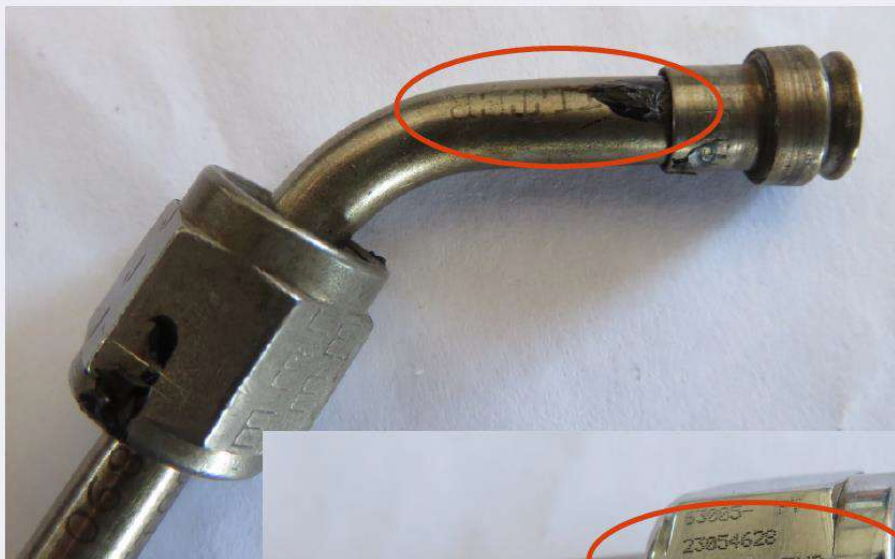
23051141

Tube End Marking
FIG. 16

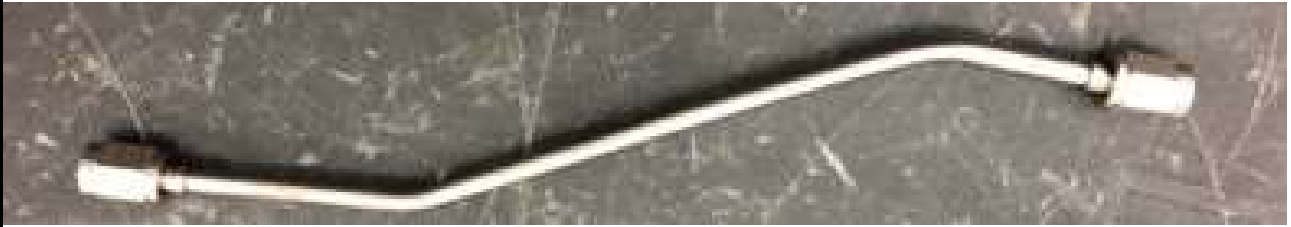
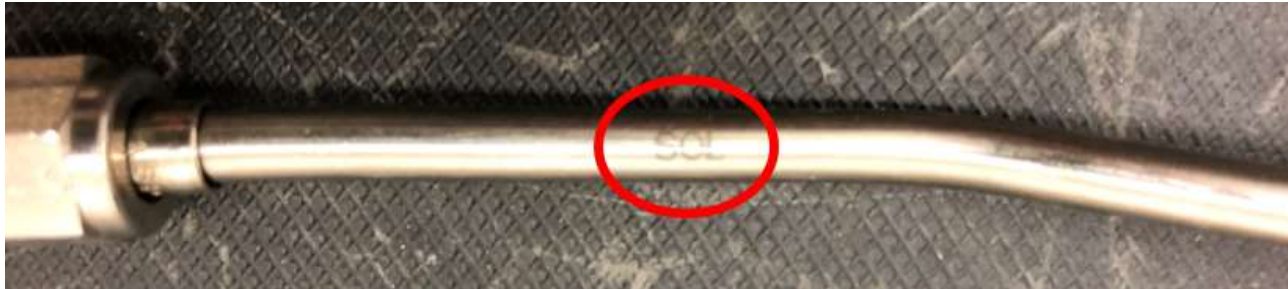
23064620 Anti-ice Valve Series IV Marked with SOL for Solenoid End
FIG. 17
