OPERATION SAFETY NOTICE

GEN-24-54

Revision A, 19 August 2024

SUBJECT: NON-CONFORMING NAS9926-4L NUTS

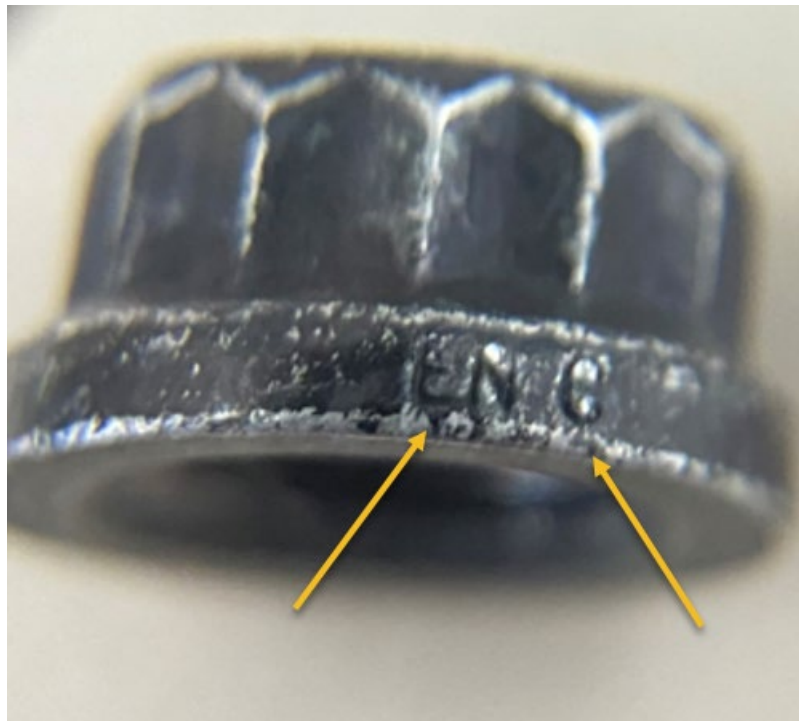
Figure 1. NAS9926 nut manufactured by ESNA

Bell and the Supplier are still investigating the root cause of the non-conformity. Based on findings, it has been established that only the NAS9926-4L ESNA manufactured nuts with the marking E or EN, as shown below, are suspected. Helicopters on the production assembly line were inspected for non-conforming nuts that could have been installed.

Note: “EN” marking indicates the manufacturer is ESNA and the letter “C” indicates CRES material.

Revision A of this OSN is to inform owners and operators of the result of our investigation. Bell findings indicate that no component or aircraft have been delivered with non-confirming NAS9926-4L nuts. However, based on the information received from the manufacturer ESNA, and the results of our inventory verification, some NAS9926-4L nuts having a tare torque below the minimum required of 3.5 inch-pounds (0.40 Nm) may have been delivered through Bell Spares between January 2023 and March 2024. As a reminder, and as instructed in the Standard Practices Manual (BHT-ALL-SPM), nuts that do not meet the minimum requirement for tare torque shall not be used.

Bell emphasizes the importance of measuring the tare torque of self-locking fasteners prior to installation. The criticality of following proper attaching hardware torquing procedures is also highlighted in the recently released General OSN, **GEN-24-53**.
