TECHNICAL BULLETIN
Bell Helicopter **TEXTRON**

No. 214-02-93

MODEL AFFECTED: 214B/214B-1

SUBJECT: **MAIN ROTOR HUB ASSEMBLY SPINDLE ASSEMBLY, P/N 214-010-103, REVISION OF INSPECTION AND OVERHAUL REQUIREMENTS.**

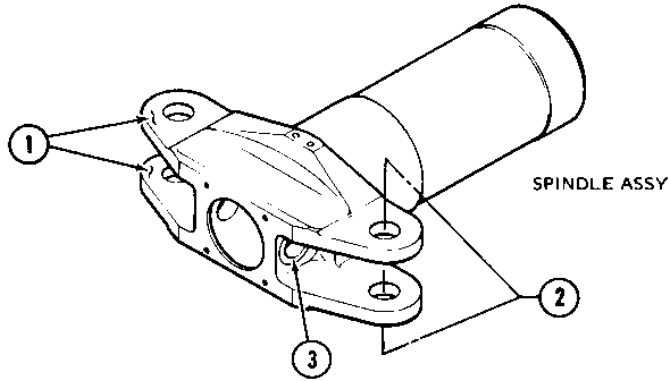
Figure 65-7. Main rotor hub conditional inspection (Sheet 4 of 6)

NO.	ITEM	REUSE SPINDLE	SCRAP SPINDLE-STRAPS-PINS	SCRAP HUB ASSY
	NOMENCLATURE			
1	Spindle lug faces, eight places	No visible deformation on lug face when checked with a straight edge	Any visible deformation on both sides of a lug when checked with a straight edge	
2	Spindle to yoke attachment bushings	Unworn 214-040-129 pin shall fit through the spindle tangs without interference. Hole round within 0.0005 inch.	Any significant bind or looseness. Out-of-round exceeds 0.0005 inch.	
3	Strap Pin Hole	Hole round within 0.0005 inch.	Out-of-round exceeds 0.0005 inch.	Out-of-round exceeds 0.0015 inch with larger dimension in a spanwise direction.

Revise as noted on page 5 of this bulletin.

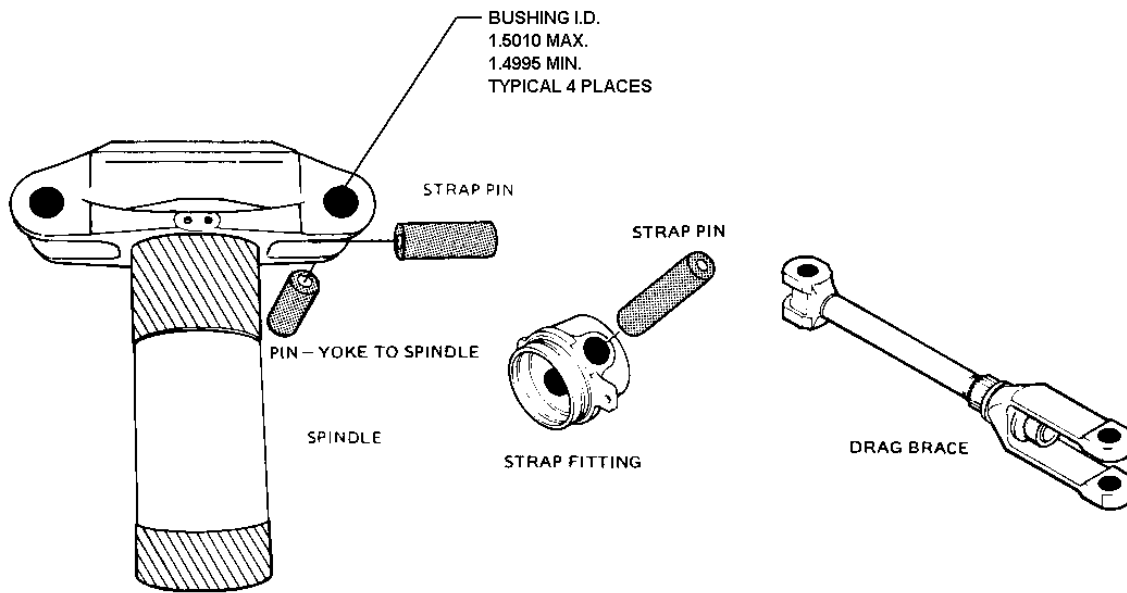
Figure 65-8. Main rotor hub mechanical and corrosion damage limits (Sheet 2 of 5)

TYPE OF DAMAGE	MAXIMUM DEPTHS AND REPAIR AREAS		
	0.001 Inch (0.0254 mm)	0.010 Inch (0.254 mm)	0.004 (0.1016 mm)
MECHANICAL DAMAGE	0.001 Inch (0.0254 mm)	0.010 Inch (0.254 mm)	0.004 (0.1016 mm)
CORROSION DAMAGE	0.001 Inch (0.0254 mm)	0.010 Inch (0.254 mm)	0.004 (0.1016 mm)
MAXIMUM AREA PER FULL DEPTH REPAIR	0.50 Inch Square (322.58 mm sq.)	Not Critical	0.50 Inch Square (322.58 mm sq.)
NUMBER OF REPAIRS	Two	Not Critical	Two Per Segment
EDGE CHAMFER	0.010 Inch (0.254 mm)	0.040 Inch (1.016 mm)	0.010 Inch (0.254 mm)
MOUNT BOLT BORE ● DAMAGE:	0.001 in. (0.0254 mm) for 1/4 circumference, size limits apply.		
CRACKS:	No cracks allowed.

Revise as noted on page 6 of this bulletin.

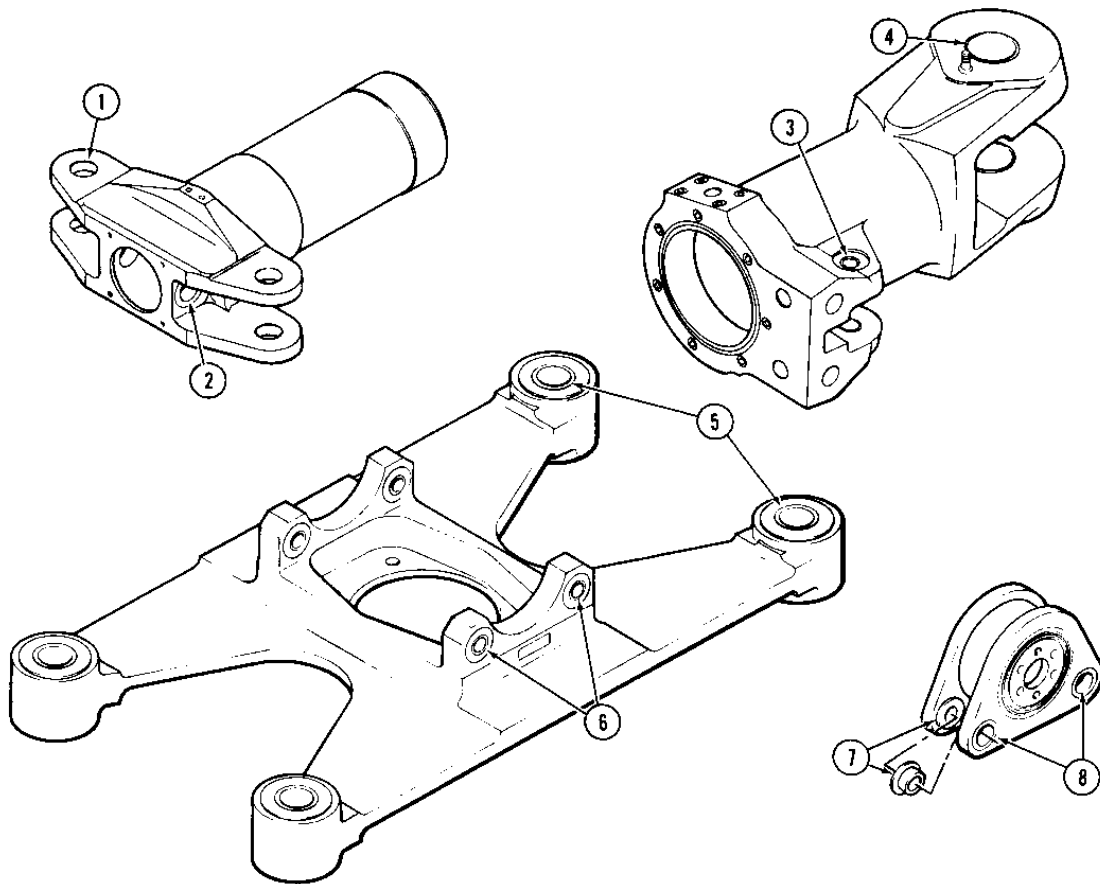
Figure 65-9. Main rotor hub hole wear limits (Sheet 1 of 2)

HOLE NO.	NOMENCLATURE	HOLE DIAMETER	
		MIN.	MAX.
1	Bushings, Spindle to Yoke	1.4995	1.5010
2	Hole, Strap Pin	1.625	1.6265
3	Bushings, Drag Brace Installation	1.000	1.002
4	Bushings, Main Blade Bolt	2.875	2.877
5	Bushings, Spindle Installation	1.4995	1.5005
6	Bushing, Bearing Installation	0.7495	0.7505
7	Bushing, Bearing to Yoke	0.7495	0.7510
8	Bushing, Slip Bushing Installation	1.0000	1.0015

Revise as noted on page 7 of this bulletin.
