TECHNICAL BULLETIN

NO. 214-78-18

Bell Helicopter **TEXTRON**

SUBJECT: REINFORCEMENT/REPAIR OF TAIL BOOM
P/N 214-030-003-7

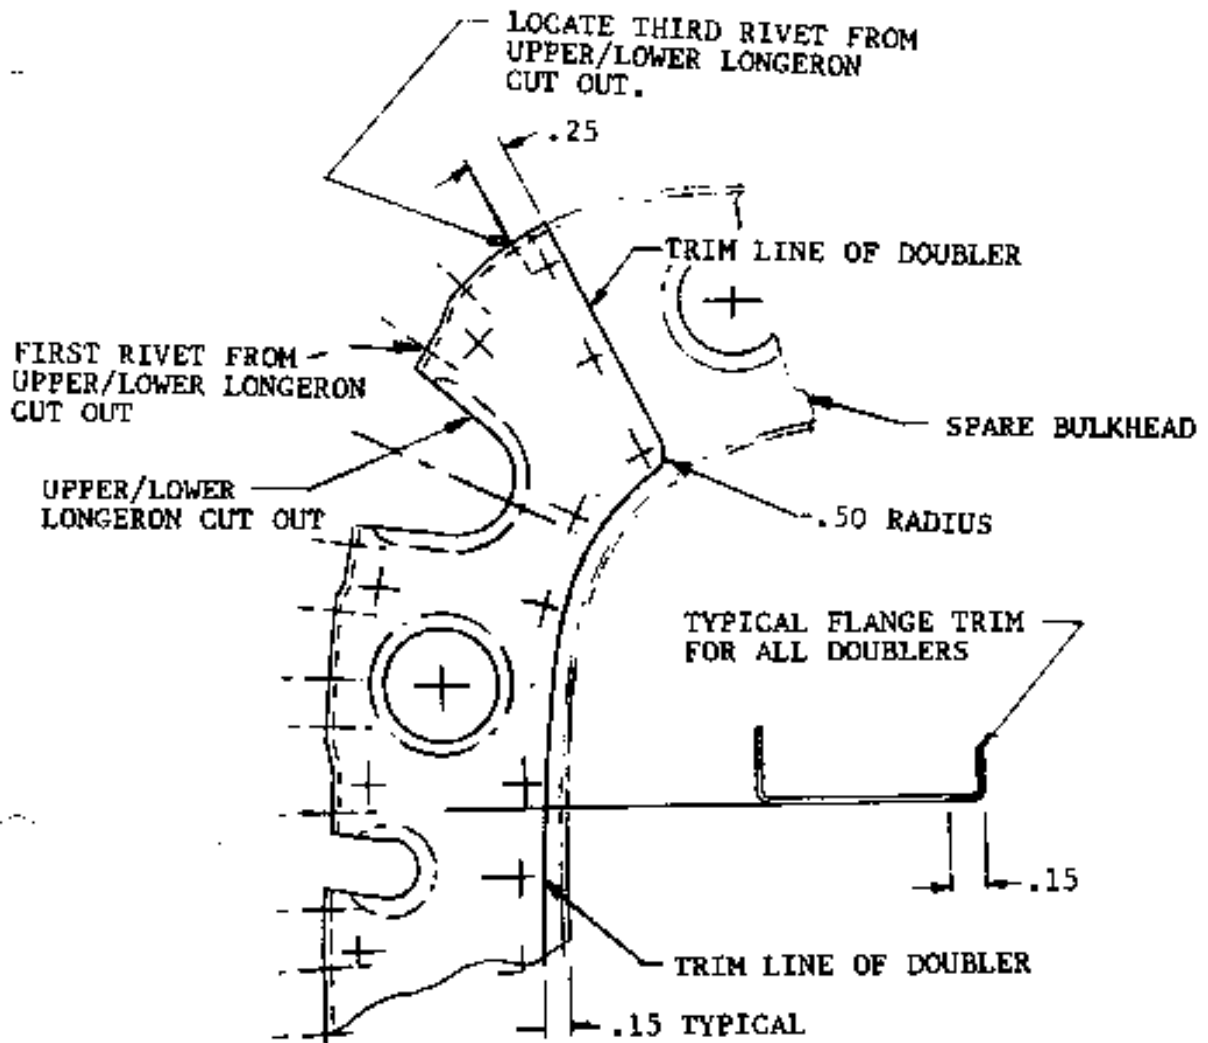
FIGURE 2

VIEW SHOWING DOUBLER CUT FROM SPARE BULKHEAD

3. Refer to figure 2 and 3. Cut doublers from each spar bulkhead. Locate and drill No. 40 pilot holes, all added holes. Mark each doubler set with bulkhead part number.

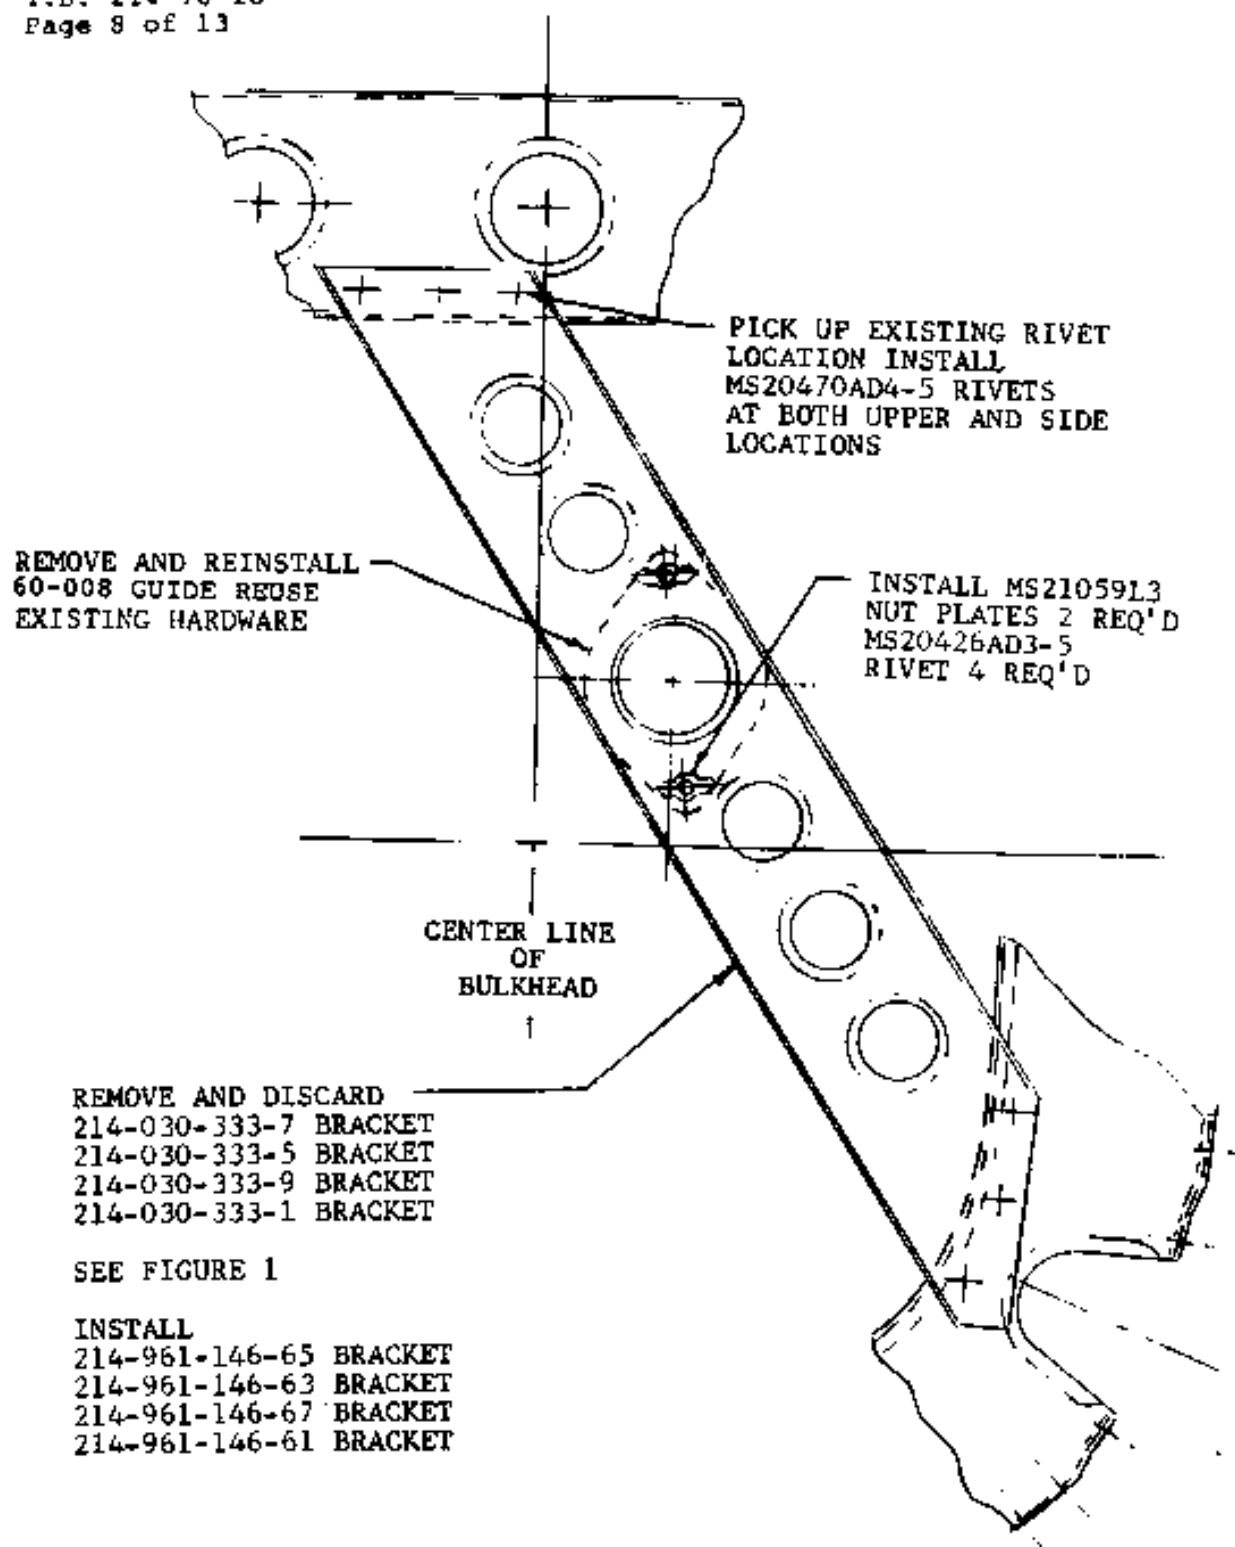
FIGURE 5

TYPICAL CONTROL GUIDE BRACKET INSTALLATION ON FOUR BHD

4. Disconnect and remove from the guide brackets all control tubes that will interfere with the installation of doublers and new guide brackets.
5. Refer to figure 5. Remove guide brackets from bulkheads. Remove the guides and retain the hardware. Install the nutplates to the new brackets, reinstall the guides with retained hardware.

7. Refer to figure 5. Install new guide brackets.
8. Refer to figure 6B. Fabricate doublers "W" and "Y" and clips "X" and "Z". Alodine and prime with epoxy primer.

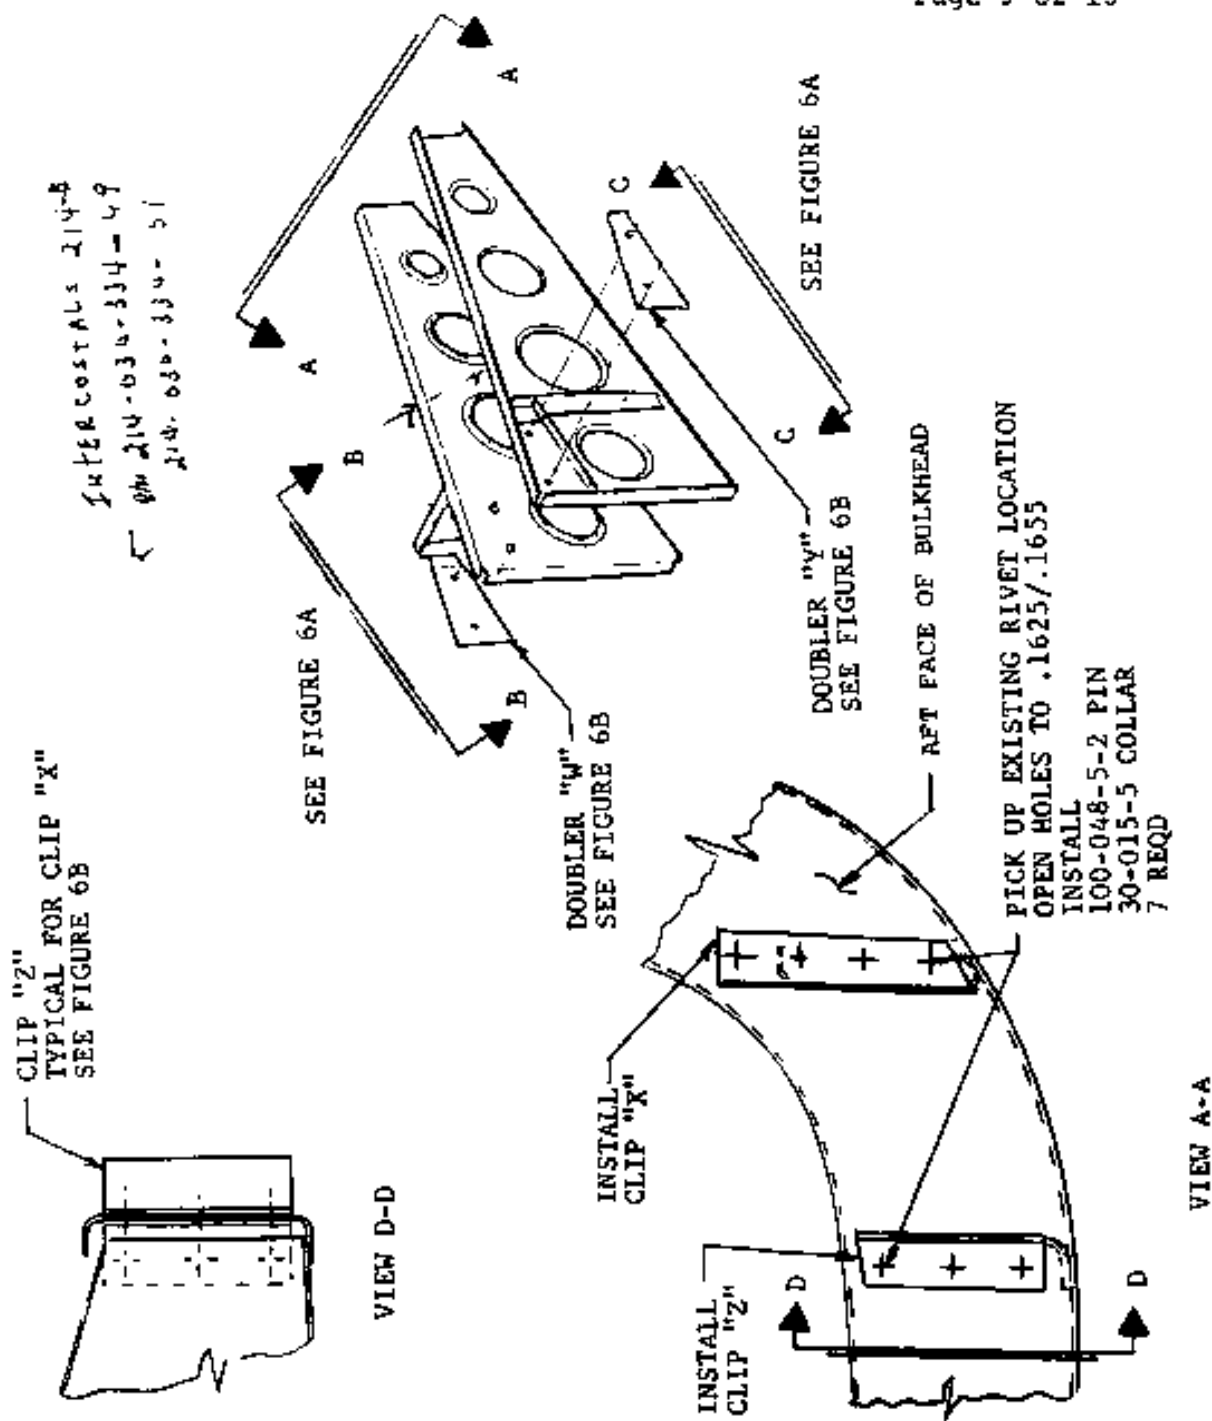
FIGURE 6

REINFORCEMENT OF ANTI-TORQUE CONTROL SUPPORT BRACKET

9. Refer to figures 6 and 6A. Remove the elevator and anti-torque, control bellcranks from support assembly. Remove rivets that fall in the area to receive the doublers. Remove (4) bushings two each side. Temporarily attach doublers and pick up existing holes, de-burr all holes. Locate and install doublers, ream hole and press the bushing in.

10. Refer to figure 6. Remove the rivets attaching the aft clip to the bulkhead. Temporarily attach the clips, pick up existing holes, de-burr all holes. Install clip with Hi-Lok pins and collars.

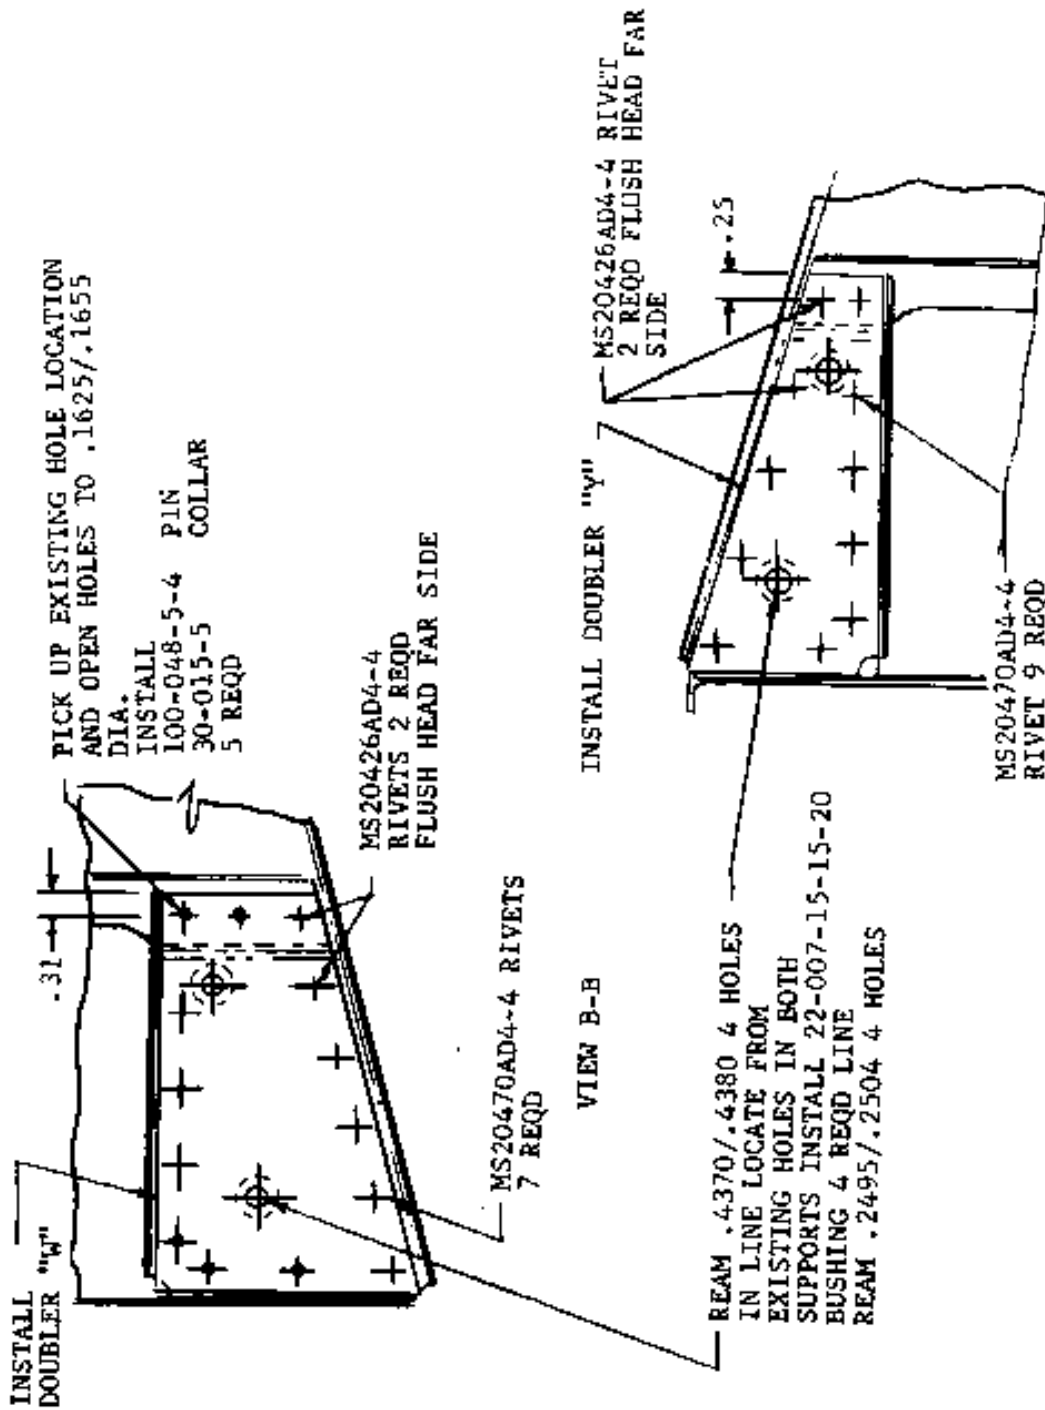
FIGURE 6A

DOUBLER INSTALLATION ON ANTI-TORQUE CONTROL SUPPORT BRACKET

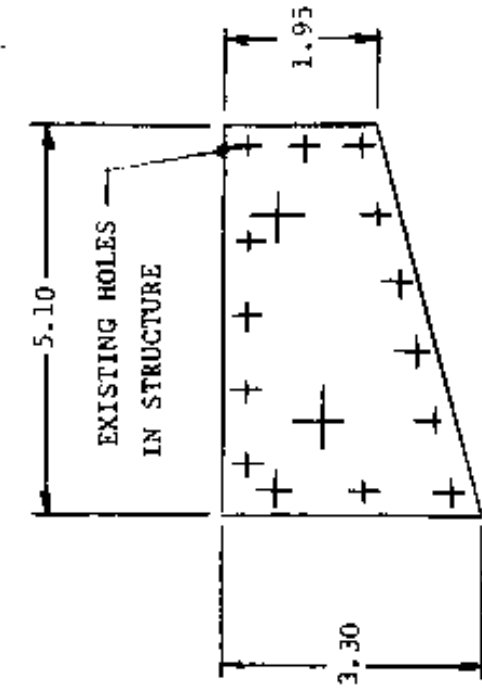
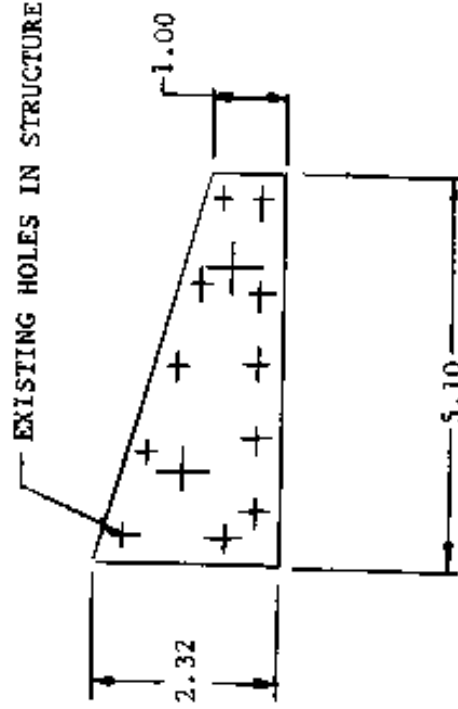
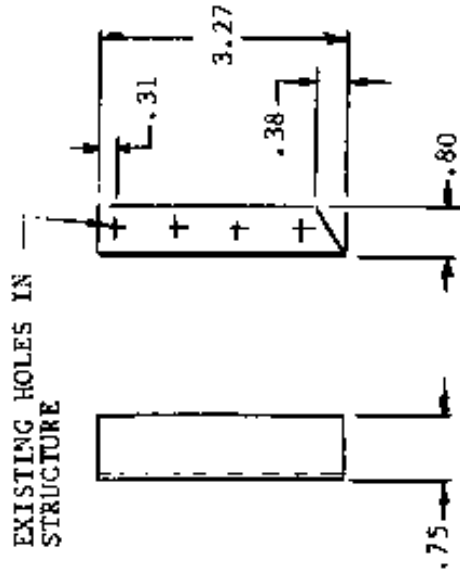
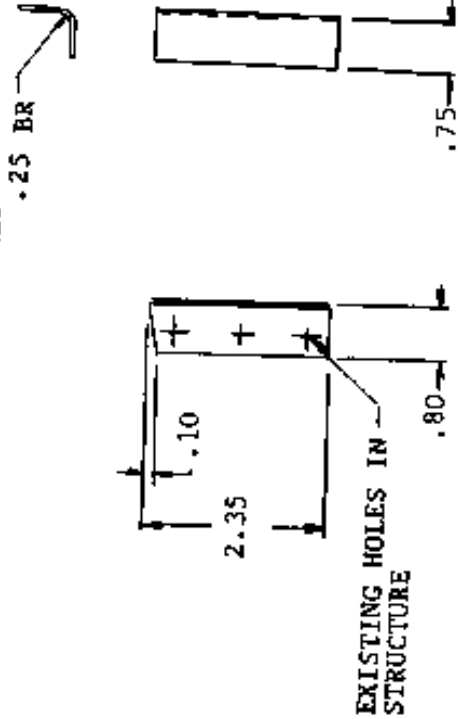
FIGURE 6B

CLIPS AND DOUBLERS DETAILS

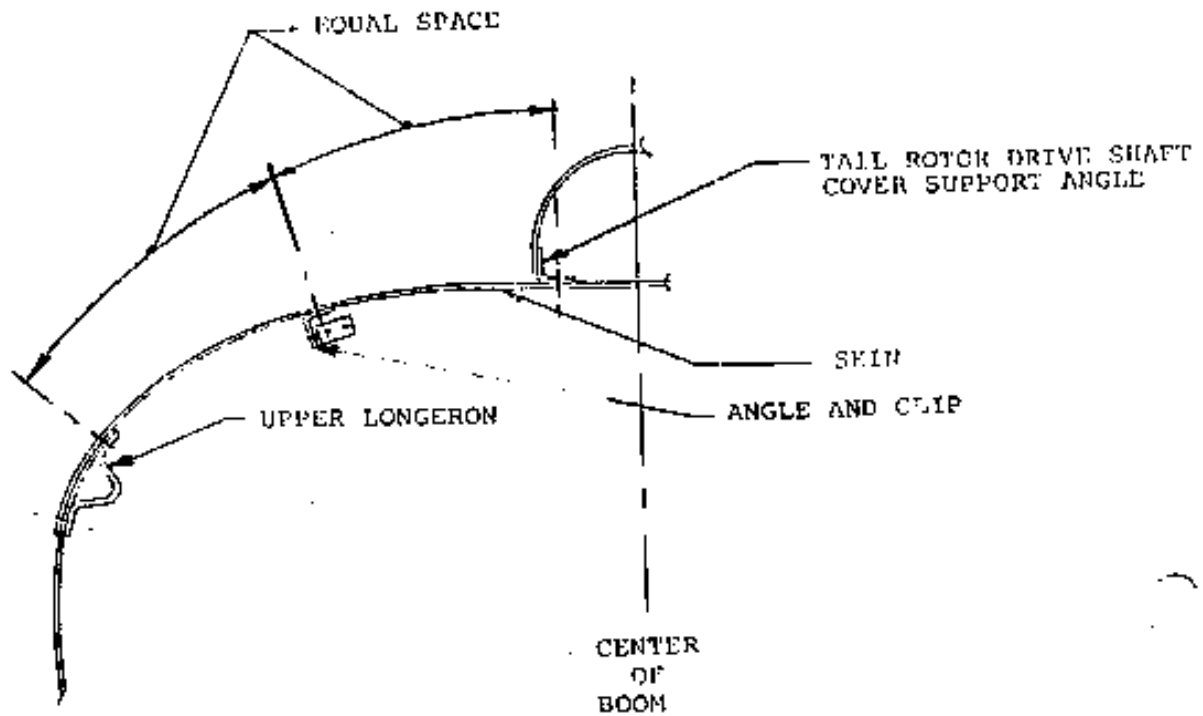
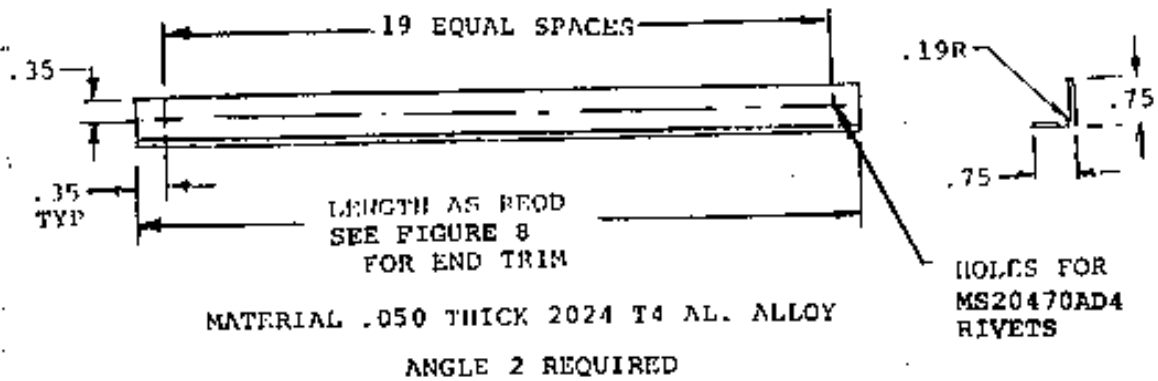
ANGLE DETAIL AND INSTALLATION
FIGURE 7

INSTALLATION OF ANGLE
SECTION A-A
SEE FIGURE 8

12. Refer to figures 7 and 8. Fabricate two angles and four clips. Locate the angles and clips. Drill all holes in the skin and bulkhead from the angles and clips. Remove angles and clips, de-burr all holes. Reinstall angles and clip with rivets as called out. Coat angles and clips with epoxy primer. Reinstall all removed panels.

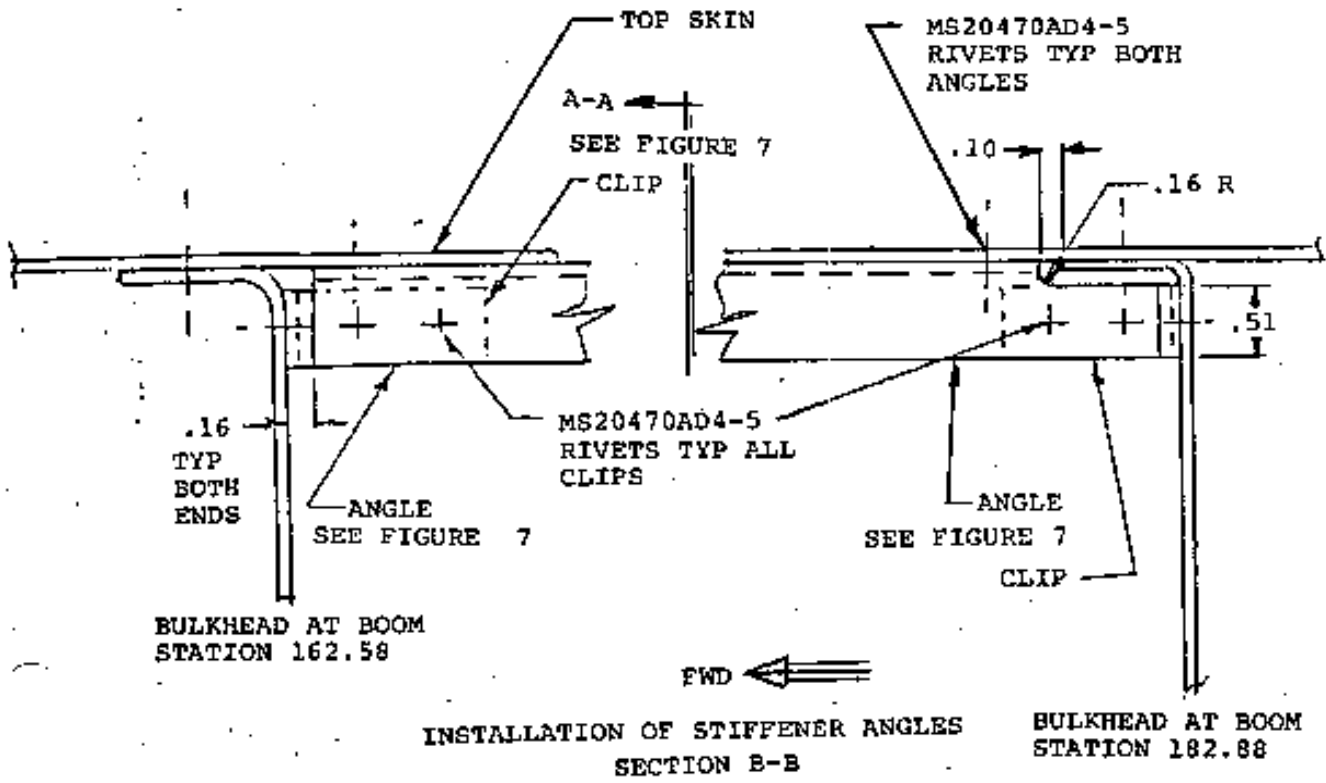
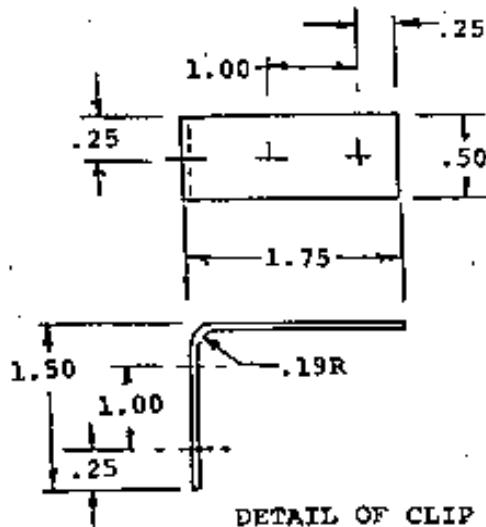
FIGURE 8

DETAIL OF CLIP 4 REQUIRED
MATERIAL .050 THICK 2024-T4 AL ALY
FINISH ALODINE AND PRIME WITH
EPOXY PRIMER
