MODEL AFFECTED: 205A & 205A-1

SUBJECT: UPPER CREW DOOR HINGE STRUCTURE,
REINFORCEMENT OF.

HELICOPTERS AFFECTED: Model 205A and 205A-1 helicopters serial
number 30001 through 30332.

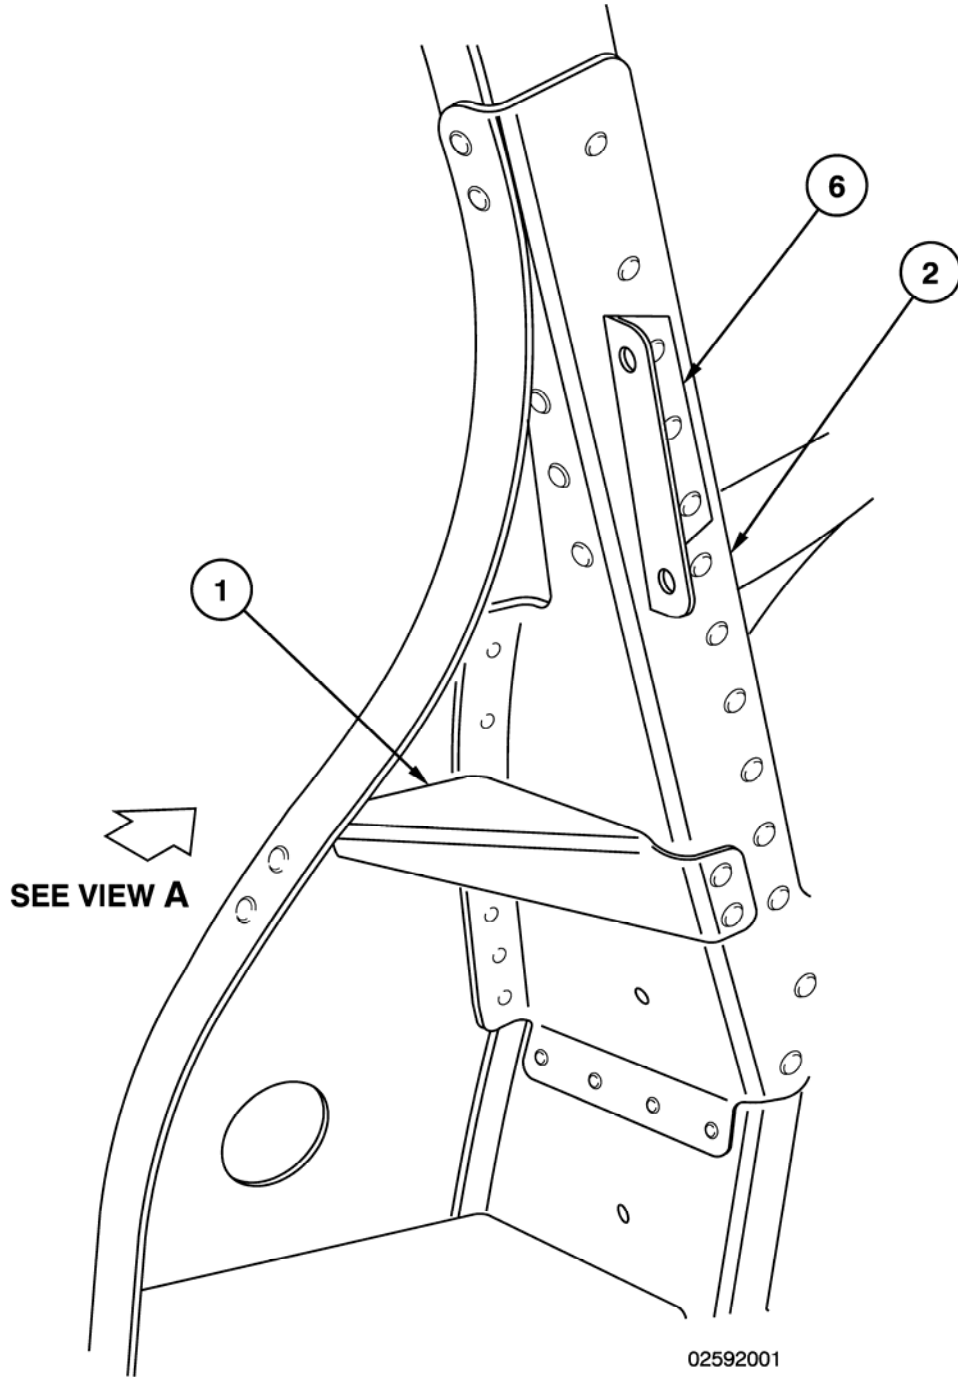
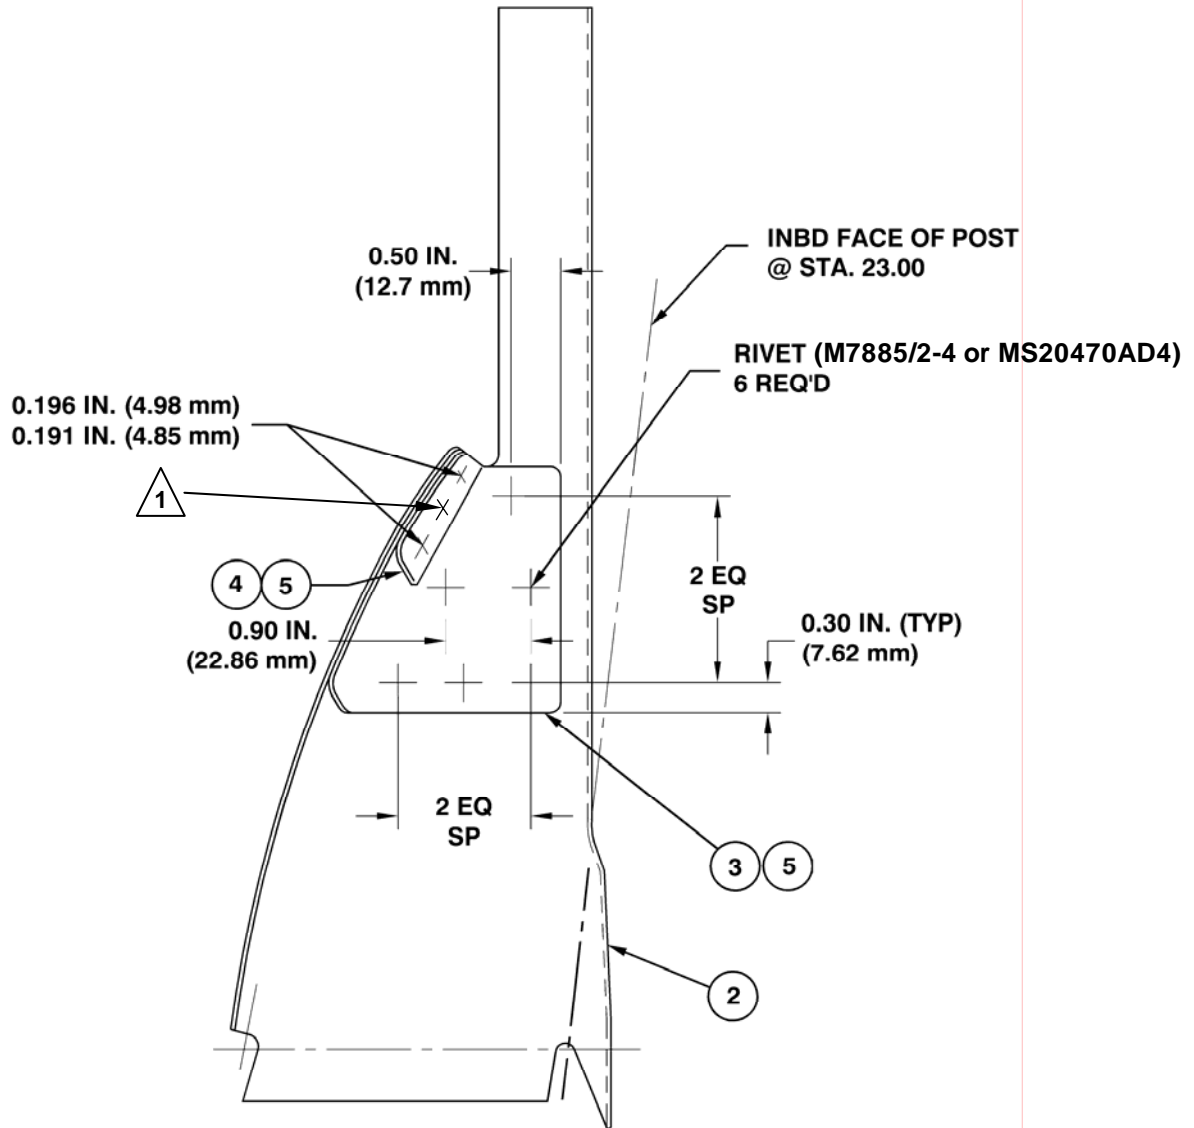
Figure 1 (Sheet 1 of 2)

Bell Helicopter has received some reports of cracking occurring at supports P/N 204-030-662-013 & -014 caused by the crew doors repeatedly hitting their open stop, especially under windy conditions. This bulletin provides the instructions for a simple reinforcement to the surrounding area.

5. On left side, remove instrument panel support fitting (6).
6. Remove support (1) and support (2) as a unit. Remove support (1) from support (2).
7. Fit doubler (3) and radius block (4); refer to View A. See note 1 in Figure 1. Verify for possible interference with support (1) and trim doubler as required. Trim radius block to follow edge of doubler (3) and support (2). Secure with Cleco fasteners.
8. Rework existing support (1) as per Figure 2 or fit new support.
9. Remove supports (1 and 2), doubler (3), radius block (4) and deburr.
10. Apply adhesive (C-317) to doubler (3) and radius block (4) and install using M7885/2-4 rivets (or MS20470AD4 rivets). Remove excess adhesive.
11. Install support (1) on support (2)

12. Install supports (1 and 2) and fitting (6).
13. Re-install upper door hinge using existing hardware except replace two existing screws with two MS27039-1-13 screws at the aft holes.
14. Rework existing ejection assy as per Figure 2 or replace with new ejection assy. Re-install door-jettisoning mechanism.
15. Repeat steps 5 to 14 for right side.
16. Apply a bead of sealant (C-308) around upper door hinges, doublers (3), radius blocks (4) and refinish as required.
17. Re-install crew doors.
18. Prepare aircraft for flight.
19. Make an entry in helicopter historical records indicating compliance with this technical bulletin.

1. Existing support (ref.)
 2. Existing support (ref.)
 3. Doubler LH (204-030-662-119)
Doubler RH (204-030-662-120)
 4. Radius Block (20-042-8-14)
 5. Adhesive (299-947-100 Type II, Class 2)
 6. Existing fitting (ref.)
- △ 1 Existing rivet hole, countersink this hole in doubler (3), dimple in support (2), if replaced
