206-17-210 2 February 2018

MODEL AFFECTED: 206A/B and TH-67

SUBJECT: LINEAR ACTUATOR ELECTRICAL CONNECTOR COVER DAMAGE LIMITS AND REPAIR INSTRUCTIONS, INTRODUCTION OF

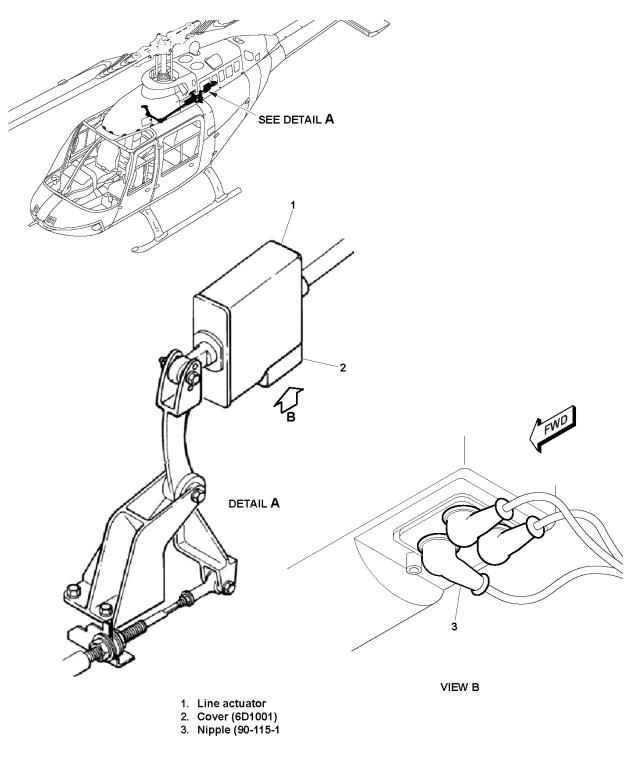
- 1. Prepare the helicopter for maintenance.
- 2. Inspect linear actuator connector cover (Figure 1, 2) for condition and security.
 - a. Cracks emanating from the attachment point screw area are not acceptable, and requires replacement of the connector cover (2).
 - b. Cracks not emanating from the attachment point screw area are acceptable, however, must be stopped drilled to prevent propagation.
 - c. Damage to the connector cover (2) that exposes the wire terminals is not acceptable, and requires replacement of the connector cover (2).

- d. Any other damage not affecting the security of attachment of the connector cover(2) or exposing the wire terminals are acceptable.
- 3. If a serviceable linear actuator connector cover (2) is not available as a replacement part, remove the cover (2) and install nipples 90-115-1 (3) on the three electrical connectors.
 - a. Remove the cover and disconnect the actuator electrical terminals one at a time to prevent mixing the cables.
 - b. Install a protective nipple 90-115-1 (3) on each terminal.
 - c. Reconnect terminals and move the protective nipple (3) into position over the attachment studs.
- 4. Make an entry in the helicopter logbook and historical service records indicating compliance with this Technical Bulletin.
