TECHNICAL BULLETIN

206L-12-245

MODEL AFFECTED: 206L, 206L-1, 206L-3 and 206L-4

SUBJECT: AUXILIARY FINS ASSEMBLY P/N 206-023-126-101/-102/-111/-112, MODIFICATION OF.

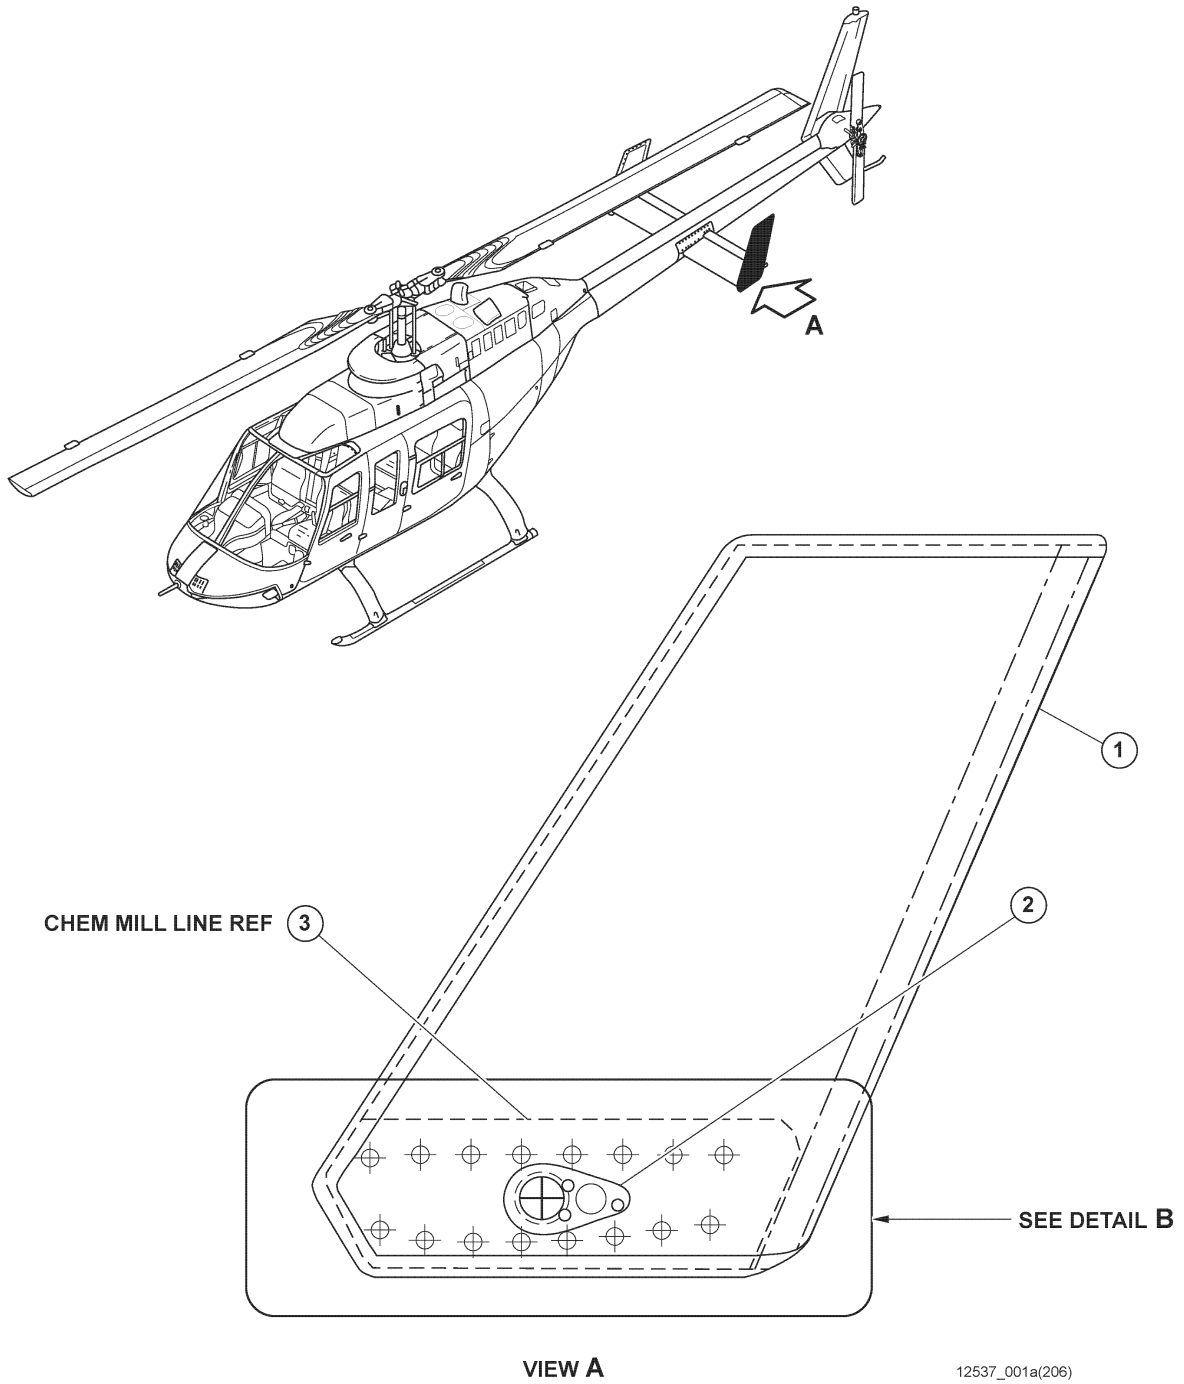
Figure 1: Auxiliary Fin modification (sheet 1 of 2)

2. Using spacer (2, Figure 1) as guide, drill through auxiliary fins (1). Hole is to be dimensioned as shown in Figure 1, View A and Detail B.
 - a. Deburr all holes and edges; remove debris and loose material. Deburr not to exceed 0.005 inch (0.13 mm) depth.
 - b. Undercut core (6) 0.20 inch (5.08 mm) from skin cut-outs as shown in section B-B. Do not damage skins (5 and 7) during undercutting operation.
 - c. Inspect exposed area of skins (5 and 7), doublers (3 and 4) and core (6) for corrosion, damage, delamination or contamination. If any such damage exists, submit to Product Support Engineering with additional information describing extent of damage (Ref. BHT-ALL-SRM, Chapter 2).

3. Clean modification area and prepare for bonding.
 - a. Fill core undercut with adhesive using bonding adhesive (C-317). See section B-B. Tape (C-426) may be used to hold adhesive in place.

4. Inspection and finishing.
 - a. Inspect for voids or debonded areas by performing a tap test inspection. Voids shall not exceed 10% of total bonded area. No one void shall exceed 0.25 square inch (161 square mm) in area. A maximum of two voids within a 6.0 inch (152 mm) diameter circle is allowed. No edge void is allowed.
