TECHNICAL BULLETIN

407-23-140

MODEL AFFECTED: 407

SUBJECT: COLLECTIVE PITCH TRANSDUCER 412-074-101-105, INTRODUCTION OF.

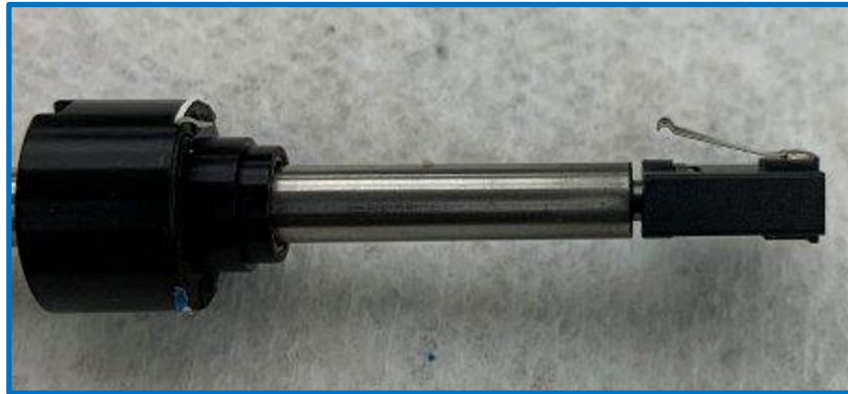
Contact staking process: Contacts installed into preset angled piece for more repeatable/consistent installation.

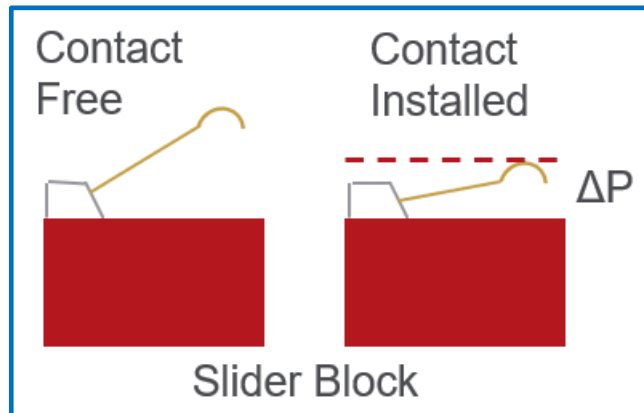
Installed vs. Uninstalled Requirements: After contacts are installed, pressure on housing is measured and must respect specific tolerance to insure consistency.

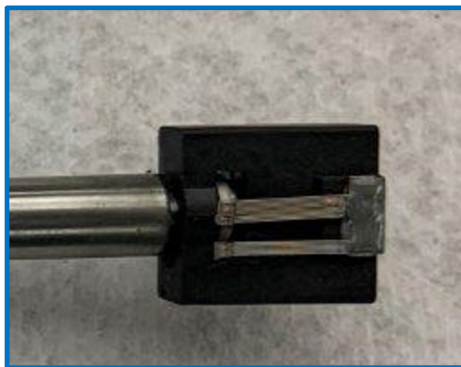
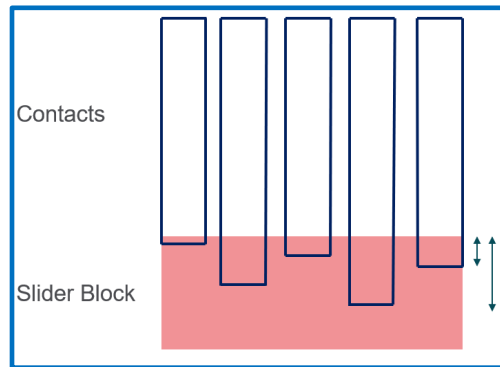
Figure 1 – Design Improvements to 412-074-101-105 Transducer

Brush Design: Brush lengths are different to help deal with different resonant frequencies. Material of brush changed and is less brittle when subjected to cold temperatures.
