TECHNICAL BULLETIN

412-19-243

MODEL AFFECTED: 412

SUBJECT: MAIN DRIVESHAFT RETAINER P/N 205-040-175-001, MODIFICATION OF

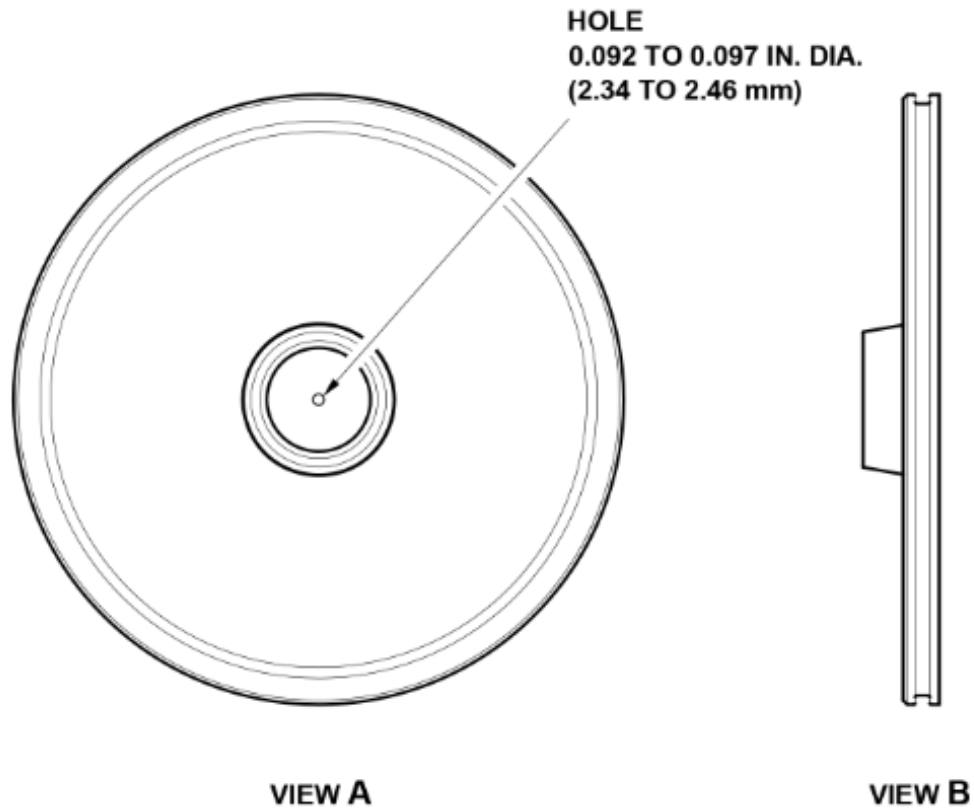
Figure 1 – Grease Retainer

This Bulletin introduces a product modification to the 205-040-175-001 retainers of the 212-040-005-103 driveshaft assemblies to improve grease retention. The modification consists of drilling a vent hole in the center of the Retainer P/N 205-040-175-001.

1. Prepare the helicopter for maintenance.
2. Remove the main driveshaft assembly from the helicopter (BHT-412-MM, Chapter 63).
3. Remove the grease retainers P/N 205-040-175-001 from each end of the main driveshaft assembly P/N 212-040-005-103 (BHT-412-CR&O, Chapter 63).
4. Thoroughly clean the retainers using dry cleaning solvent (C-304) and dry the parts using dry filtered compressed air.
5. Secure the retainers flat and drill a 0.092 – 0.097-inch diameter hole directly in the center of each retainer as shown in Figure 1.
6. Deburr the holes to remove sharp edges.
7. Carry out chemical film treatment (alodine) (C-100) on the repaired areas (BHT-ALL-SPM, Chapter 3).
