## **ALERT SERVICE BULLETIN**

**407-23-132**

**MODEL AFFECTED:** 407

**SUBJECT:** TAIL ROTOR BLADE 406-016-100-119,  
INSPECTION OF

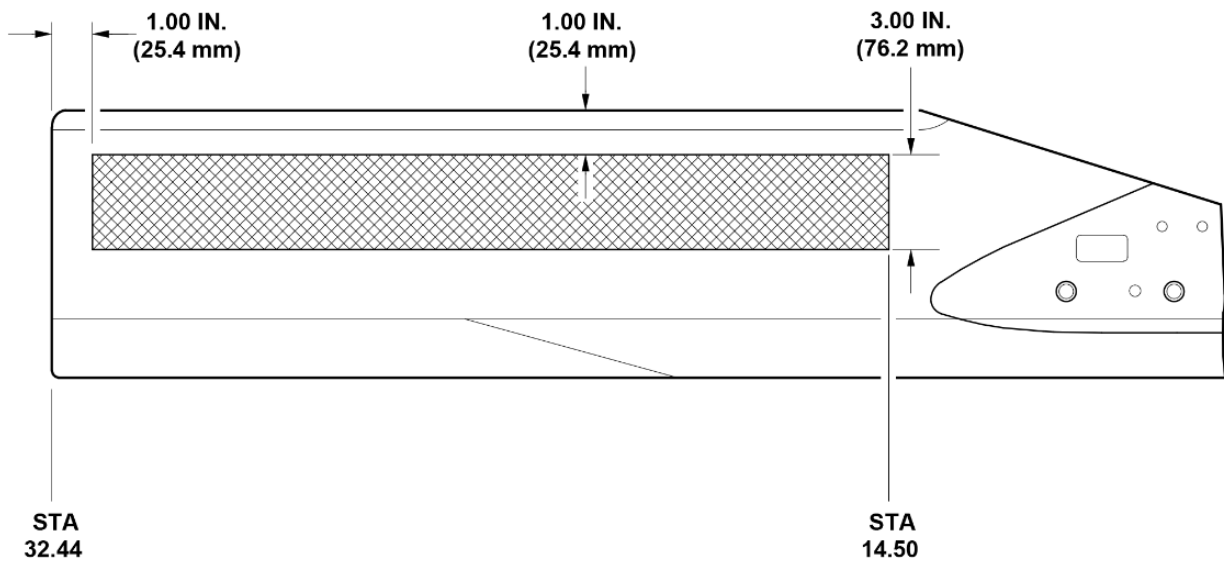
**Figure 1 – Tail Rotor Blade 406-016-100-119  
(Cross hatched inspection area – both sides of blade)**

Bell has received a report of a subject tail rotor blade with signs of voids between the skin and the honeycomb. The anomaly was detected during blade handling as part of a maintenance activity. Affected tail rotor blades could potentially have skin voids caused during the manufacturing process.

3. Inspect affected tail rotor blade for skin to core voids ([DMC-407-A-64-12-00-01A-280A-A](#) Paragraphs 3.2 and 3.3). The zone to be inspected is on both sides of the tail rotor blade as shown in the cross hatched area (Figure 1).

4. If the tail rotor blade is determined to be serviceable following the tap test, continue to step 7.
5. Tail rotor blades with skin to core voids exceeding the limits specified in Step 3 of this bulletin shall be replaced as per **PART II** of this Alert Service Bulletin.
