## **TECHNICAL BULLETIN**

**412-24-250**  
31 October 2024

**MODEL AFFECTED:** 412EP

**SUBJECT:** BLEED AIR DUCT CLAMP, REPLACEMENT OR REWORK OF

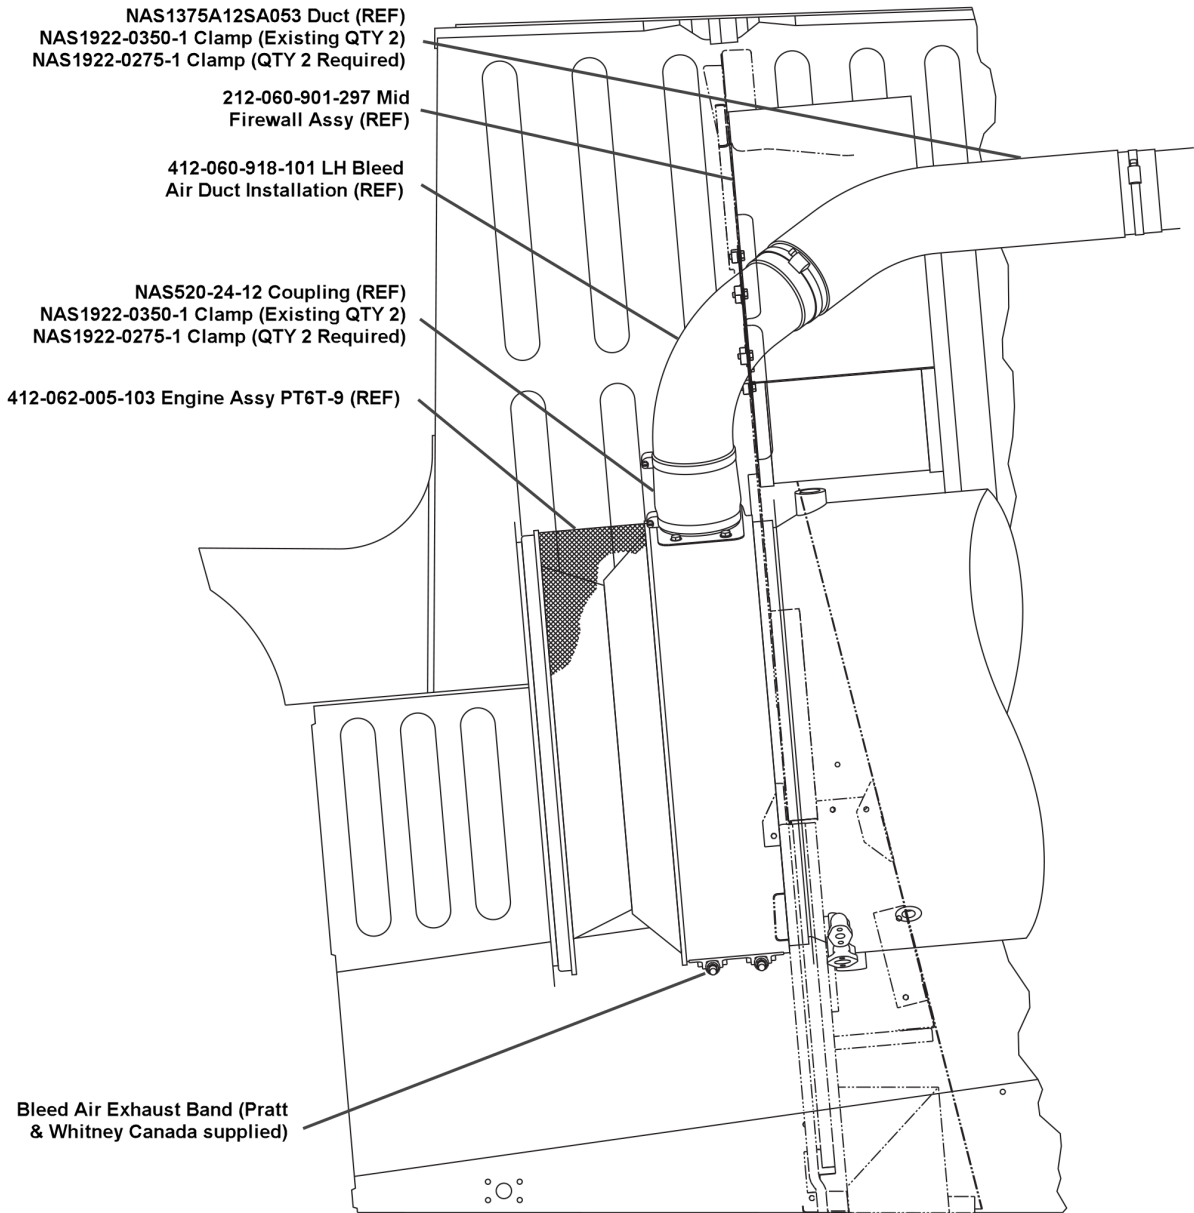
**Figure 1  
 Bleed Air Duct Installation**

Bell has discovered that clamps NAS1922-0350-1, used in the bleed air duct installations 412-060-918-101/-102, are too large and in some cases the "tail" of the clamp failed in service due to vibration causing a possible foreign object debris (FOD) condition. This technical bulletin provides instructions to either trim the excess material or replace the existing clamps with smaller clamp NAS1922-0275-1.

Figure 1 shows the LH duct installation 412-060-918-101, RH duct installation 412-060-918-102 is similar.

2. Gain access to the LH duct installation 412-060-918-101 (Refer to Figure 1).
3. Inspect the four existing clamps NAS1922-0350-1 for excess material, more than 0.25 inch (6.35 mm), beyond the clamp screw mechanism.
  - a. If the clamp has excess material:
    - (1) Either cut off the excess material and trim the sharp edges or replace with smaller clamp NAS1922-0275-1.
  - b. If any of the existing clamps NAS1922-0350-1 excess material has broken off:
    - (1) Inspect the engine compartment for the broken off material.

(3) Either trim the sharp edges or replace with smaller clamp NAS1922-0275-1.

4. Gain access to the RH duct installation 412-060-918-102 (Refer to Figure 1).
5. Repeat step 3.
6. Make an entry in the helicopter logbook and historical service records indicating compliance with this Technical Bulletin.
