## **TECHNICAL BULLETIN**

**412RSAF-24-29**

**MODEL AFFECTED:** 412RSAF

**SUBJECT:** BLEED AIR DUCT CLAMP, REPLACEMENT OR REWORK OF

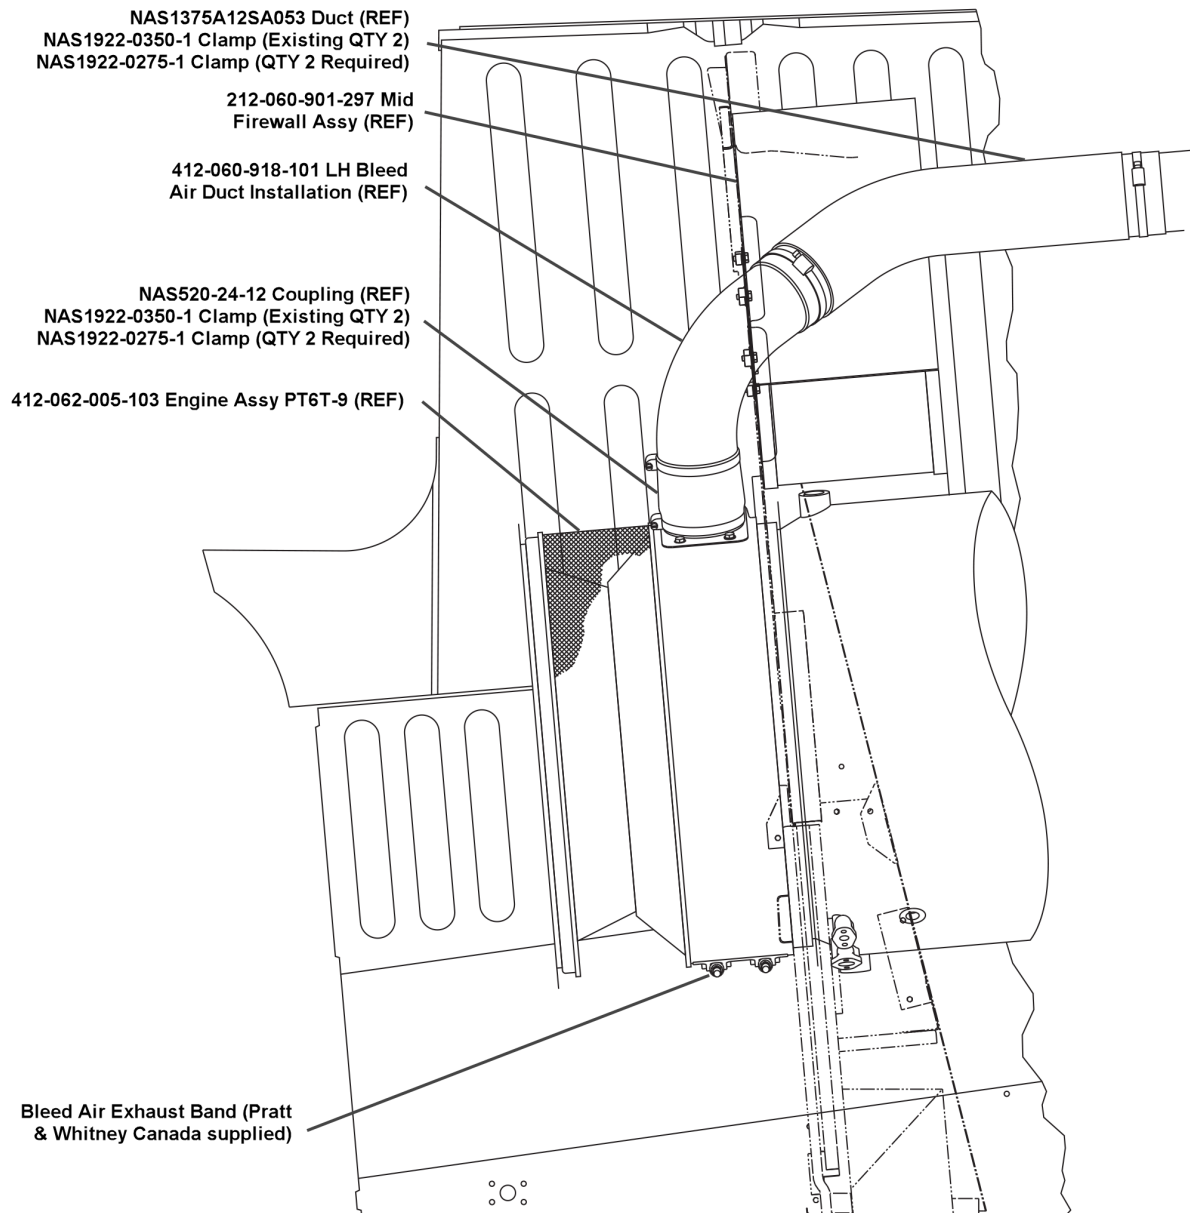
**Figure 1  
 Bleed Air Duct Installation**

Bell has discovered that clamps NAS1922-0350-1, used in the bleed air duct installations 412-060-918-101/-102, are too large and in some cases the "tail" of the clamp failed in service due to vibration causing a possible foreign object debris (FOD) condition. This technical bulletin provides instructions to either trim the excess material or replace the existing clamps with smaller clamp NAS1922-0275-1.

2. Gain access to the LH duct installation 412-060-918-101 (Refer to Figure 1).
3. Inspect the four existing clamps NAS1922-0350-1 for excess material, more than 0.25 inch (6.35 mm), beyond the clamp screw mechanism.
  - a. If the clamp has excess material:
    - (1) Either cut off the excess material and trim the sharp edges or replace with smaller clamp NAS1922-0275-1.
  - b. If any of the existing clamps NAS1922-0350-1 excess material has broken off:
    - (1) Inspect the engine compartment for the broken off material.

- (2) If the excess material cannot be located inspect the engine compressor in accordance with the Pratt & Whitney Canada PT6T-9 Engine Maintenance Manual.
    - (3) Either trim the sharp edges or replace with smaller clamp NAS1922-0275-1.
4. Gain access to the RH duct installation 412-060-918-102 (Refer to Figure 1).
5. Repeat step 3.
6. Make an entry in the helicopter logbook and historical service records indicating compliance with this Technical Bulletin.
