INFORMATION LETTER

206L-14-99
30 September 2014

SUBJECT: TACTAIR HYDRAULIC SERVO ACTUATOR (HSA) FIELD REPLACEMENT INSTRUCTIONS FOR THE CYLINDER EXTENSION BEARING P/N C42642-68.

ATA CHAPTER 67**ROTORS FLIGHT CONTROL - TACTAIR HYDRAULIC SERVO ACTUATOR (HSA)
FIELD REPLACEMENT INSTRUCTIONS FOR THE
CYLINDER EXTENSION BEARINGS P/N C42642-68****1. PLANNING INFORMATION****A. EFFECTIVITY**

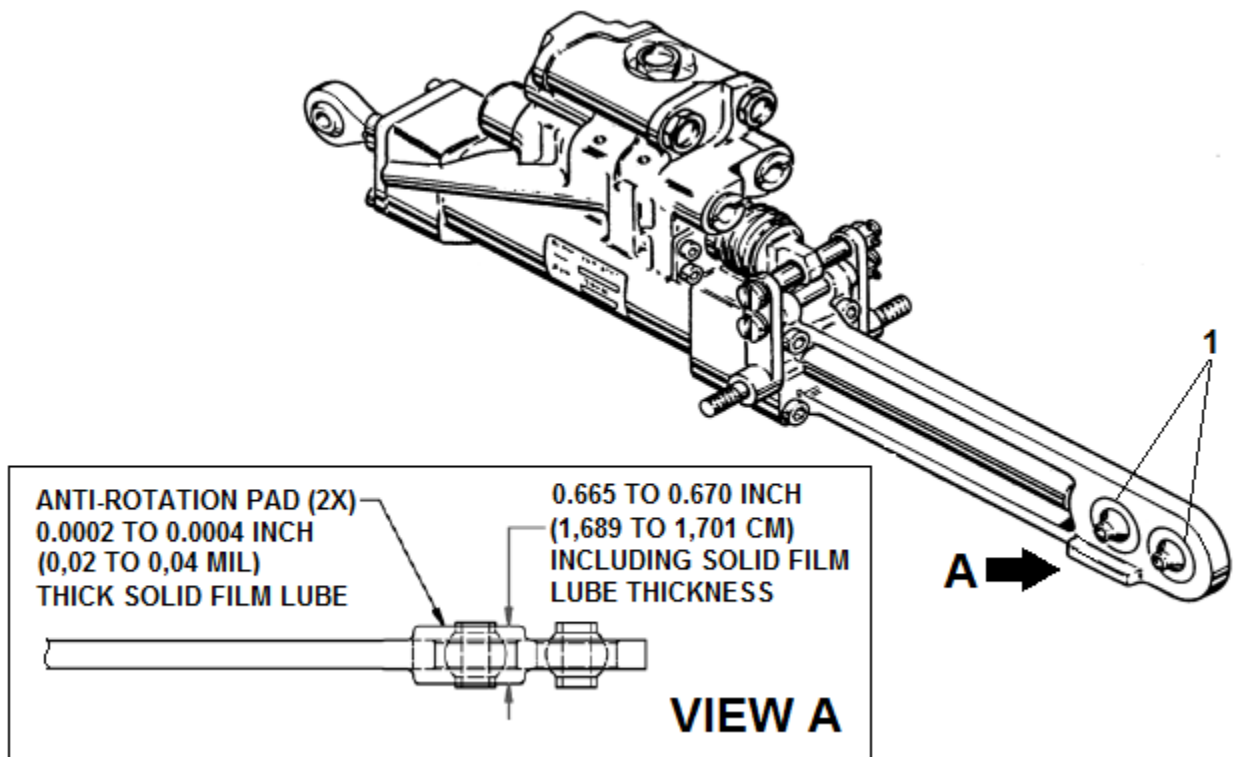
Field Replacement Instructions for Pregrooved Bearings P/N C42642-68
Figure 1

Reports from the field have indicated that a few HSA Cylinder Extension Bearings have worn ahead of TBO time. This condition requires Owner/Operators to remove the HSA from service early. To prevent operational disruptions in these cases, this Service Bulletin is being released to allow replacement of worn HSA Cylinder Extension Bearings in the field if necessary.

- C. Inspect Bearings (1, Figure 1) in accordance with the following Table 1., Bearing Wear Limits. Radial wear is measured 90° from the bolt mating with inner race of spherical ball of bearings (1). Axial wear is measured parallel to the bolt mating with inner race of spherical ball of bearing (1).

BEARINGS PART NUMBER	RADIAL		AXIAL	
	(INCH)	(CM)	(INCH)	(CM)
C42642-68	None	None	0.010	(0,0254)

- D. Remove and replace worn Bearings (1, Figure 1) on HSA in accordance with the following:
- (1) Remove worn bearings (1). Support parent part so that bending cannot occur. It is recommended that both Bearings (1) be replaced as completed sets.
 - (2) Inspect parent part for damage around and in bores for cracks and remove all burrs and sharp edges. Verify that 0.9060 to 0.9065 inch (2,3012 to 2,3025 cm) diameter is maintained.
 - (3) Perform Fluorescent Penetrant Inspection in accordance with ASTM E1417, Type I. Acceptance shall be per MIL-STD-1907, Grade A.
 - (4) Apply wet Zinc Chromate Primer coating (TT-P-1757) to outside diameter of bearings (1).
 - (5) Anvil Stake or Roll Swage bearings (1) as follows:

- (a) Anvil Stake bearings (1) using Anvil Staking Tool (P/N AT-5-441, Cabco Industries) with 9,000 to 13,500 pounds of force, flush to 0.005 inch (0,0127 cm) from cylinder extension chamfer.

- (b) Roll Swage bearings (1) using Roll Swage Tool (P/N T101530-3, Bell® Helicopter Textron Inc.) at standard drill press speed of 60 to 250 RPM, flush to 0.005 inch (0,0127 cm) from cylinder extension chamfer.

- (6) Apply 100 ± 5 pounds (45,359 ± 2,267 kg) proof load to outer race of bearings (1) while supporting cylinder extension. Outer race shall not move relative to cylinder extension. If any movement occurs, repeat step (5)(a) or step (5)(b).

- (7) Mark bearings (1) that pass proof load with a green dot using Torque Seal (F-900GRE) after proof load is completed.
 - (8) Using feeler gage or equivalent, inspect gap between the bearings (1) and cylinder extension chamfer. Maximum allowable gap is 0.005 inch (0,0127 cm). Visually inspect bearings and cylinder extension mating area for cracks with minimum of 10x magnification.

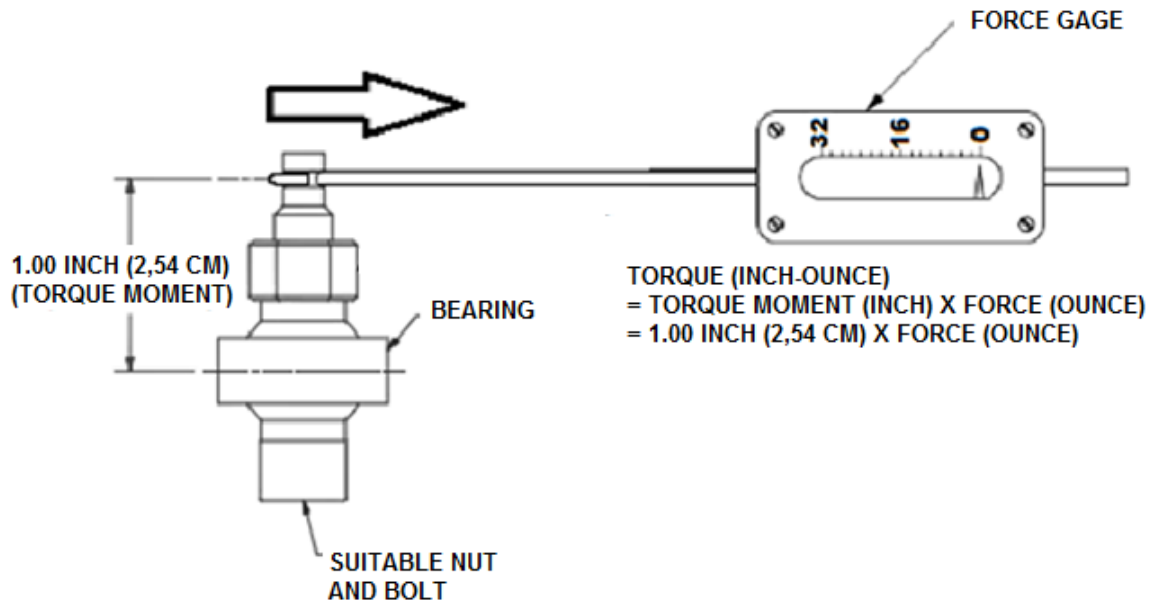
Bearing Misalignment Breakaway Torque Inspection
Figure 2

- (10) Check bearings misalignment breakaway torque as shown in Figure 2. Misalignment breakaway torque shall be 4 to 24 inch-ounce (0,0282 to 0,1694 N•m) force with no radial play or axial play permitted for newly installed bearings.
- (11) Mark bearings that pass misalignment breakaway torque checks with yellow dot using Torque Seal (F-900YEL).

CAUTION: BREAKING THE SPHERICAL BALL FREE FROM THE OUTER RACE OF THE BEARING BEFORE CHECKING TORQUE IS VERY IMPORTANT. DUE TO THE PRELOAD BETWEEN THE BALL AND RACE, THE TEFLON LINER, UNDER COMPRESSION, SLOWLY CONFORMS TO THE MICROSCOPIC SURFACE IRREGULARITIES OF THE BALL. TO INITIATE MOVEMENT AFTER A PERIOD OF TIME, ALL OF THE MICROSCOPIC LINER PROJECTIONS INTO THE BALL SURFACE MUST BE SHEARED OFF. ONCE THIS HAS BEEN ACCOMPLISHED, THE TORQUE REVERTS BACK TO ITS RATED/SERVICEABLE VALUE.

MANUALLY MOVE BALL IN SEVERAL DIRECTIONS IMMEDIATELY BEFORE INSPECTION.
