TO: All owners and operators of Model 206L-1, 206L-3 and 206L-4 helicopters

SUBJECT: ENGINE FOREIGN OBJECT DAMAGE (FOD), PREVENTION OF

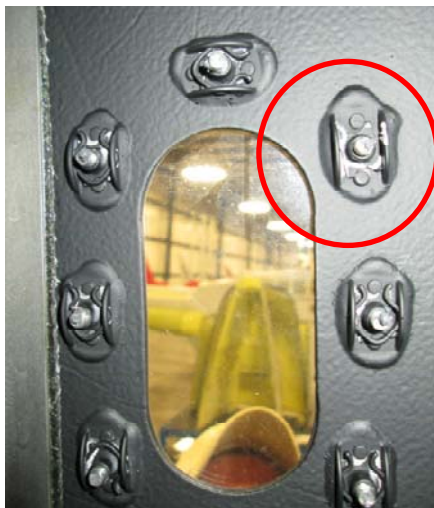
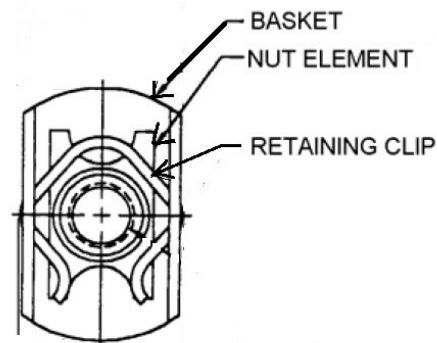
These cowlings are configured with nutplates 90-104C08-1 that are bonded on the inner surface to mount the inspection window. The 90-104C08-1 nutplate is designed with a replaceable nut element that is held in place by a retaining clip.

Bell Helicopter encourages maintainers to carefully inspect the nutplates for integrity when removing/reinstalling the inspection window. This practice may prevent a broken nutplate to become FOD to the engine.
