INFORMATION LETTER

206L-18-102
15 October 2018

SUBJECT: AIR COMM CORPORATION SERVICE BULLETIN 206EC-18-07, BELL 206 AIR CONDITIONER SPLINE INSPECTION

Title: SB206EC-18-07; Bell 206 Air Conditioner Spline Inspection

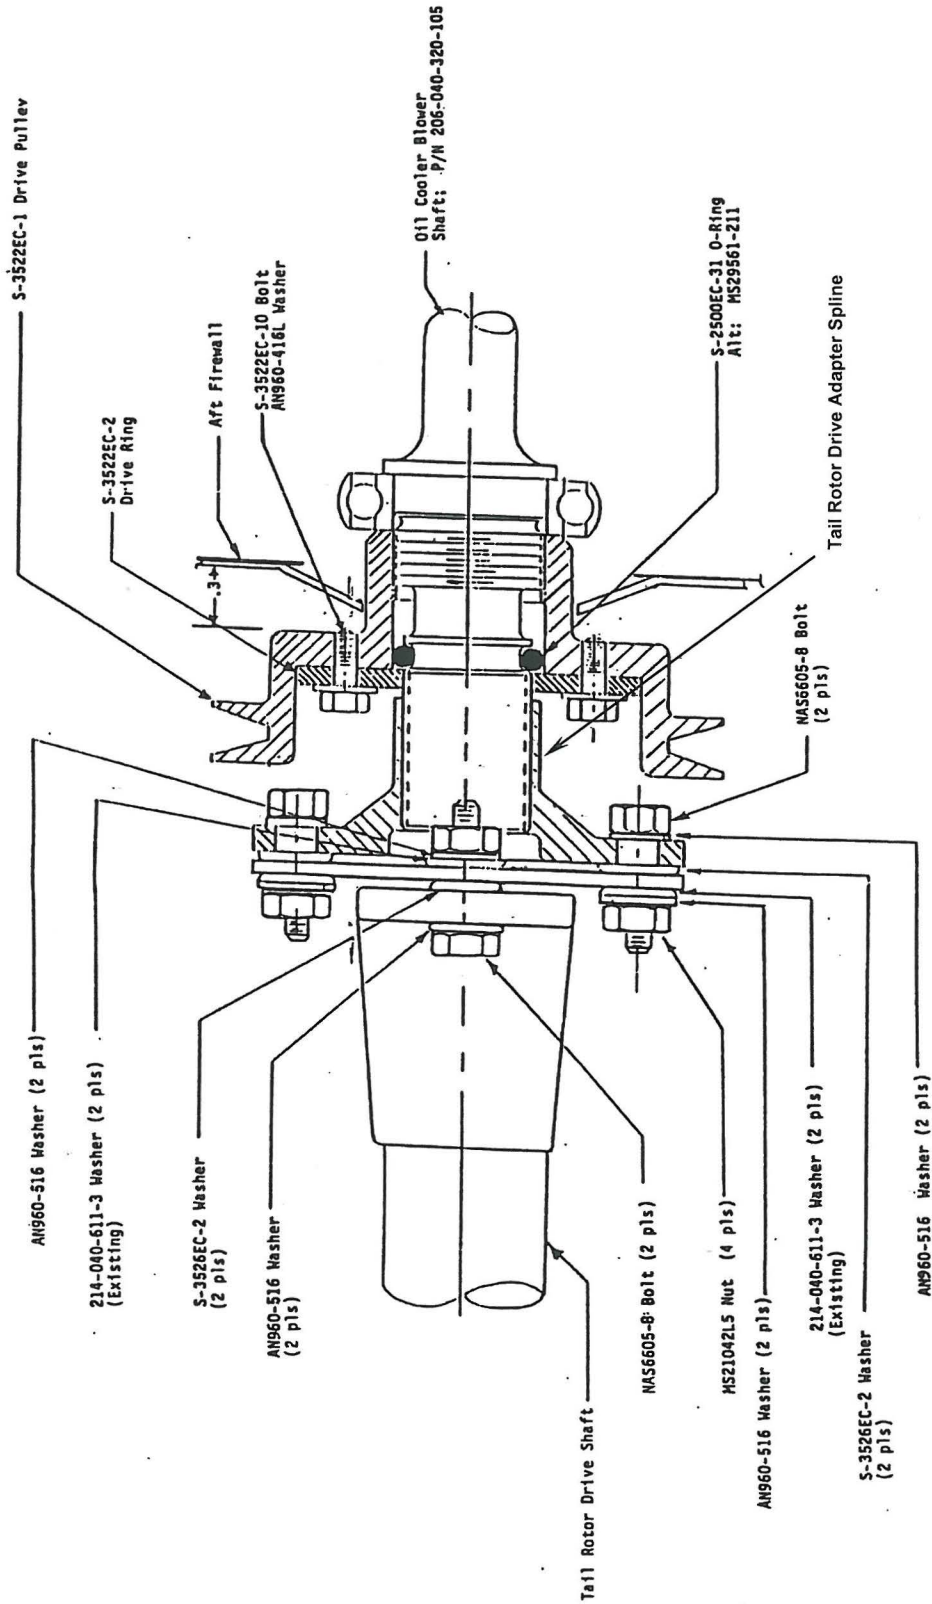
Figure 1: Drive shaft assembly

Field reports have found a number of Bell Model 206 L-4 aircraft with the Air Comm Corporation air conditioning system that have had excessive spline tooth wear and/or damage of both the ACC drive ring spline and to the respective mating area of the oil cooler shaft spline. The reported wear did not affect the tail rotor drive adapter spline or the respective mating area on the oil cooler shaft spline.

4. Remove the drive ring p/n S-3522EC-2 and visually inspect the drive ring spline teeth for signs of fretting or wear. Use the Bell wear criteria in the BHT-206L-CR&O component repair and overhaul manual for the drive adapter spline as the evaluation criteria for the ACC drive ring spline.

9. If unacceptable wear is found on the drive ring or oil cooler shaft assembly, then replace the worn components per the Bell BHT-206L1-MM, BHT-206L3-MM, or BHT-206L4-MM maintenance manual or the BHT-206L-CR&O component repair and overhaul manual as applicable and the Air Comm Corp service manual prior to return to service.
