## ALERT SERVICE BULLETIN

**505-25-43**

**SUBJECT:** CREW SEAT RESTRAINT ROTARY BUCKLE ASSEMBLY 1111475-01, ONE-TIME INSPECTION OF.

## Information Regarding Screw Inspection for the Restraint Systems

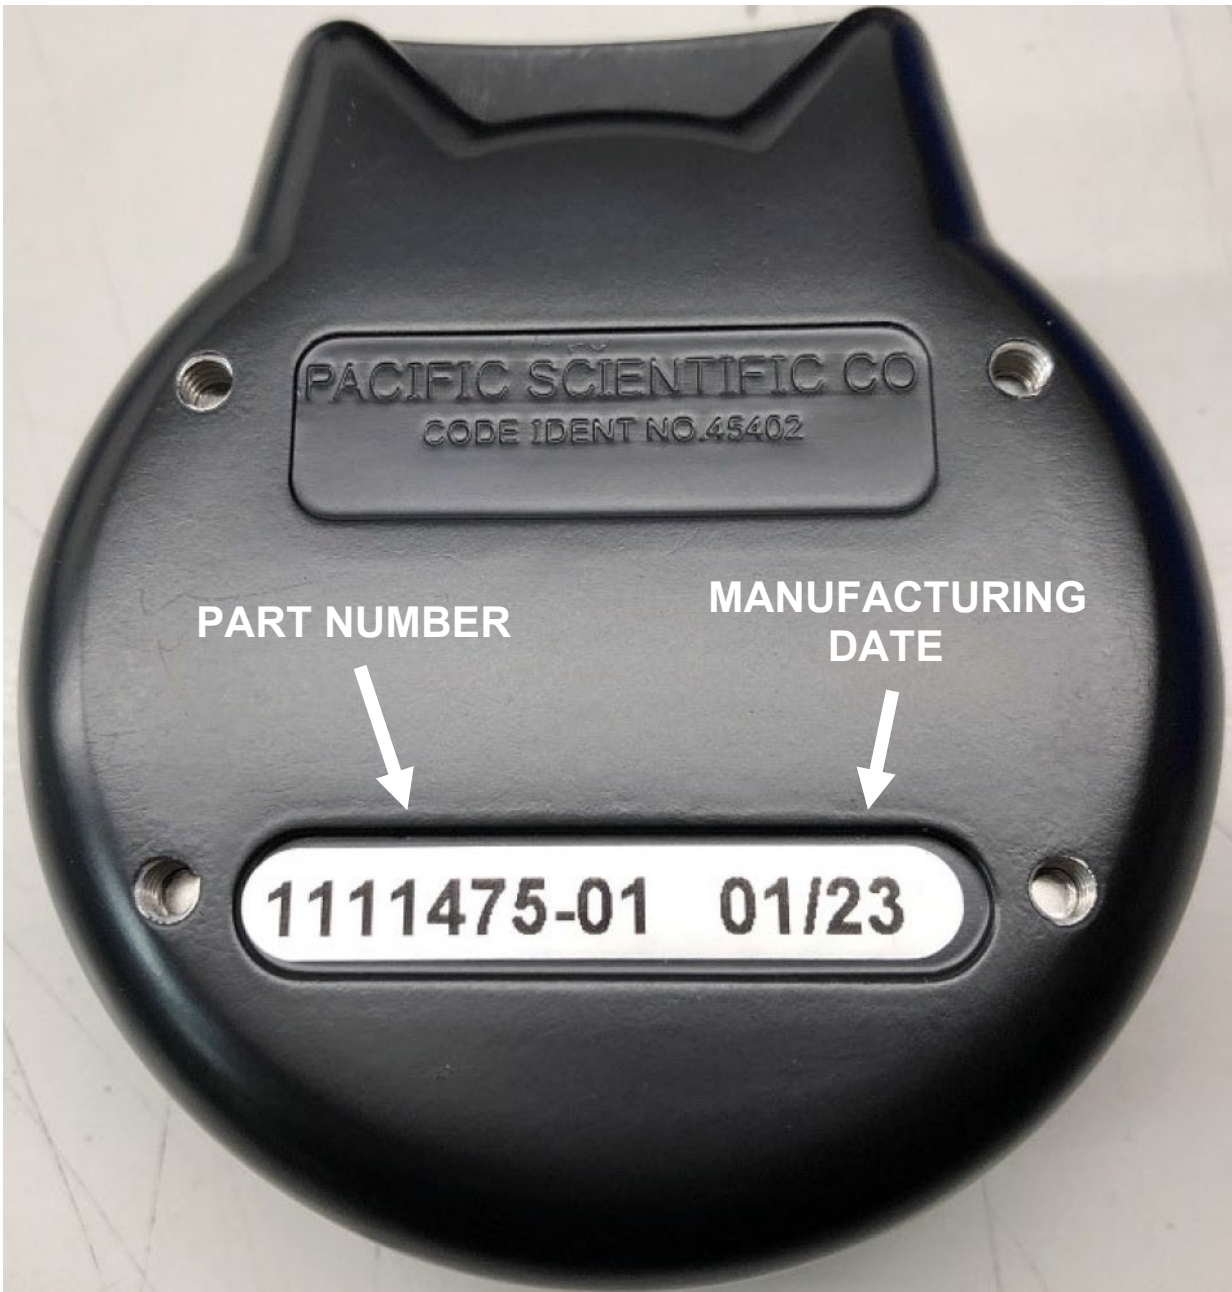
**Figure 1 – Crew Seat Restraint Assembly Rotary Buckle (Rear View)**

1. Prepare the helicopter for maintenance.
2. Verify part number and manufacturing date on back of crew seat (pilot and co-pilot) restraint assembly rotary buckles (Figure 1).

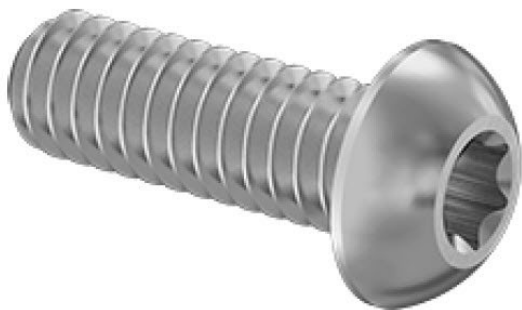
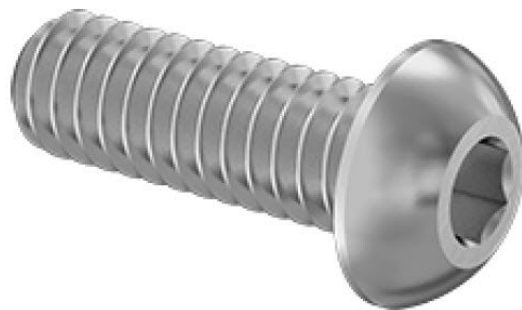
**Figure 2 – Internal Rotary Buckle Screw Types**

- b. If the screw heads are intact, go to step 4.
4. Do one of the three methods highlighted in the Parker Meggitt SB section 4.B.(4) to determine which type of screws (Torx or hex heads) are installed in the rotary buckle assembly (Figure 2).

**PART NUMBER  
0901101-123**

**PART NUMBER  
0901101-149**

- a. If **any** of the screws are Torx head screws, prior to next flight replace the screws using the procedures in section 4.D. of the Parker Meggitt SB. Got to step 5.

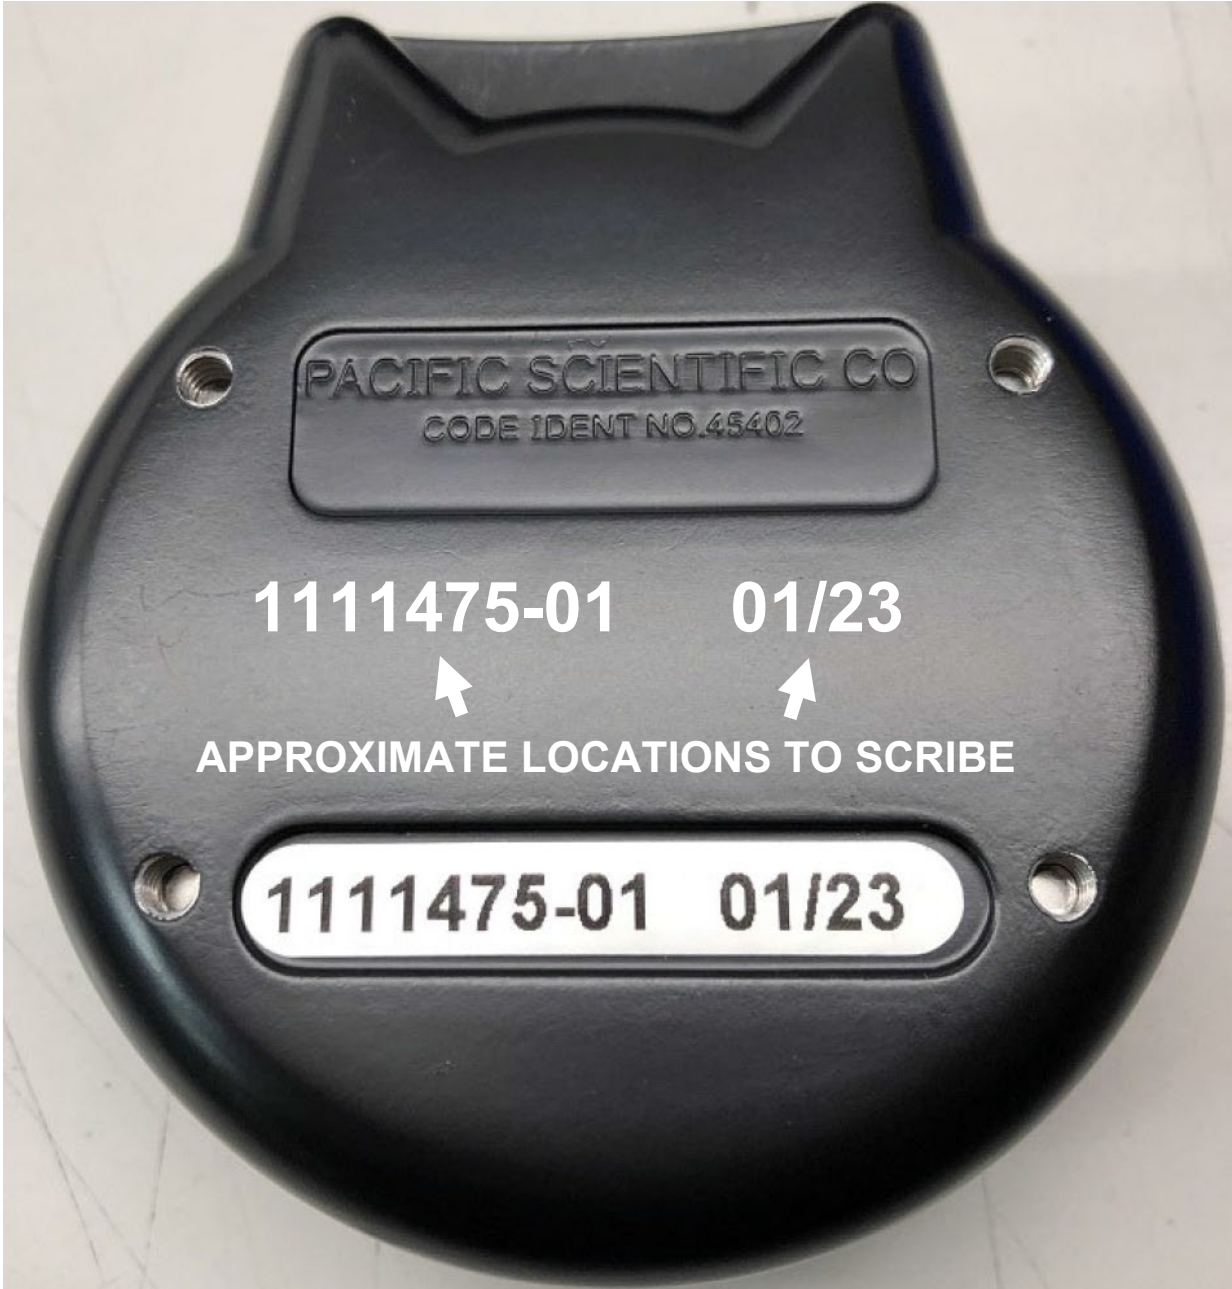
**Figure 3 – Vibro-Etching of Part Number and Manufacturing Date**

- a. For rotary buckles that have manufacturing dates **not** within January 2012 (01/12) and April 2013 (04/13) scribe the part number and manufacturing date in the locations identified (Figure 3), go to step 6.

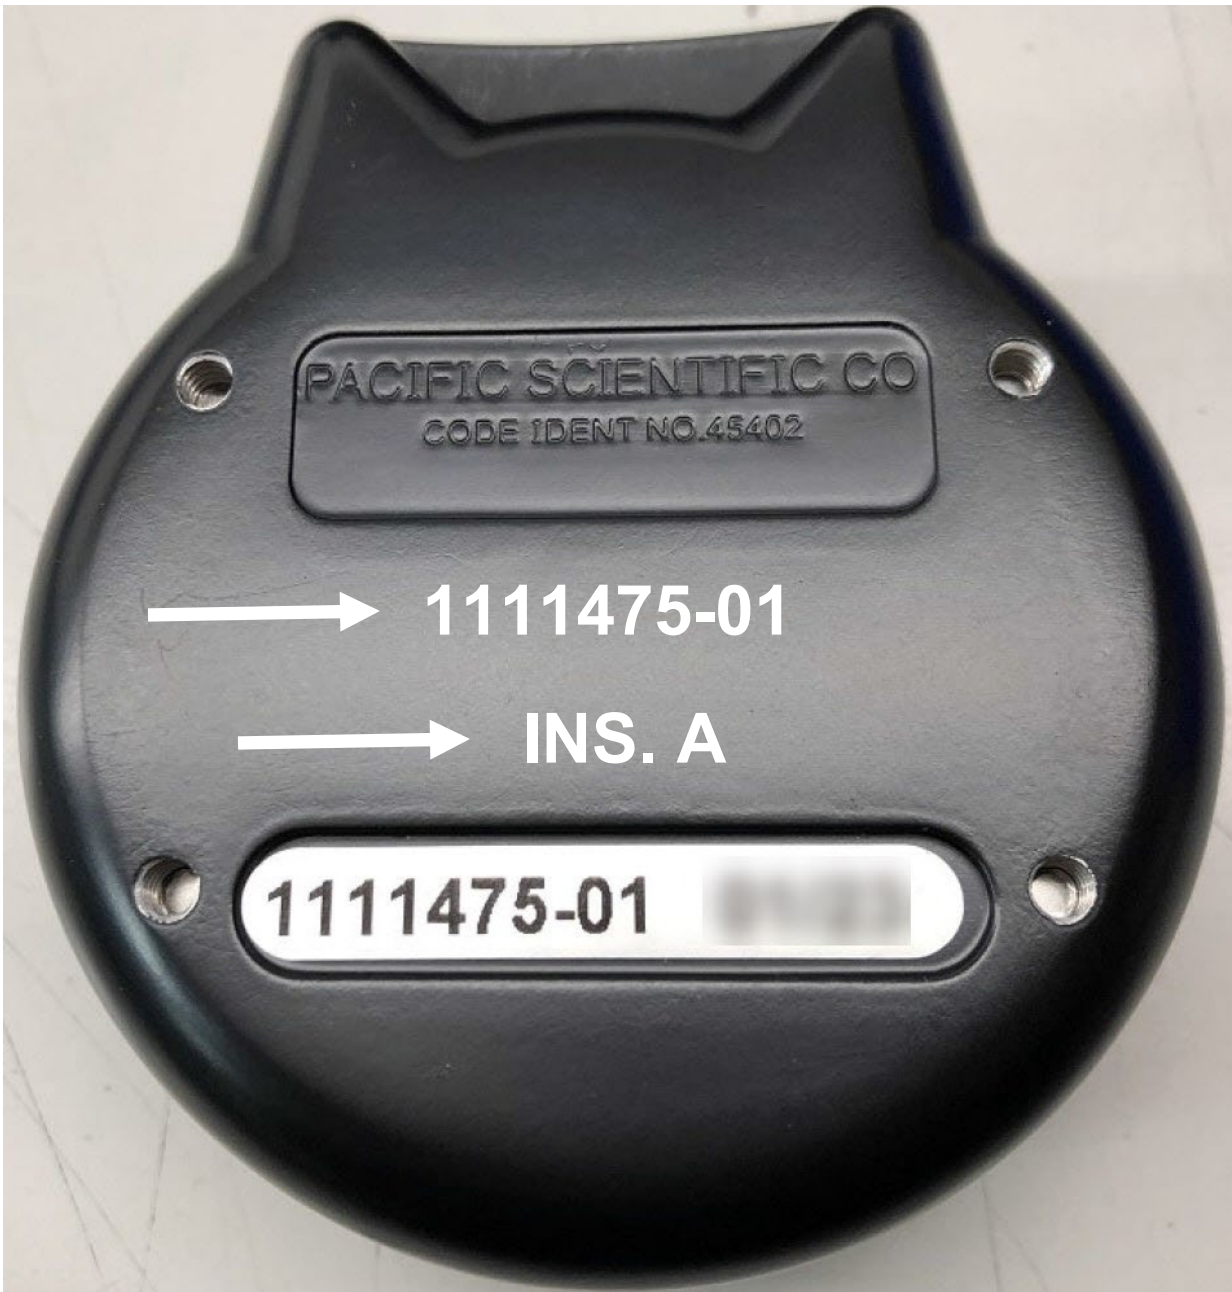
**Figure 4 – Vibro-Etching of Part Number and “INS. A” on Rotary Buckle Assembly**

- b. For rotary buckles that have been inspected in step 4 and **do not** have a legible manufacturing date, scribe the part number and “INS. A” in the locations identified (Figure 4), go to step 6.

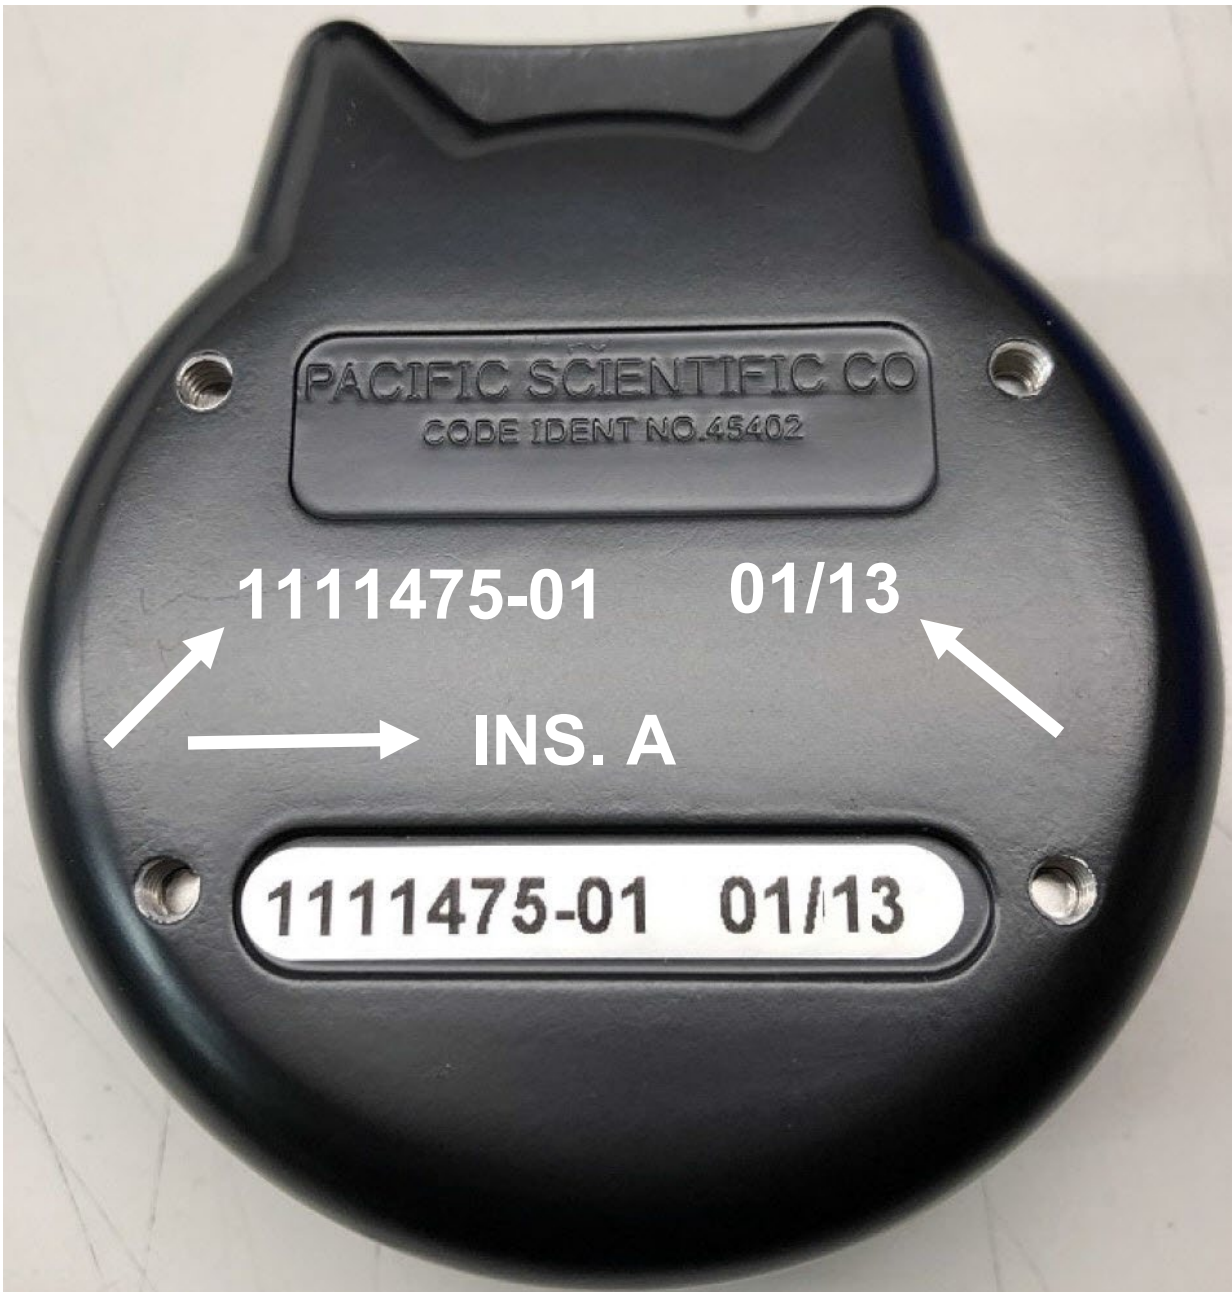
**Figure 5 - Vibro-Etching of Part Number, Manufacturing Date, and “INS. A” on Rotary Buckle Assembly**

- c. For rotary buckles that have been inspected in step 4 and **do** have a legible manufacturing date, scribe the part number, manufacturing date, and “INS. A” in the locations identified (Figure 5), go to step 6.

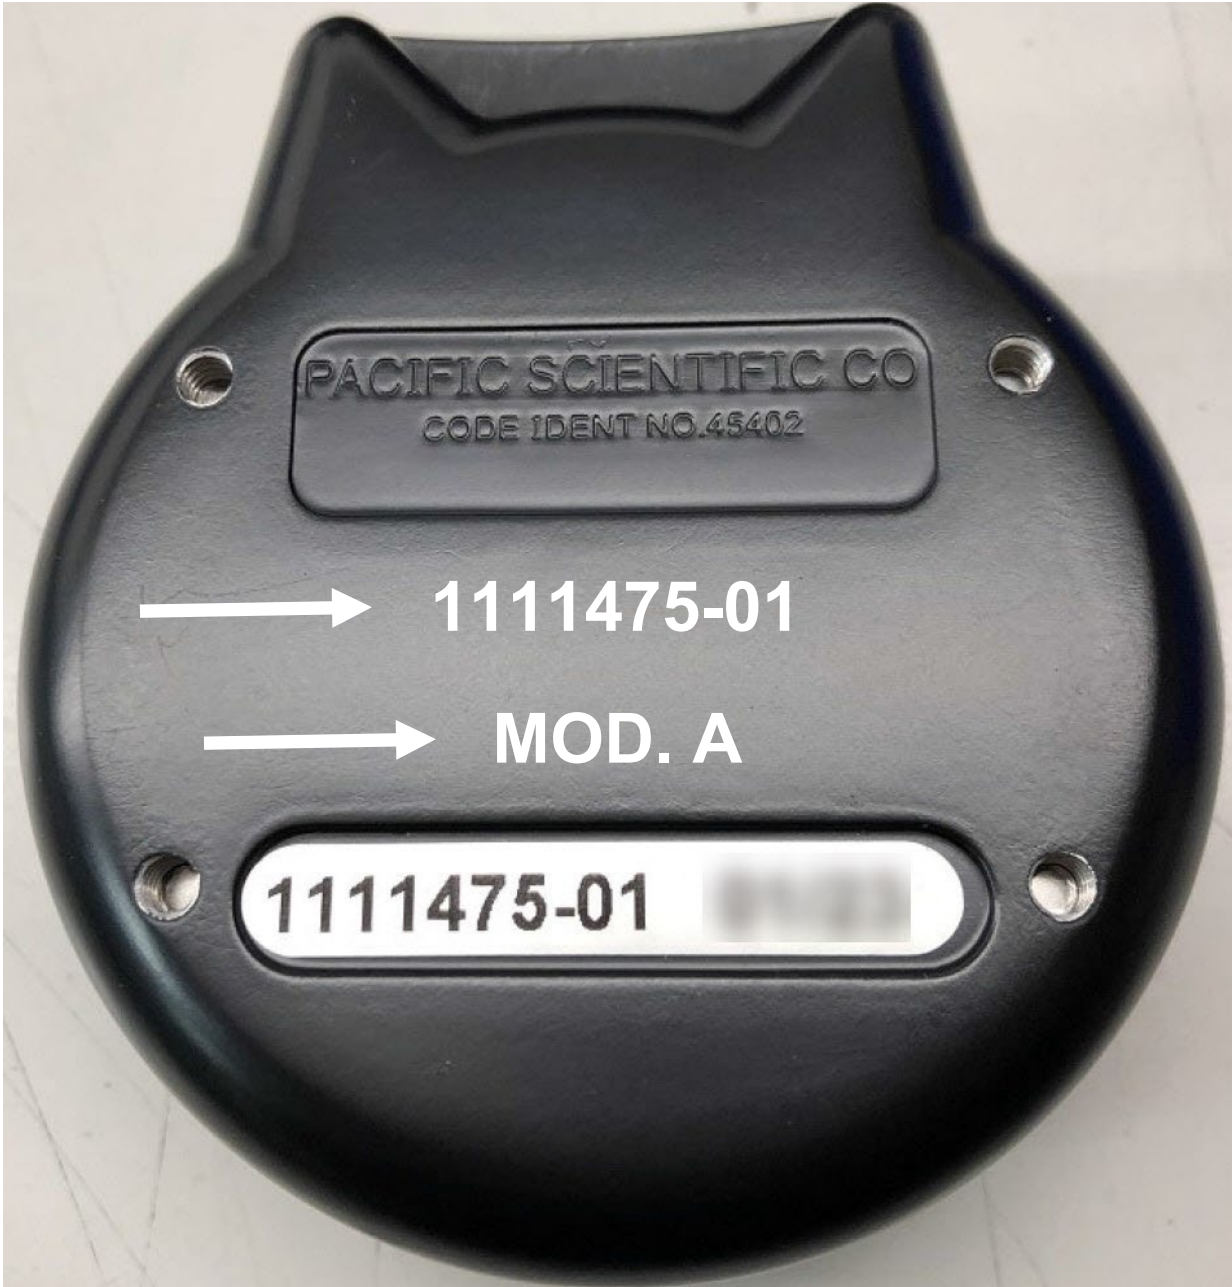
**Figure 6 - Vibro-Etching of Part Number and “MOD. A” on Rotary Buckle Assembly**

- d. For rotary buckles that have had the Torx head screws replaced by hex head screws in step 4.a. and **do not** have a legible manufacturing date, scribe the part number and “MOD. A” in the locations identified (Figure 6), go to step 6.

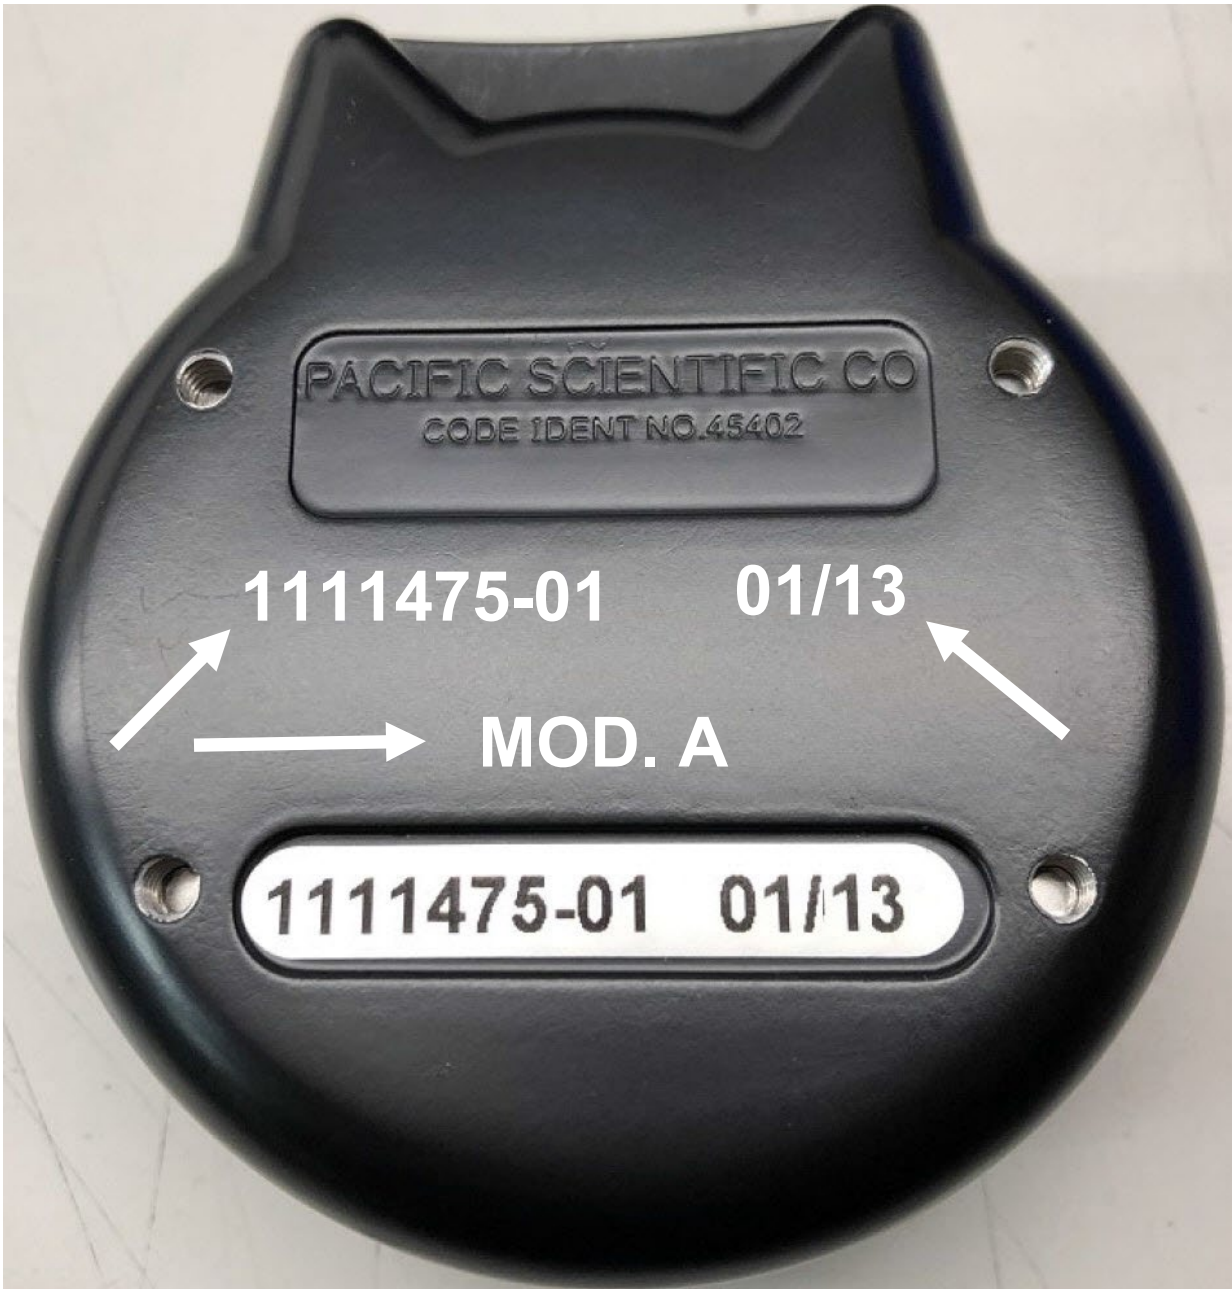
**Figure 7 – Vibro-Etching Part Number, Manufacturing Date, and “MOD. A” on Rotary Buckle Assembly**

- e. For rotary buckles that have had the Torx head screws replaced by hex head screws in step 4.a. and **do** have a legible manufacturing date, scribe the part number, manufacturing date, and “MOD. A” in the locations identified (Figure 7), go to step 6.

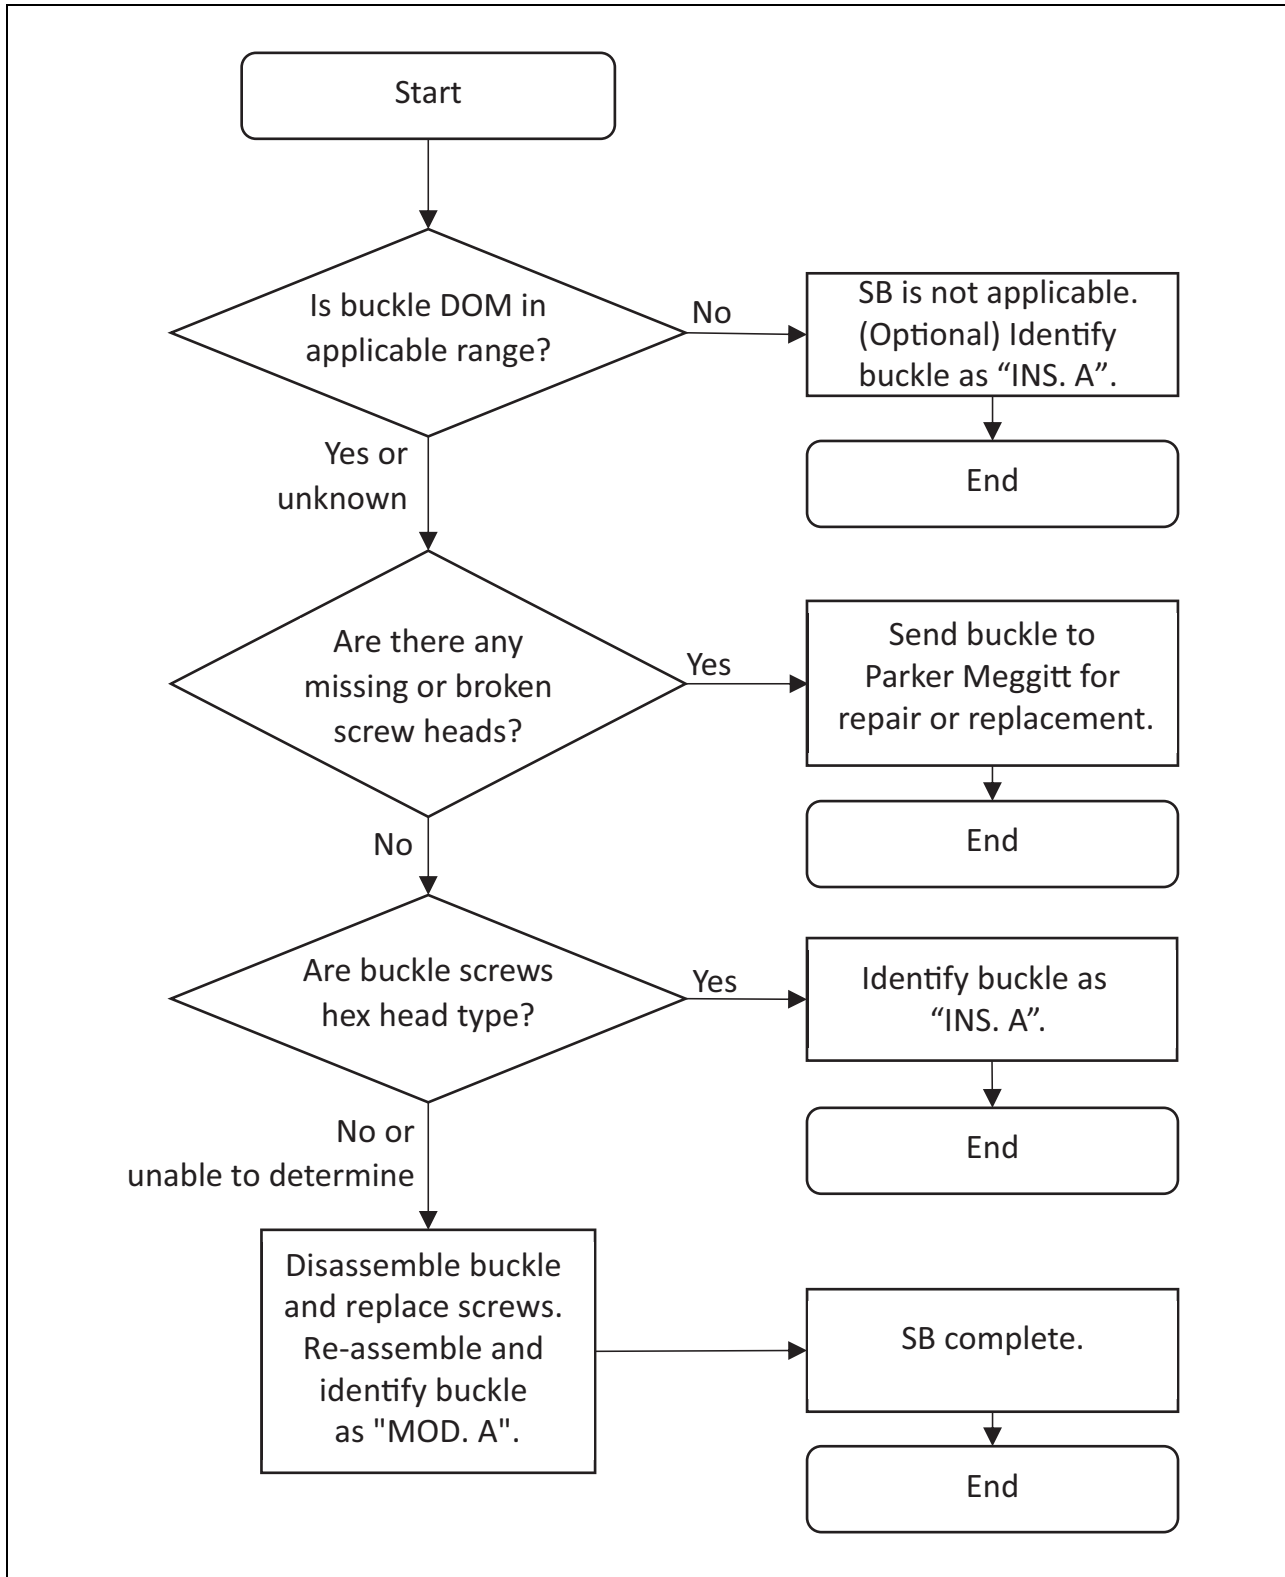
**Figure 2**  
*Flowchart of Required Operator Action*

- (a) Refer to the flowchart in Figure 2 on page 10.
- (b) Operators should check all restraint systems and buckle assemblies in service and inventory that meet the criteria in sections 1.A. & 1.B. This also applies to restraint systems in storage or any restraint system that may have had a buckle replaced with one of these part numbers, or that may have been repaired using the suspect screws.

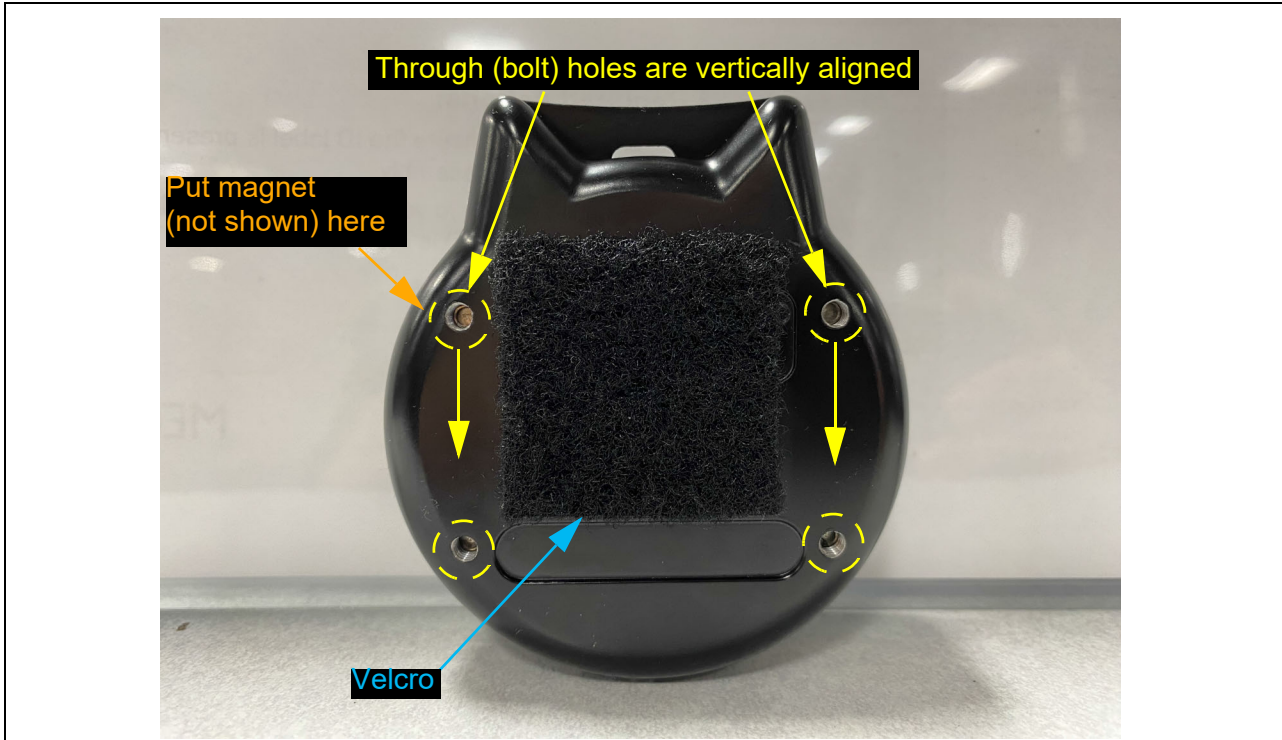
**Figure 6**  
*Magnet Test on PNR 1111475 Series Rotary Buckle with Velcro*

- 1 Use a disc magnet (recommended 3/8 inch diameter by 1/8 inch thick) [9,5 mm diameter by 3,2 mm thick] to check the magnetism of the alloy versus stainless steel screws.

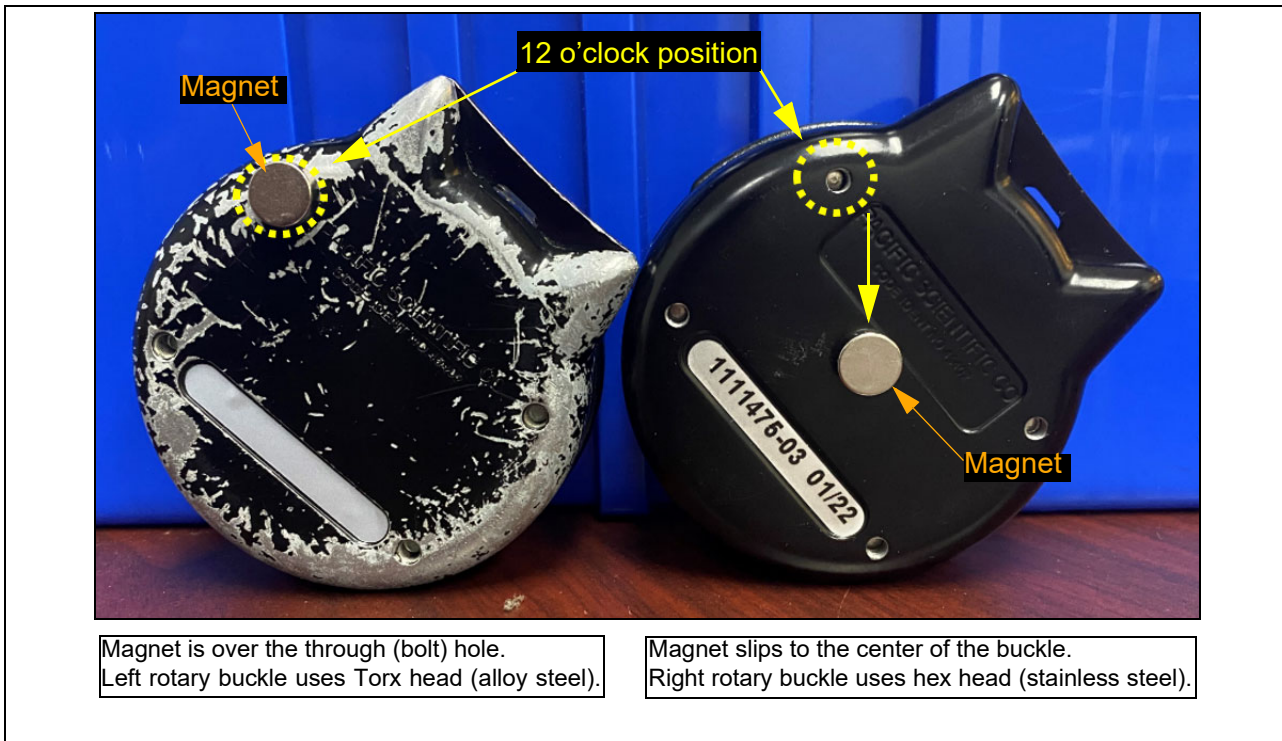
**Figure 7**  
*Magnet Test on PNR 1111475 Series Rotary Buckle*

- 5 Interpret results for each of the following :
  - a If the magnet stays in place over the through (bolt) hole, this shows that the buckle has the Torx head (alloy steel) screws installed. The buckle WILL need the screws replaced. An example of this is shown in the left image of Figure 7 on page 18.

- b If the magnet slips down to and stops at the center of the buckle, this shows that the buckle has the hex head (stainless steel) screws. The buckle will NOT need the screw replaced. An example of this is shown in the right image of Figure 7 on page 18.

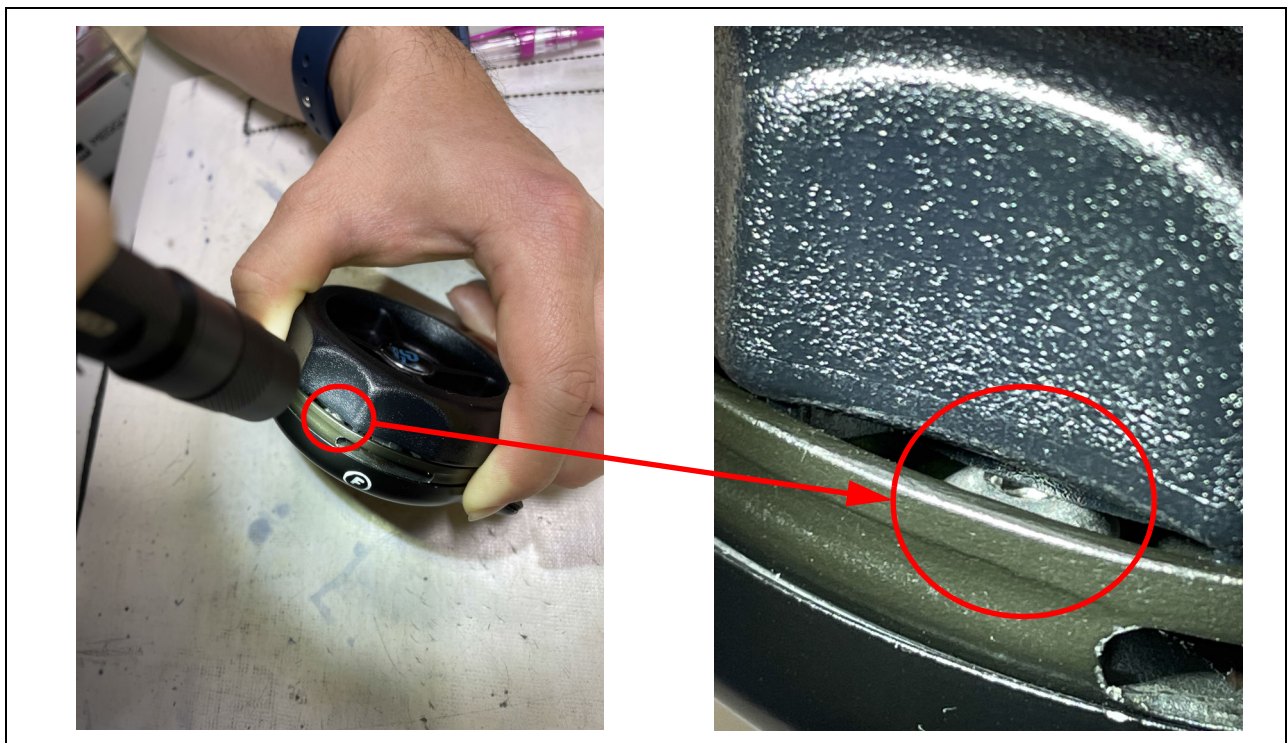
**Figure 8**  
*Side Belt Opening Inspection*

- 1 Use an inspection light (100+ lumens light with eye loupe recommended) to look through the aperture between the handle and the non-rotating portion of the buckle (Figure 8) and inspect the screws to determine whether they have Torx heads or hex heads. The handle will need to be rotated slightly to provide the best view of the two lower screws and rotate fully to view the top screws. All screws will be in the same configuration within the affected production window. Refer to Figure 9 on page 20 to distinguish the screw head types.

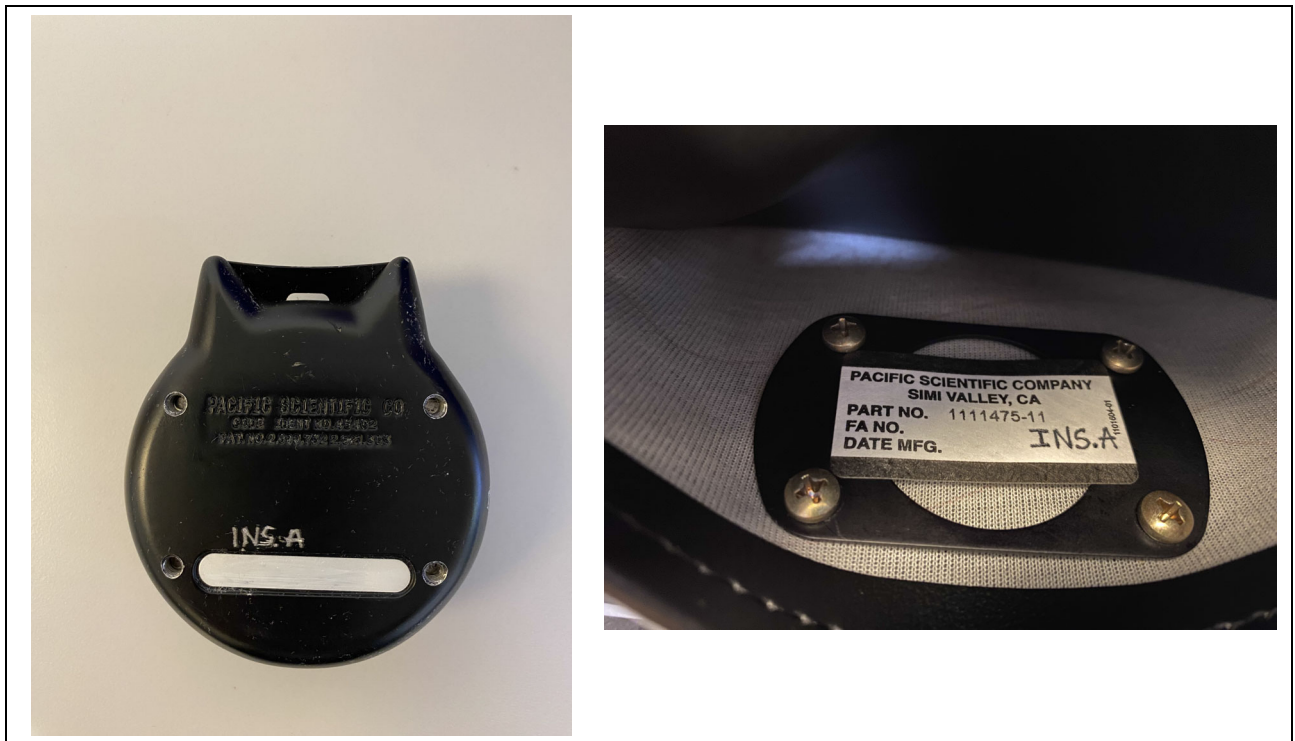
**Figure 10**

- (1) Before removing the rotary buckle from the restraint system, make sure the rotary buckle is identified (refer to Figure 10). If the rotary buckle is not identified, the rotary buckle should either be “Bag and Tagged” with restraint system upon removal or re-identified (refer to 4.B.(7) on page 20).

*Re-Identified PNR 1111475 Series Rotary Buckle Assembly with “INS. A”*

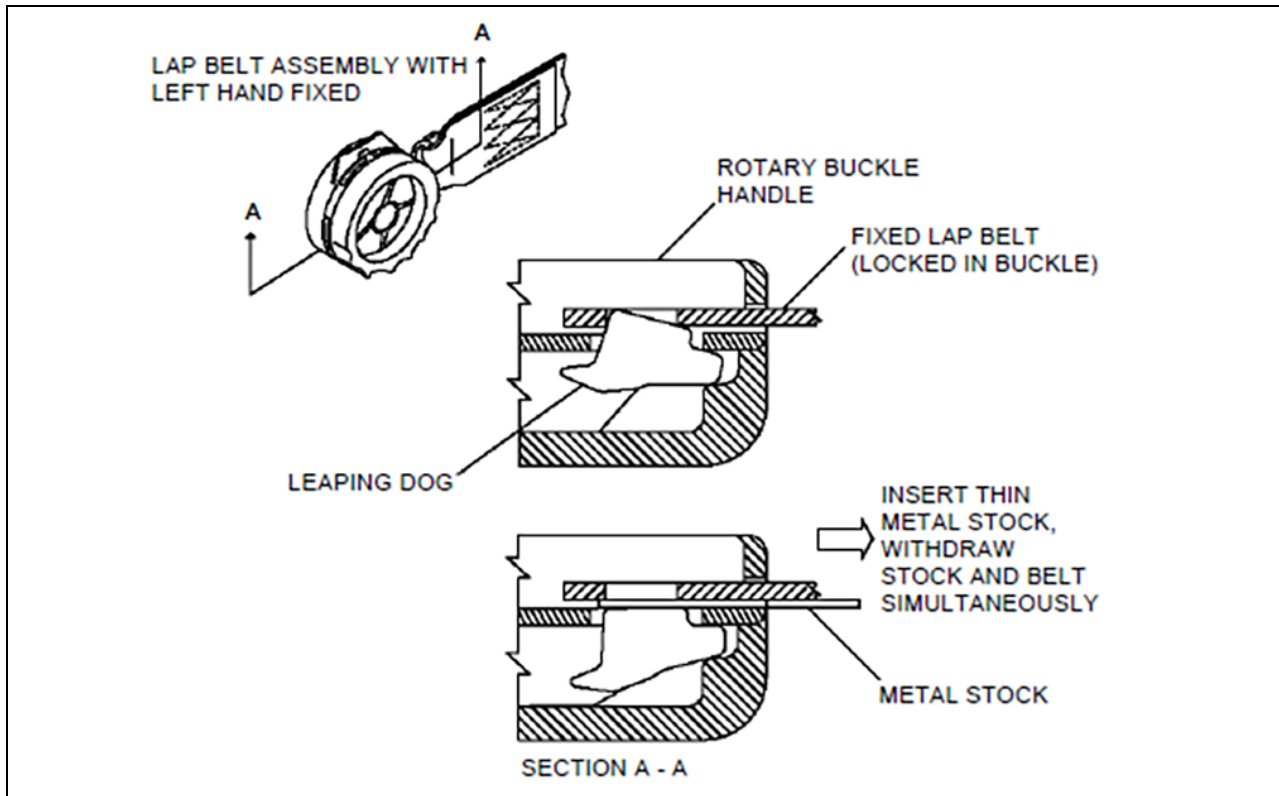
**Figure 11**  
*Removal of Rotary Buckle*

- (2) Refer to Figure 11.
- (3) Insert a piece of thin metal stock or shim into the slot of the rotary buckle and push inward between the fitting and the buckle locking mechanism.
- (4) Pull the fitting from the buckle.

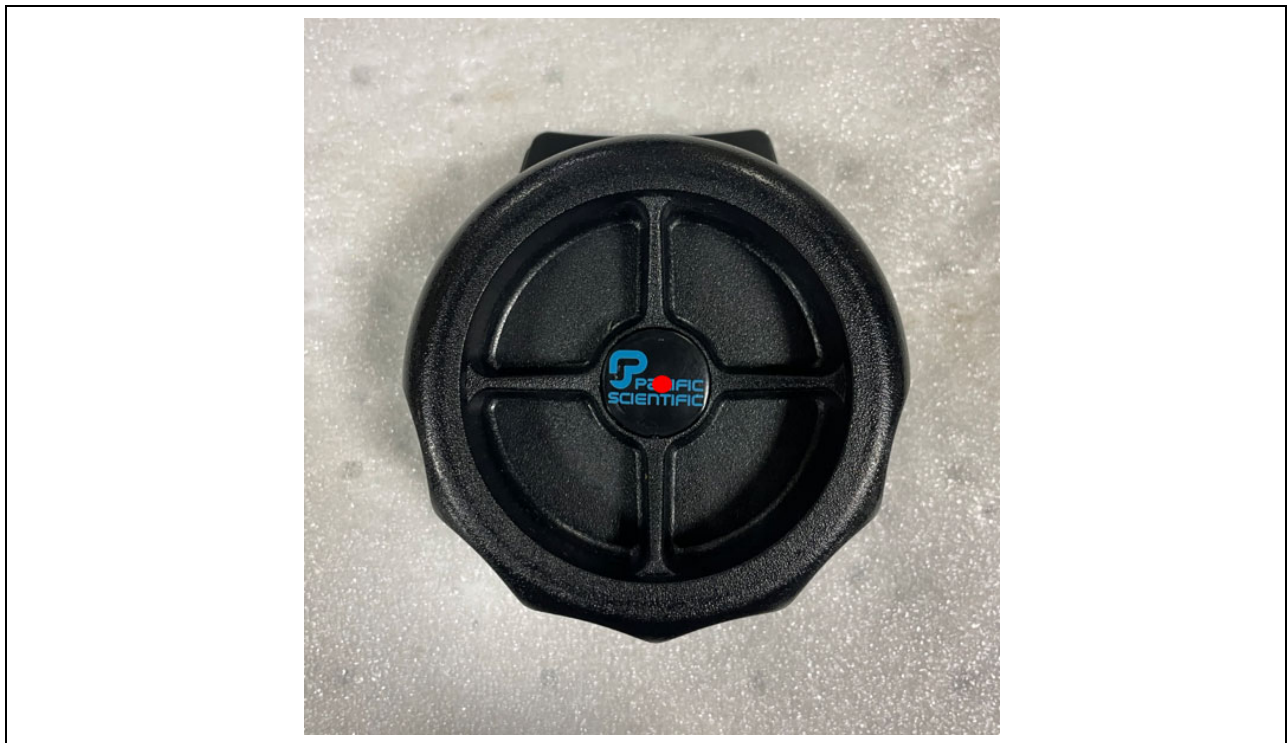
**Figure 12**  
*Logo Button Optimal Pierce Location*

- (a) Use a pry tool to pry the nameplate button (PNR 1101813-01) free from the buckle. If necessary, pierce the middle of the button (button is soft material). Try to damage the button as little as possible so that it can be used again.

NOTE : An example of the optimal pierce location is shown with a red dot in Figure 12.

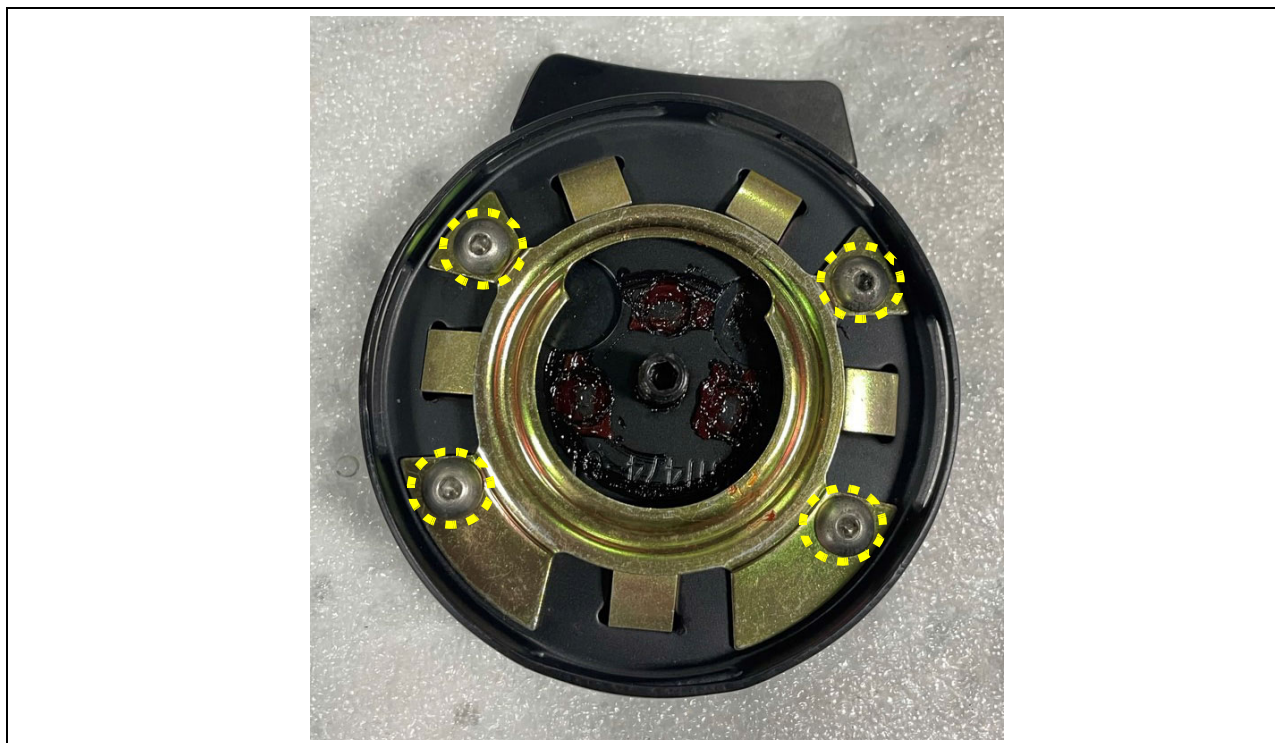
**Figure 13**  
*Disassembled Rotary Buckle with Suspect Torx Head Screws*

- (e) If the screws are the Torx head type (PNR 0901101-123) (as shown in Figure 13), then replace the screws with the new stainless steel hex head type (PNR 0901101-149) as follows :

- 4      Torque the four screws (PNR 0901101-149) to 15 to 25 in-lbs (1.69 to 2.82 N-m).

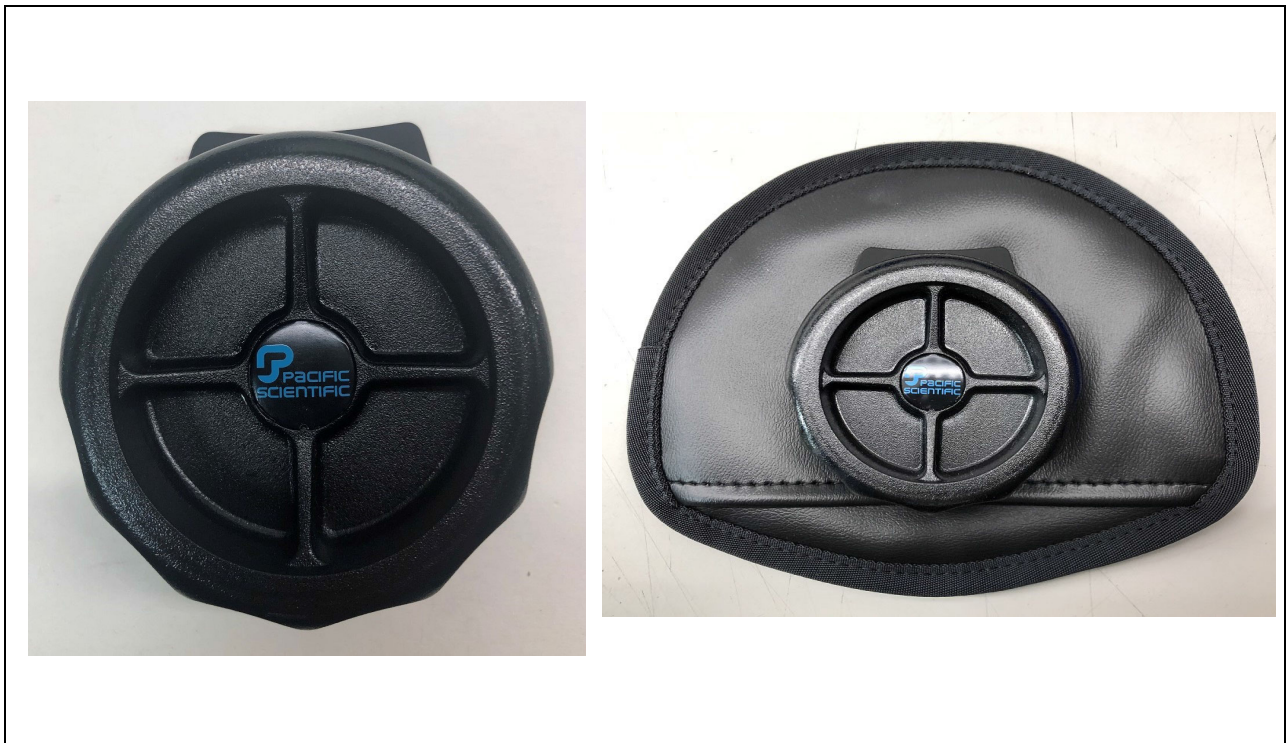
**Figure 14**  
*PNR 1111475 Series Rotary Buckle Logo Button Alignment*

- (j) Put the buckle in an arbor press or equivalent tool. Put the logo on the center of the buckle, with the "PACIFIC SCIENTIFIC" text levelled evenly with the two plates.

- NOTE :** An example of the alignment can be seen in Figure 14.
- (k) Hold a 7/16 inch [11 mm] socket in place on the button. Use arbor press or equivalent tool to press the button in place on the buckle.

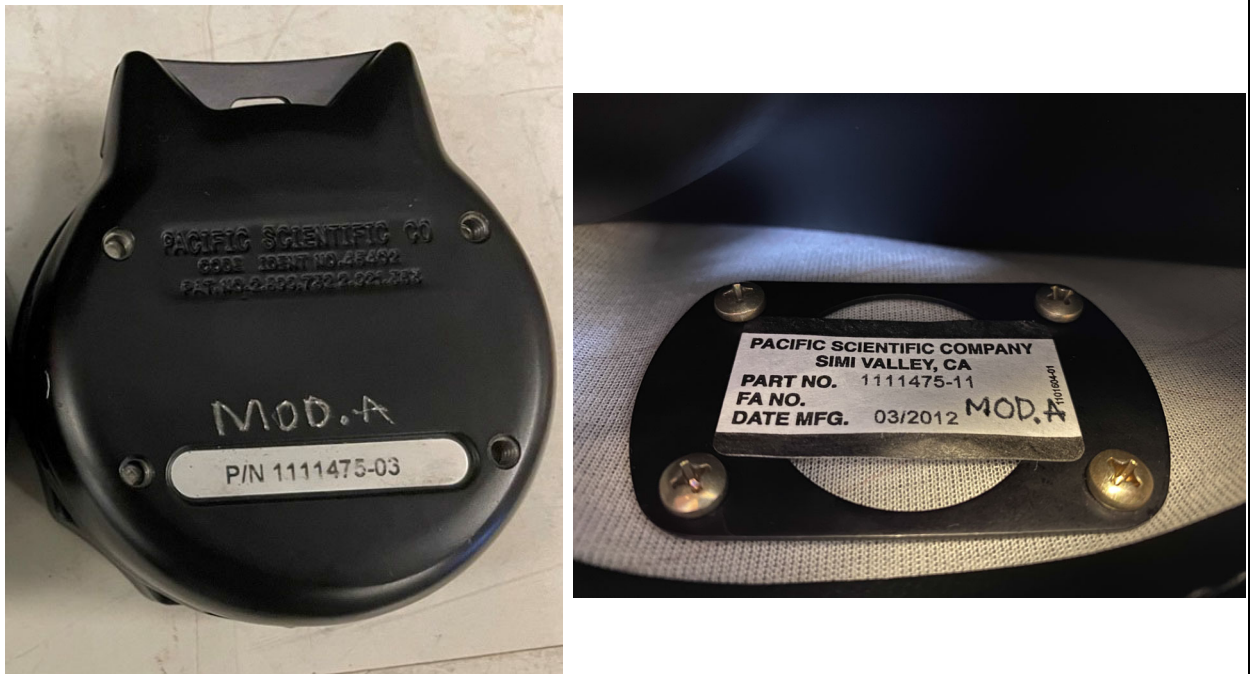
**Figure 15**  
*Re-Identified PNR 1111475 Series Rotary Buckle Assembly with “MOD. A”*

- (1) Buckles with the new screws installed shall be identified as "**MOD. A**". Refer to 4.D.(1).(m) on page 26 for the marking process for each buckle.
- (2) Buckles that have been inspected and found to have the stainless steel screws with the hex head installed shall be identified as "**INS. A**". Refer to 4.B.(6) on page 20 for the marking process for each buckle.
- (3) Removed buckles with missing part number shall be marked. Refer to 4.B.(7) on page 20 for marking process and refer to Table 1 on page 3 for part numbers of the restraint systems and related rotary buckles.
