ALERT SERVICE BULLETIN

212-20-163

MODEL AFFECTED: 212

SUBJECT: ENGINE OIL CHECK VALVE P/N 209-062-520-001,
INSPECTION AND REPLACEMENT OF.

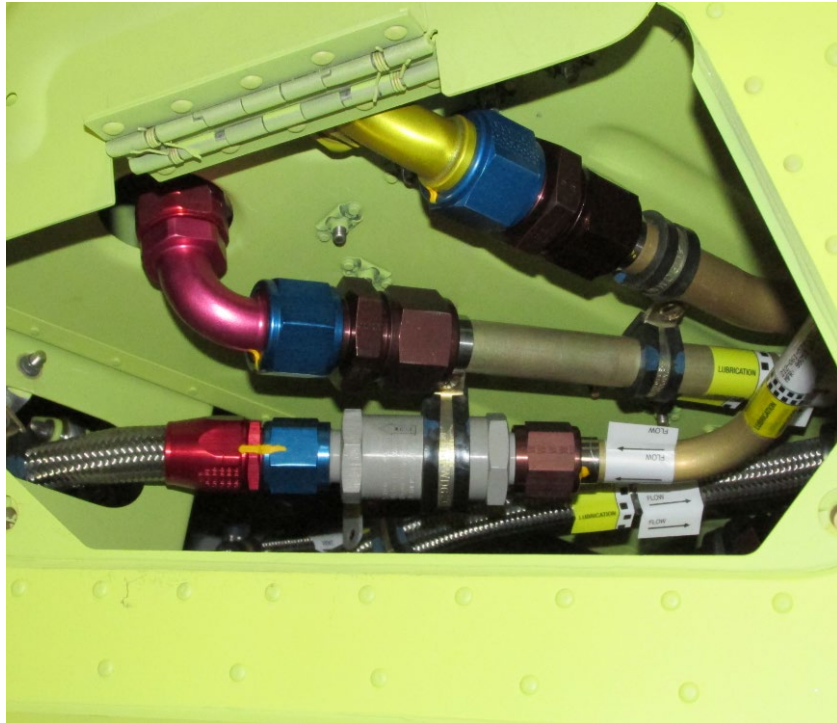
Detail A. Engine Number 2 (Right Side)

Figure 1. Engine Oil Check Valves Locations

1. Prepare the helicopter for maintenance and gain access to the engine oil check valves. The engine oil check valves are located in the engine reduction gearbox compartment under the oil coolers (Figure 1, Details A and B).

1. Prepare the helicopter for maintenance and gain access to the engine oil check valves (Figure 1, Details A and B).
2. Using a strong light source, visually inspect the oil check valves for general condition and oil leaks. Inspect for cracks at the inlet end where the threaded fitting is installed (Figure 3).
3. If a crack is found, replace the check valve prior to next flight. Figure 4 shows an example of a cracked check valve.
4. If no cracks or any other defects that would cause the valve to be unserviceable are found, make an entry in the helicopter logbook and historical service records indicating the findings and that Part II will require accomplishment until Part III is accomplished.

1. Prepare the helicopter for maintenance and gain access to the engine oil check valves (Figure 1, Details A and B).

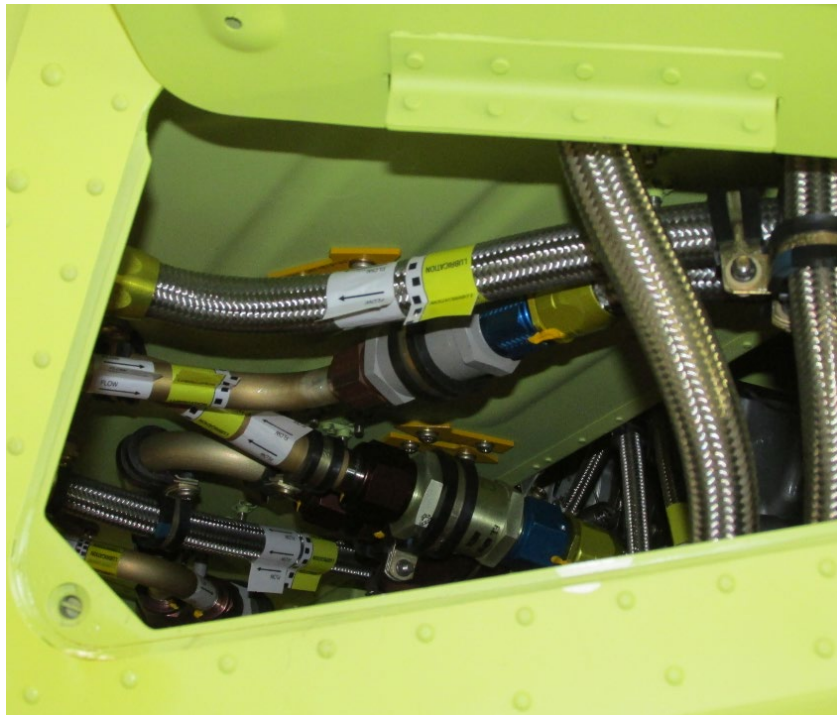
Detail B. Engine Number 1 (Left Side)
