## **ALERT SERVICE BULLETIN**

**412CF-20-69**

**MODEL AFFECTED:** 412CF

**SUBJECT:** ENGINE OIL CHECK VALVE P/N 209-062-520-001,  
INSPECTION AND REPLACEMENT OF.

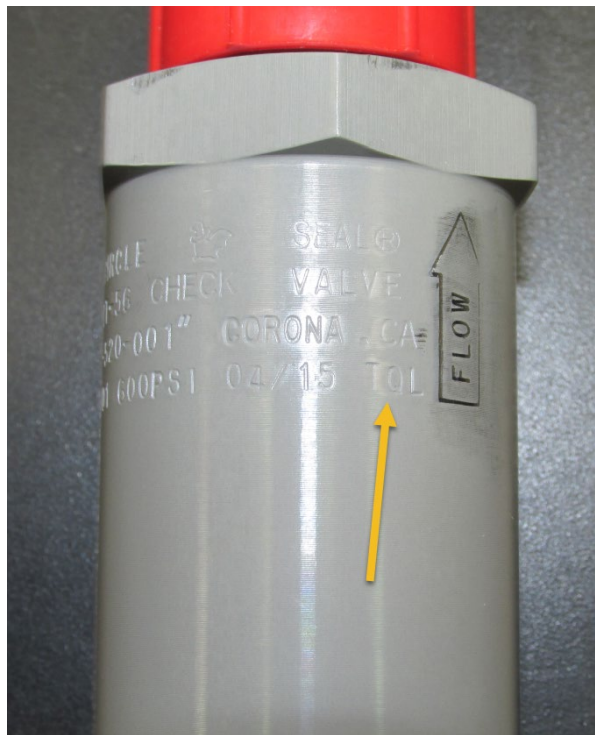
Detail A. Circor Aerospace Engine Oil Check Valve Marked “TQL”

It is not necessary to remove the oil check valve for inspection however some clamping may require removal for better access. Regardless of manufacturing date, any oil check valves with the "TQL" marking are not affected by this bulletin. Oil check valves manufactured by other suppliers are also not affected by this bulletin. Oil check valves with the "CORONA CA" marking and without the "TQL" marking are affected by this bulletin. (Figure 2, Details A and B).

Figure 2. Engine Oil Check Valves not Affected

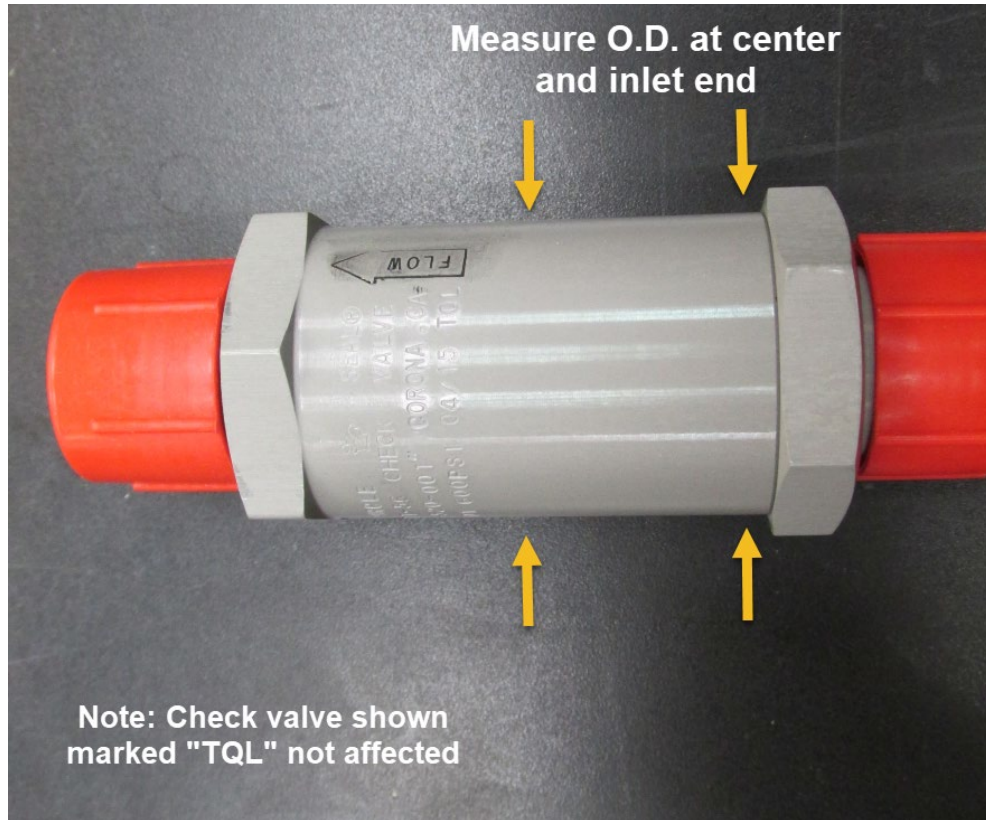
2. Verify if the check valves installed are affected by this bulletin.
3. If the check valves are not affected, make an entry in the helicopter logbook and historical service records indicating the findings and compliance with this Alert Service Bulletin.
4. If one or both check valves are affected, proceed as follows:
  - a. Using a caliper or equivalent, measure the check valve housing at the center and record dimension (Figure 3).
  - b. Measure the housing at the inlet end where the threaded fitting is installed and record dimension.
  - c. If the dimension measured at the inlet end is no more than 0.003 inch (0.0762 mm) greater than the measurement at the center, the valve is serviceable and

- d. If the dimension measured at the inlet end is greater than 0.003 inch (0.0762 mm) when compared to the measurement at the center, the valve will require replacement. Part III can be accomplished immediately, or Part II can be accomplished until the defective valve can be replaced in accordance with Part III.
- e. If the defective check valve is not replaced immediately, make an entry in the helicopter logbook and historical service records indicating the findings and that Part II must be accomplished every 25 flight hours or 30 days whichever comes first until Part III is accomplished.

Figure 3. Engine Oil Check Valve Outside Diameter Measurement

1. Prepare the helicopter for maintenance and gain access to the engine oil check valves (Figure 1, Details A and B).
2. Using a strong light source, visually inspect the oil check valves for general condition and oil leaks. Inspect for cracks at the inlet end where the threaded fitting is installed (Figure 3).
3. If a crack is found, replace the check valve prior to next flight. Figure 4 shows an example of a cracked check valve.
4. If no cracks or any other defects that would cause the valve to be unserviceable are found, make an entry in the helicopter logbook and historical service records indicating the findings and that Part II will require accomplishment until Part III is accomplished.
