INFORMATION LETTER 222-06-22
222U-06-17
230-06-13
430-06-37

TO: All Owners/Operators of Bell 222/230/430 Helicopters

SUBJECT: Tail Rotor Blade Identification

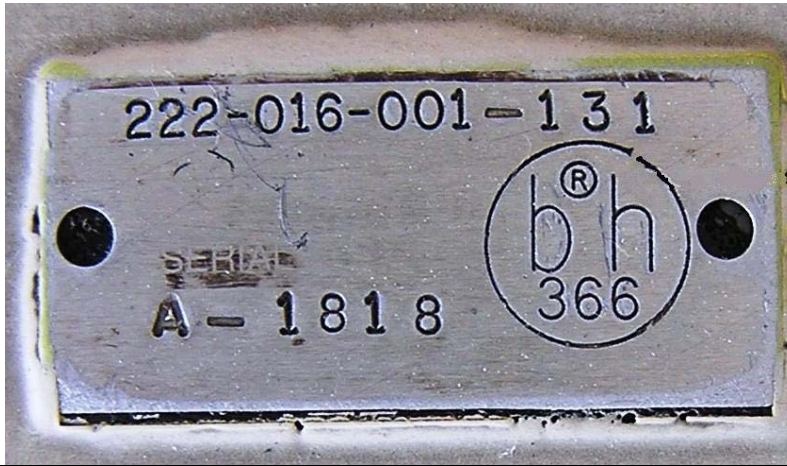
A) The small letter R in a circle seen on Data plate shown on Figure 1 is the Copyright ® of Bell Helicopter Textron.

Original Data plate with the Copyright ® of Bell Helicopter Textron

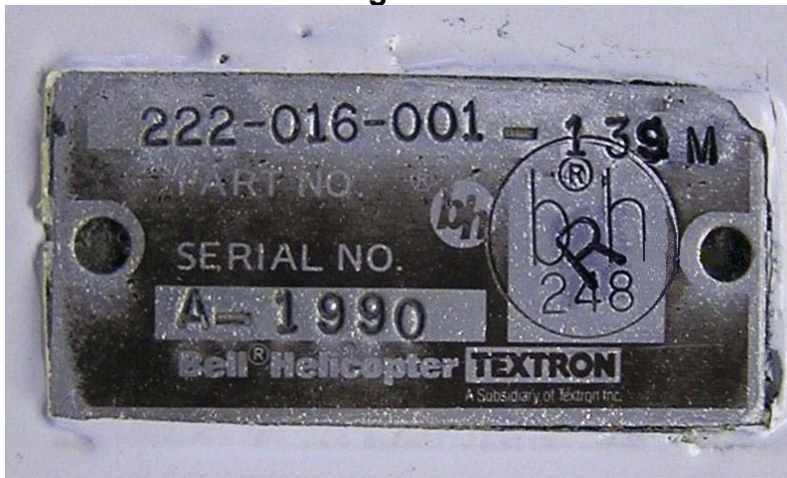
Figure 2

Original Data plate with R to indicate Rework

B) Following the rework process per Part III of ASBs listed above, each tail rotor blade will be re-identified by a large letter " R " stamped in the square block of the ID plate. Refer to Figures 2 and 3 for details. In addition, each blade history card will be clearly annotated to reflect compliance with reference bulletin.

Only tail rotor blades re-identified with a large letter " R " as shown in Figures 2 and 3 of this letter are exempt from the repetitive inspections.

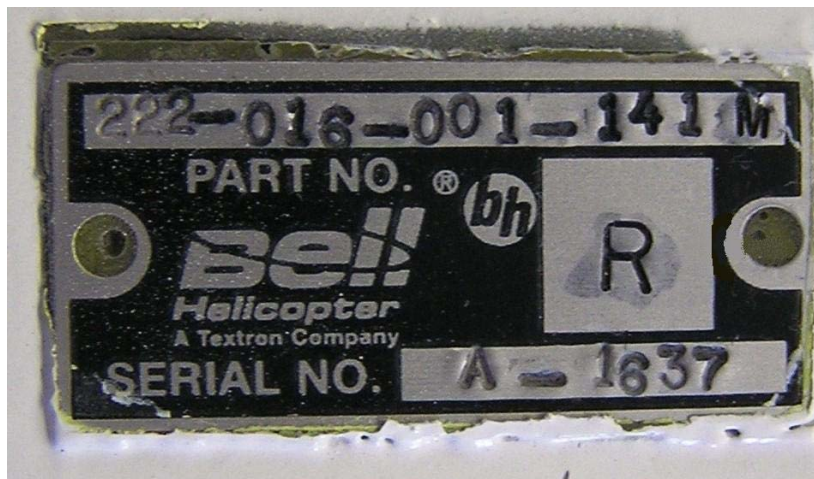
Figure 3

New Data plate with R to indicate Rework
