ALERT SERVICE BULLETIN

412-21-185

- MODEL AFFECTED:** 412/412EP
- SUBJECT:** TAIL ROTOR DRIVE SHAFT ASSEMBLY 412-040-620-103 INSPECTION AND REMOVAL FROM SERVICE
- HELICOPTERS AFFECTED:** Serial numbers 34025 through 34036, 36020 through 36687, 36689 through 36999, 37002 through 37018, 37021 through 37051 and helicopters with upgrade kit 412-704-052 installed per BHT-412-SI-74 or modified in accordance with drawing 412-570-001 or 412-706-100 (412SP to HP upgrade).

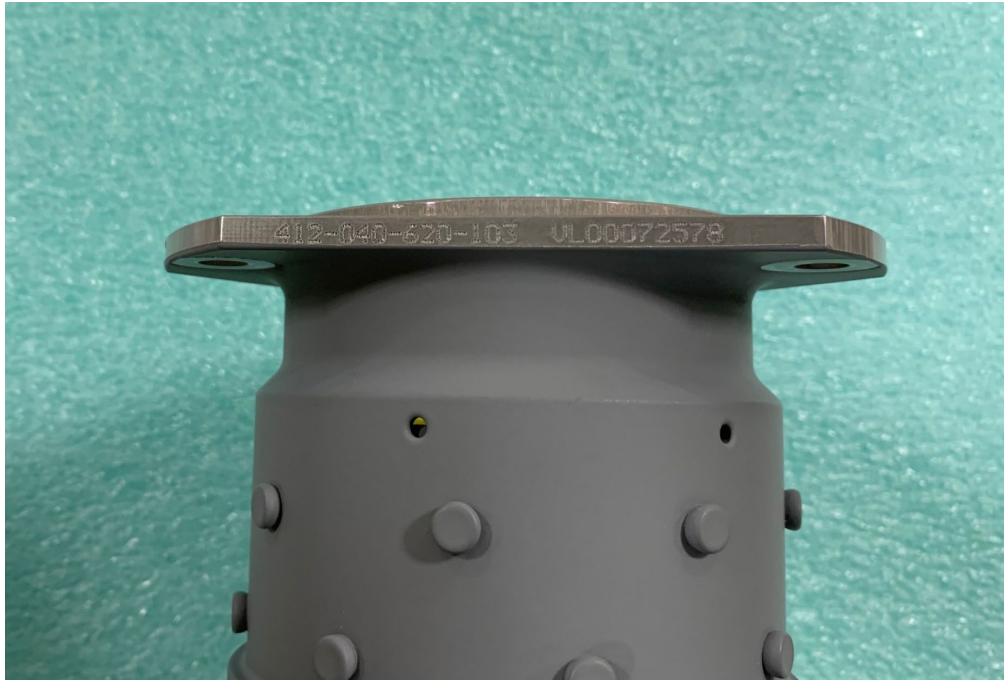
3. Verify the serial number of the tail rotor drive shaft assembly installed on the helicopter. The drive shaft assembly part number and serial number are located on the flange of the drive adapter attached to the intermediate gearbox (refer to Figure 1) Do not confuse drive adapter 412-040-623-101 serial number with the drive shaft assembly 412-040-620-103 serial number.

Figure 1. Location of part and serial numbers
