ALERT SERVICE BULLETIN

429-19-43

MODEL AFFECTED: 429

SUBJECT: MAIN ROTOR MAST ASSEMBLY 429-040-040-105
LOWER SPLINE INSPECTION, INTRODUCTION OF

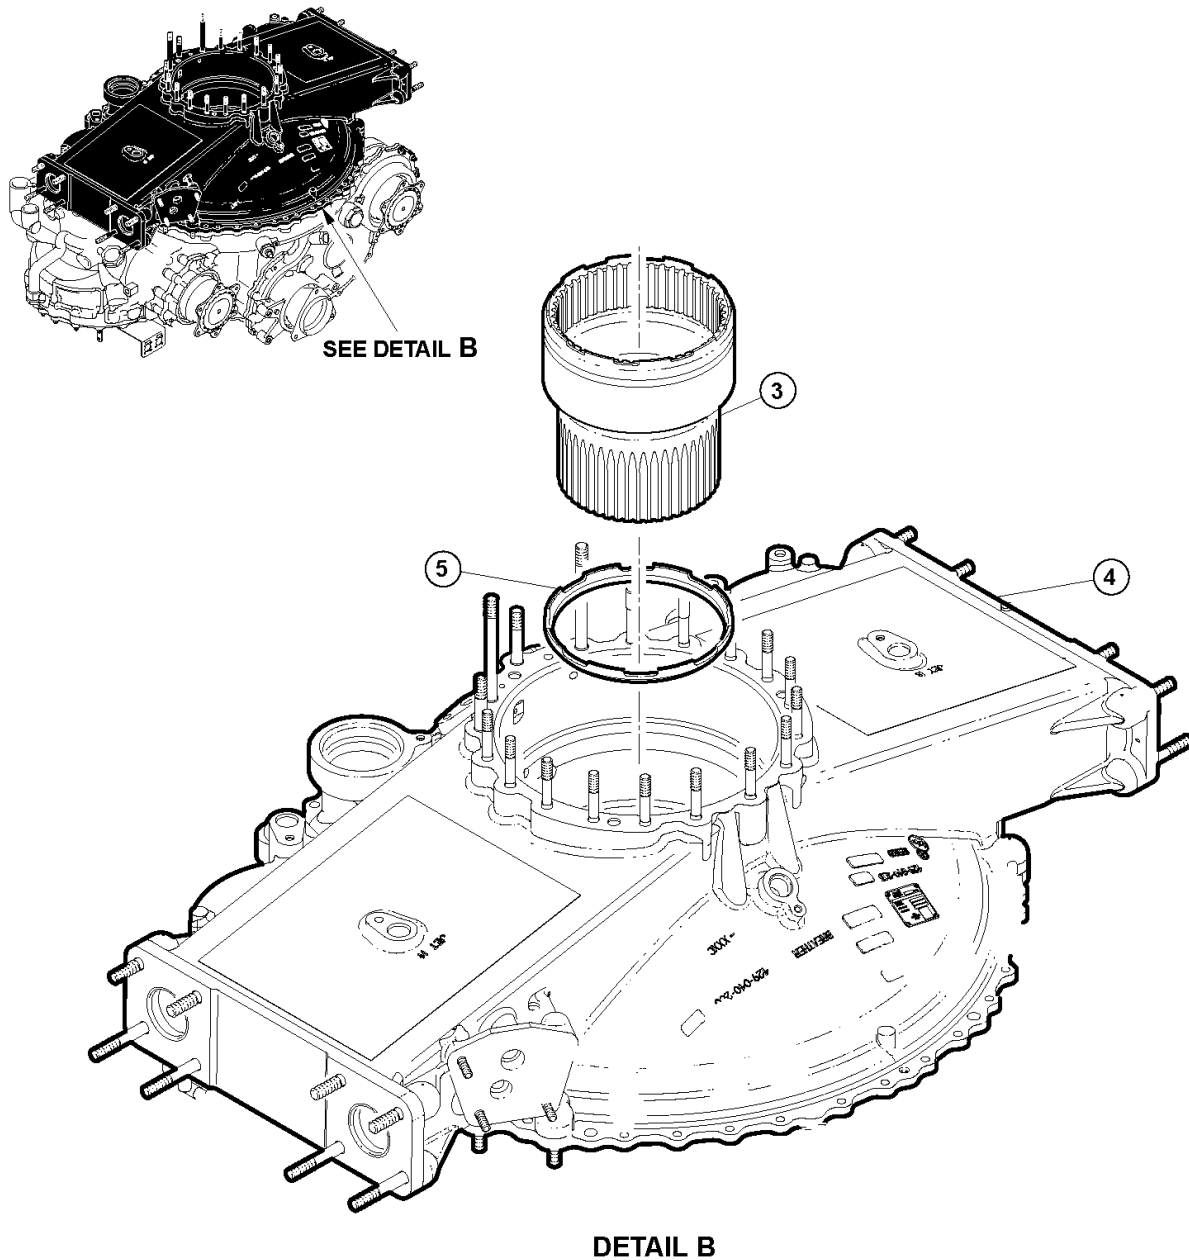
Figure 1 - Mast Assembly and Splined Shaft Removal and Installation (Page 2 of 2)

1. Mast assembly
2. Debris Pan
3. Splined Shaft
4. Transmission Assembly
5. Splined Shaft Support

9. Install a serviceable main rotor mast assembly (1) in the transmission assembly (4) (DMC-429-A-63-10-00-00A-720A-A).
