**OPERATION SAFETY NOTICE**

**206L-19-54**

**SUBJECT: ROLLS-ROYCE M250 ENGINES - MAINTENANCE WARNING - EXTERNAL LINES**

## MAINTENANCE WARNING - EXTERNAL LINES

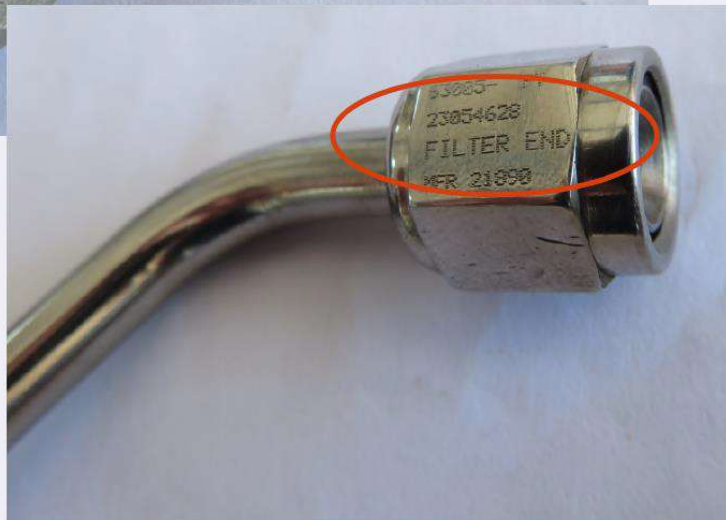
Tube End Marking  
FIG. 16

Many tubes are not marked at either end, and can be installed either way. When fitting these tubes, loose fit the tube both ways before you determine the best fit. Make sure there is no contact with the other tubes. These tubes include:
