ALERT SERVICE BULLETIN

430-15-56

MODEL AFFECTED: 430

SUBJECT: Seat Belt Comfort Clips, Removal of.

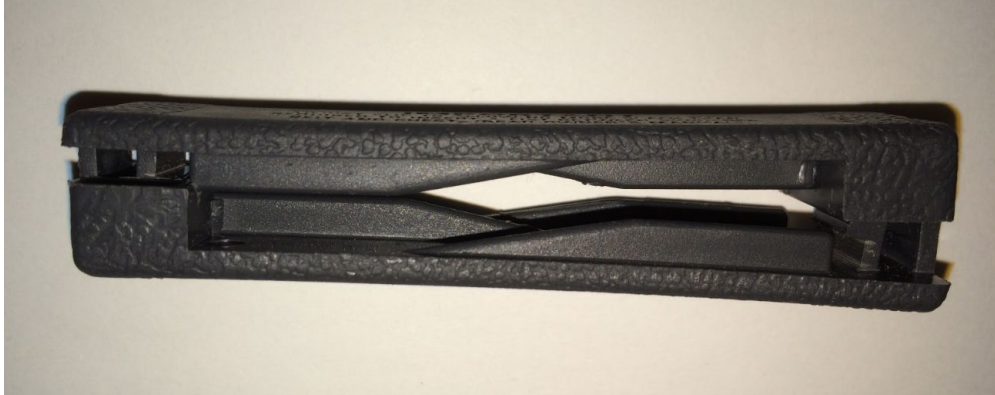
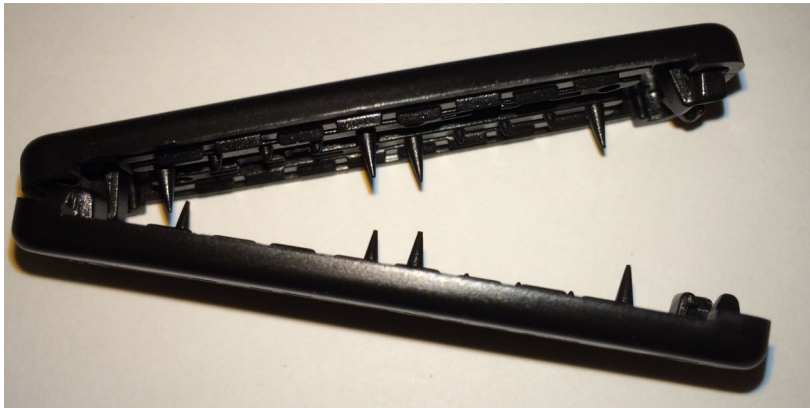
Figure 1 – Seat Belt Comfort Clips

P/N D7LZ-6560286-B

P/N 504636-401

1. Prepare the helicopter for maintenance.
2. Verify if the seat belt comfort clips are installed on any of the crew or passenger shoulder harness seat belts (Figure 1). If installed, remove and discard.
3. Make an entry in the helicopter logbook and historical service records indicating compliance with this Alert Service Bulletin.
