ALERT SERVICE BULLETIN

205B-15-66
20 January 2016

MODEL AFFECTED: 205B

SUBJECT: Seat Belt Comfort Clips, Removal of.

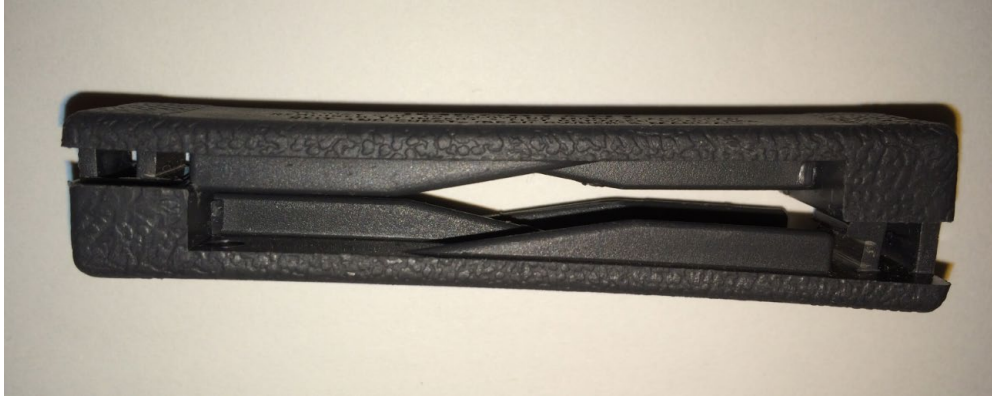
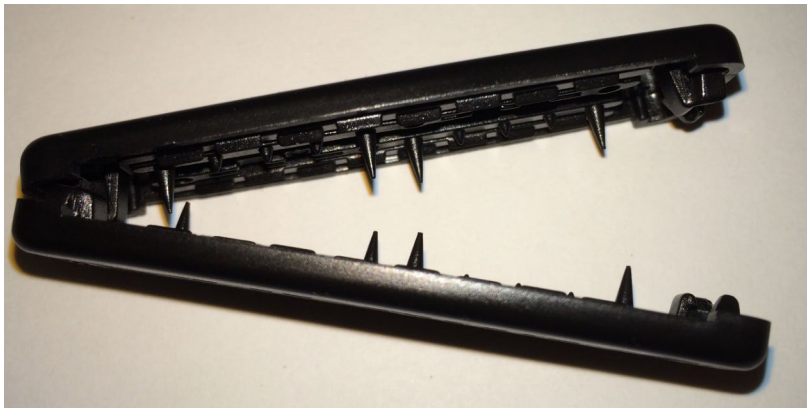
Figure 1 – Seat Belt Comfort Clips

Bell Helicopter has become aware of an issue that affects the seat belt assemblies on Bell Helicopter models. This Service Directive requires the removal of all variants of comfort clips from all seat belt assemblies on the affected helicopters. Comfort clips D7LZ-6560286-A and D7LZ-6560286-B, which have been used on different seat belt assemblies, have been superseded to the 504636-401. We have identified concerns with the use of the comfort clips relevant to the designed safety features of the seat belt assemblies. We have since stopped delivering the comfort clips with our current production helicopter seat belt assemblies, and have made the parts no longer procurable from Bell Helicopter. Although this helicopter model was not affected by original design at the time of certification and delivery of the helicopter, we are making this bulletin applicable as the subject parts may have been installed post delivery to end owners/operators. Applicability of this bulletin to any spare part shall be determined prior to its installation on an affected helicopter.

P/N D7LZ-6560286-B

P/N 504636-401

1. Prepare the helicopter for maintenance.
2. Verify if seat belt comfort clips are installed on any of the crew or passenger shoulder harness seat belts (Figure 1). If installed, remove and discard.
