ALERT SERVICE BULLETIN

210-16-11  
31 March 2016

**SUBJECT:** 210 Stabilizer Bar Damper Lever and Damper Assembly, One Time Inspection.

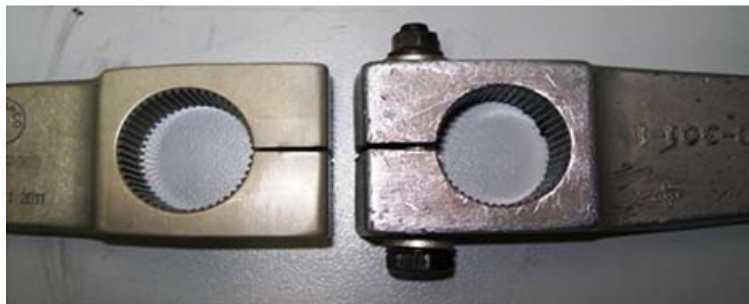
**Figure 1**

Bell Helicopter has been informed that a 212-010-301-105 Damper Arm had been installed on a 204-010-937-009 Damper Assemblies. The 212-010-301-001 and the 212-010-301-105 Damper Arms are not interchangeable. Damper Arm 212-010-301-001 has 48 serrations and Damper Arm 212-010-301-105 has 42 serrations.

1. Access 210 pylon and inspect the Main Rotor Damper Assemblies.
2. If the Damper Assembly is a 204-010-937-009 or alternate -103, a compatible 212-010-301-001 Damper Lever should be installed. If a 204-010-937-105 Damper Assembly is installed then a compatible 212-010-301-105 Damper Lever should be installed.

3. If an out of configuration Damper Arm and Damper Assembly is found. Inspect parts for serviceability per maintenance manual criteria and install correct parts configuration per information provided in this Alert Service Bulletin.
