ALERT SERVICE BULLETIN

212-20-164

MODEL AFFECTED: 212

SUBJECT: FUEL CHECK VALVE P/N 209-062-607-001,
INSPECTION AND REPLACEMENT OF.

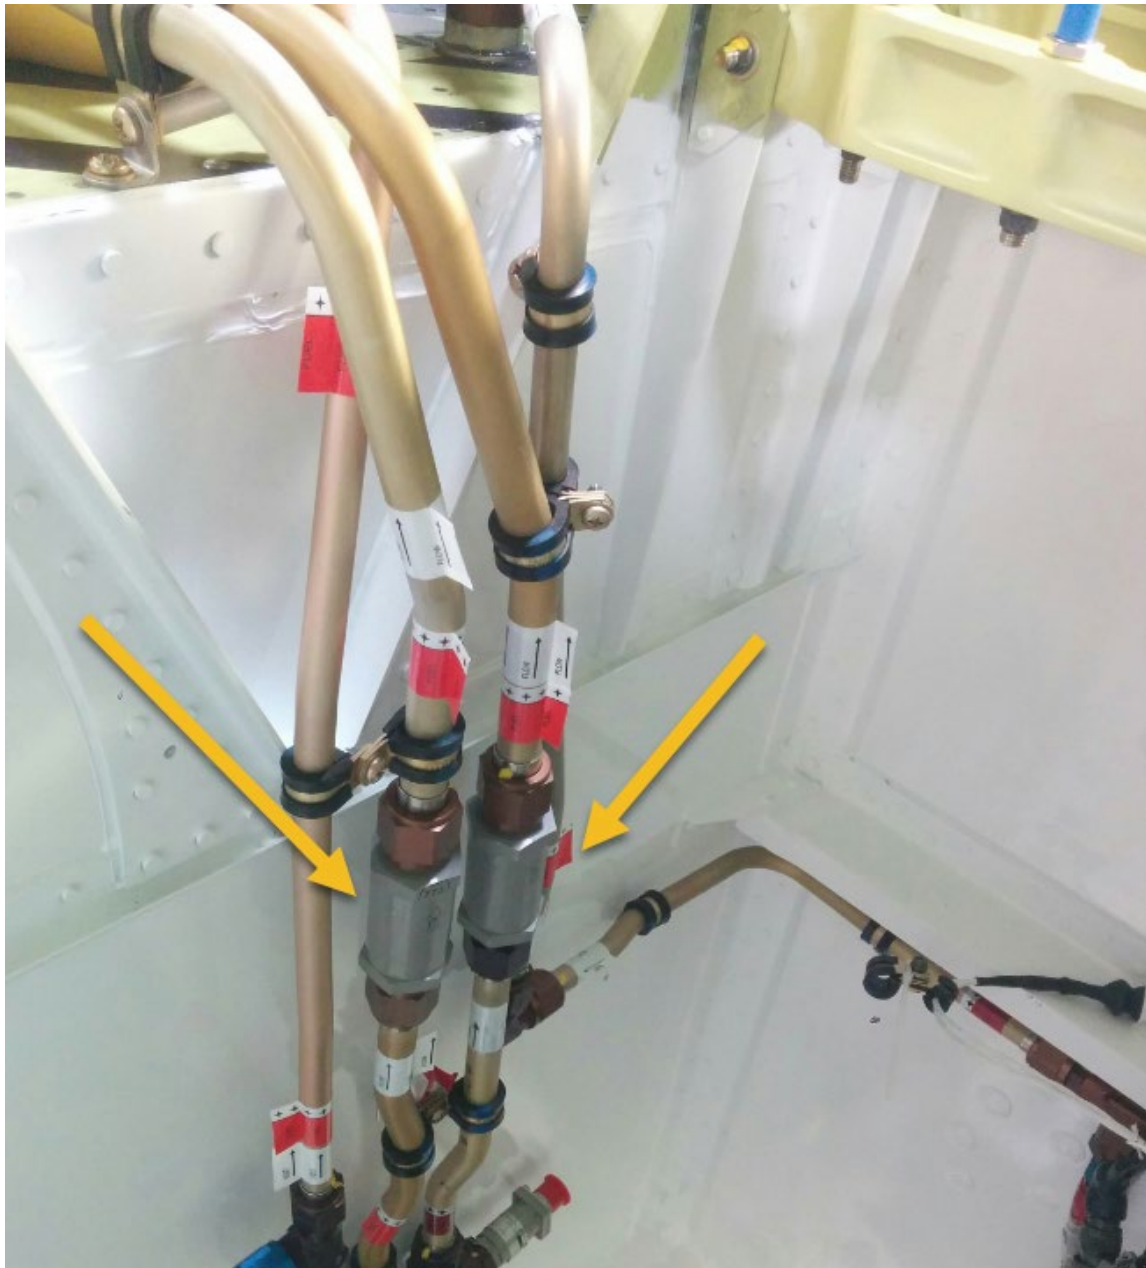
Figure 1. Fuel Check Valves Location

1. Prepare the helicopter for maintenance and gain access to the fuel check valves. The check valves are located in the aft pylon area (Figure 1).

1. Prepare the helicopter for maintenance and gain access to the fuel check valves (Figure 1).
2. Using a strong light source, visually inspect the fuel check valves for general condition and fuel leaks. Inspect for cracks at the inlet end where the threaded fitting is installed (Figure 3).
3. If a crack is found, replace the check valve prior to next flight. Figure 4 shows an example of a cracked check valve.
4. If no cracks or any other defects that would cause the valve to be unserviceable are found, make an entry in the helicopter logbook and historical service records indicating the findings and that Part II will require accomplishment until Part III is accomplished.

1. Prepare the helicopter for maintenance and gain access to the fuel check valves (Figure 1, Details A and B).
2. Refer to the applicable Maintenance Manual and replace defective fuel check valve(s) (BHT-212-MM, Chapter 28).
3. Make an entry in the helicopter logbook and historical service records indicating compliance with this Alert Service Bulletin.
