## ALERT SERVICE BULLETIN

**412CF-20-69**

**MODEL AFFECTED:** 412CF

**SUBJECT:** ENGINE OIL CHECK VALVE P/N 209-062-520-001, INSPECTION AND REPLACEMENT OF.

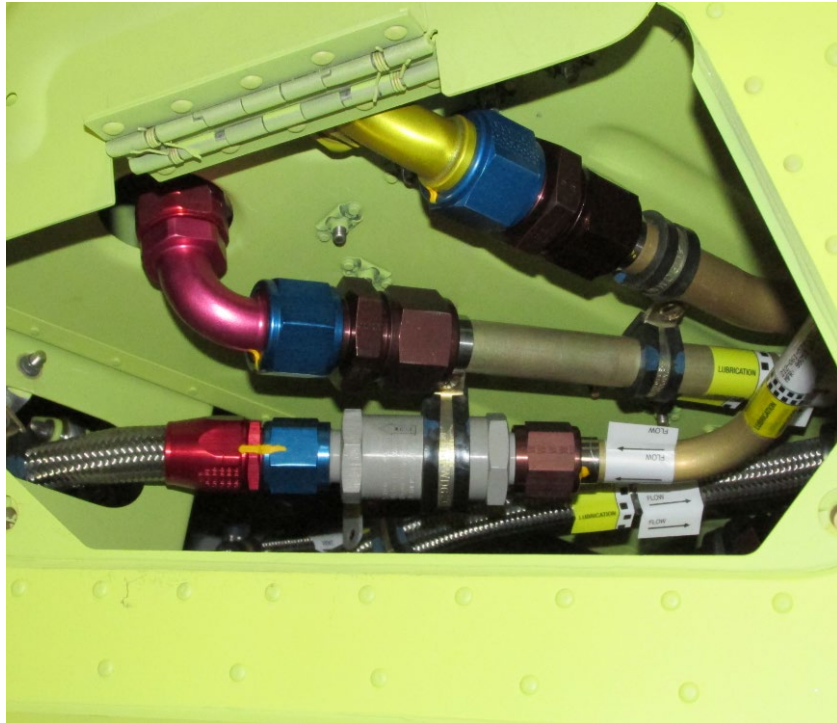
Figure 1. Engine Oil Check Valves Locations

Detail A. Engine Number 2 (Right Side)

1. Prepare the helicopter for maintenance and gain access to the engine oil check valves. The engine oil check valves are located in the engine reduction gearbox compartment under the oil coolers (Figure 1, Details A and B).

1. Prepare the helicopter for maintenance and gain access to the engine oil check valves (Figure 1, Details A and B).
2. Using a strong light source, visually inspect the oil check valves for general condition and oil leaks. Inspect for cracks at the inlet end where the threaded fitting is installed (Figure 3).
3. If a crack is found, replace the check valve prior to next flight. Figure 4 shows an example of a cracked check valve.
4. If no cracks or any other defects that would cause the valve to be unserviceable are found, make an entry in the helicopter logbook and historical service records indicating the findings and that Part II will require accomplishment until Part III is accomplished.

1. Prepare the helicopter for maintenance and gain access to the engine oil check valves (Figure 1, Details A and B).
2. Refer to the applicable Maintenance Manual and replace defective oil check valve(s) (C-12-146-000/MF-001, Maintenance Manual, Chapter 79).
3. Make an entry in the helicopter logbook and historical service records indicating compliance with this Alert Service Bulletin.

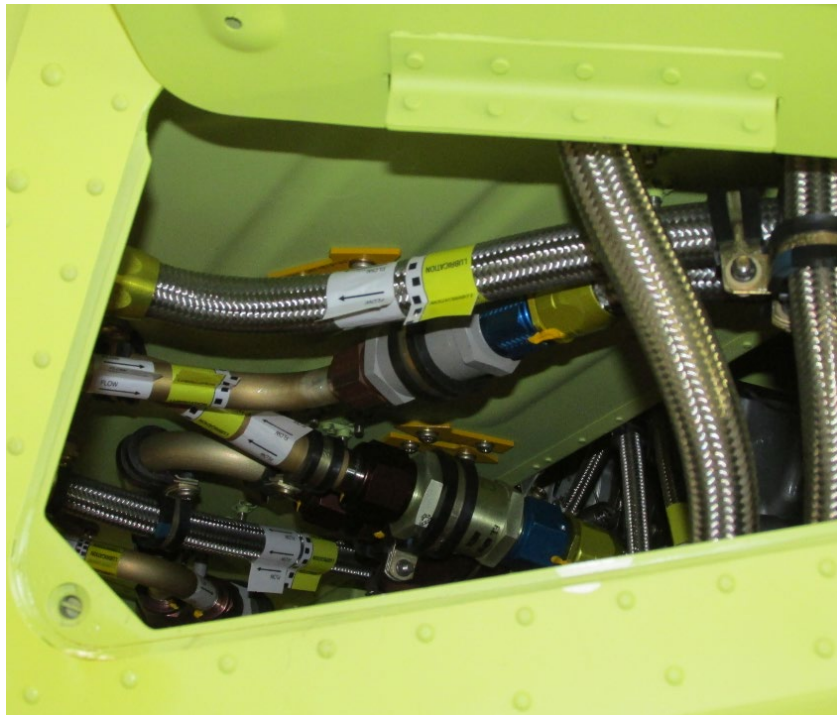
Detail B. Engine Number 1 (Left Side)

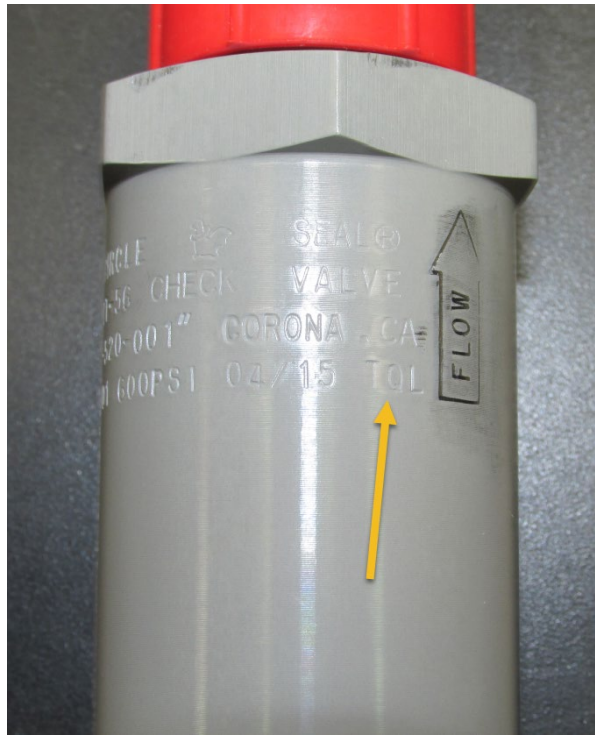
Figure 2. Engine Oil Check Valves not Affected

Detail A. Circor Aerospace Engine Oil Check Valve Marked "TQL"

It is not necessary to remove the oil check valve for inspection however some clamping may require removal for better access. Regardless of manufacturing date, any oil check valves with the "TQL" marking are not affected by this bulletin. Oil check valves manufactured by other suppliers are also not affected by this bulletin. Oil check valves with the "CORONA CA" marking and without the "TQL" marking are affected by this bulletin. (Figure 2, Details A and B).

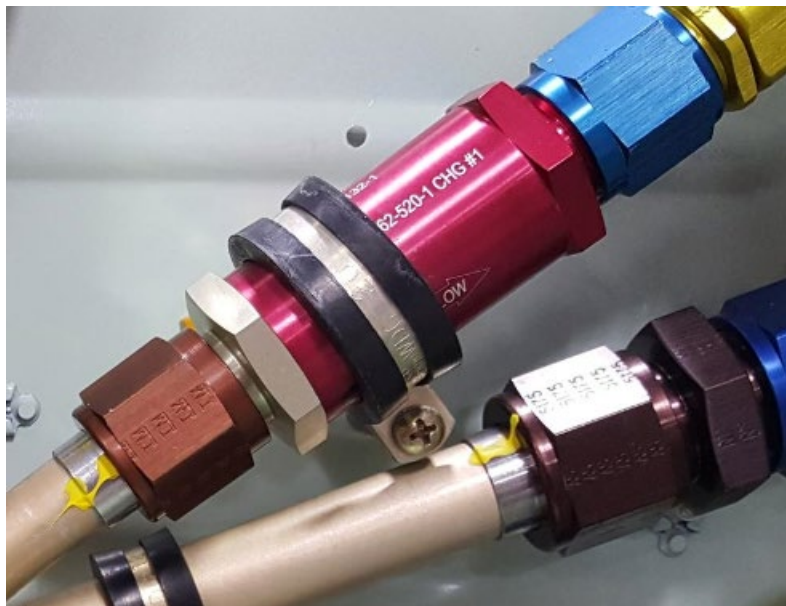
Detail B. Engine Oil Check valve not Manufactured by Circor Aerospace

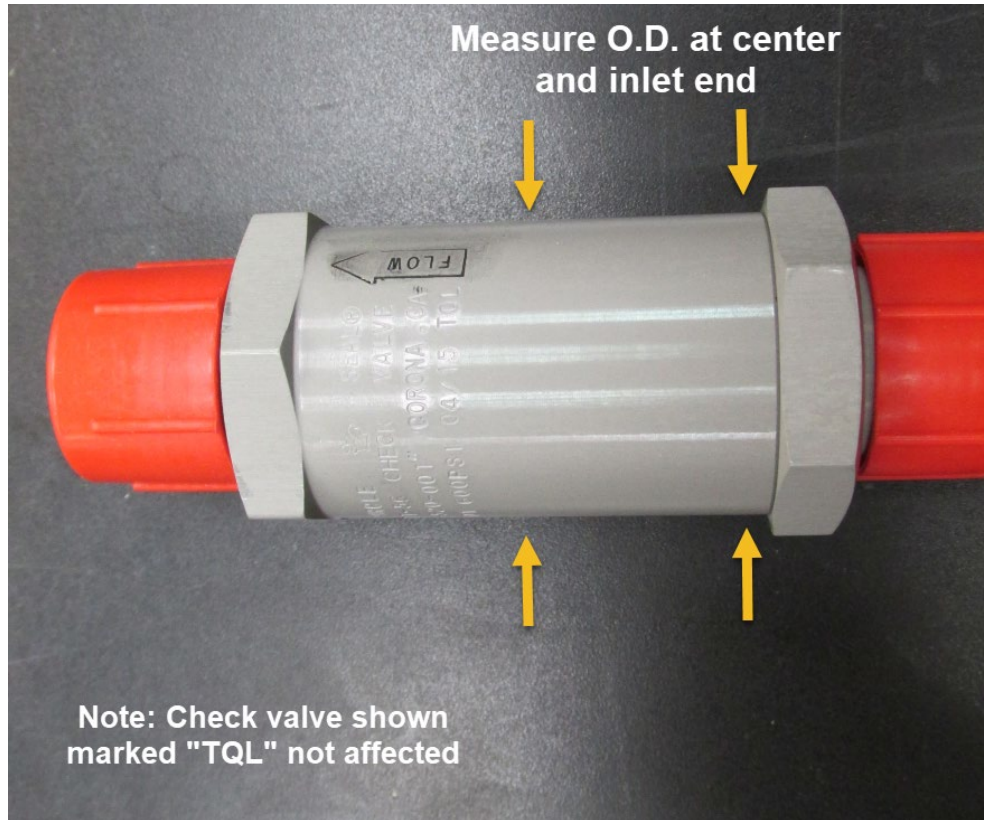
Figure 3. Engine Oil Check Valve Outside Diameter Measurement

4. If one or both check valves are affected, proceed as follows:
  - a. Using a caliper or equivalent, measure the check valve housing at the center and record dimension (Figure 3).

- b. Measure the housing at the inlet end where the threaded fitting is installed and record dimension.
  - c. If the dimension measured at the inlet end is no more than 0.003 inch (0.0762 mm) greater than the measurement at the center, the valve is serviceable and does not require further inspection or replacement. Make an entry in the helicopter logbook and historical service records indicating the findings and compliance with this Alert Service Bulletin.

- d. If the dimension measured at the inlet end is greater than 0.003 inch (0.0762 mm) when compared to the measurement at the center, the valve will require replacement. Part III can be accomplished immediately, or Part II can be accomplished until the defective valve can be replaced in accordance with Part III.
- e. If the defective check valve is not replaced immediately, make an entry in the helicopter logbook and historical service records indicating the findings and that Part II must be accomplished every 25 flight hours or 30 days whichever comes first until Part III is accomplished.

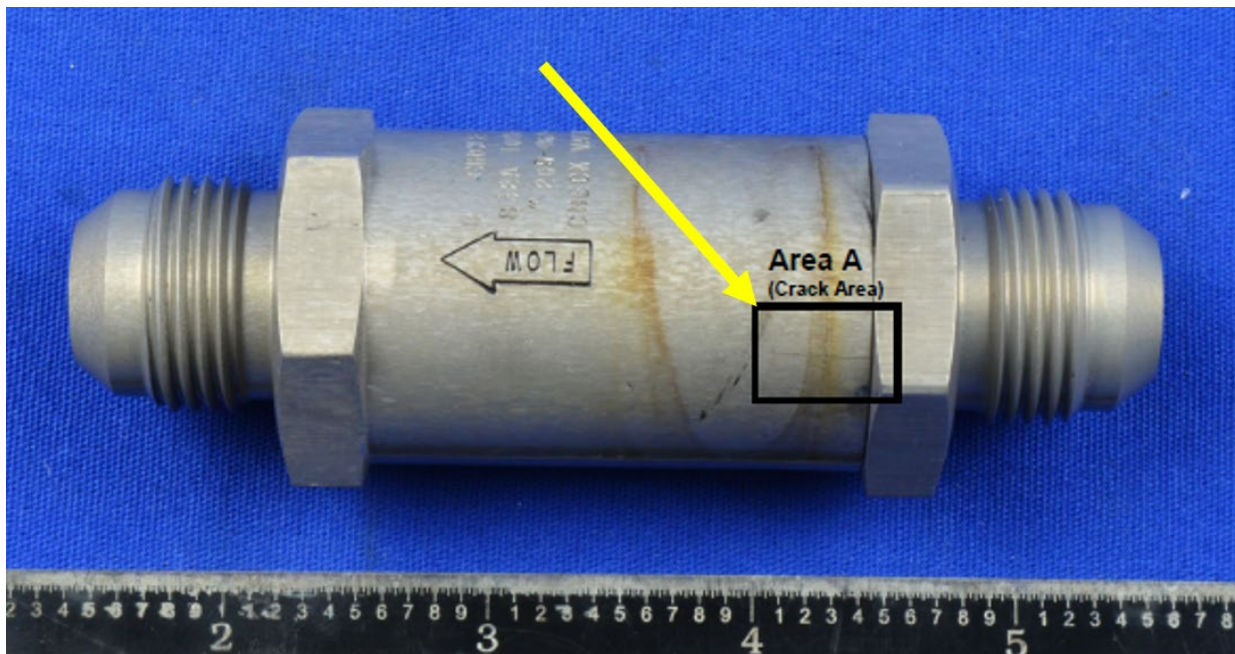
Bell recently received a report of a cracked check valve manufactured by Circor Aerospace (Circle Seal). This check valve was manufactured in 2009 which is outside of the manufacturing date range (October 2011 – March 2015) addressed by the ASB 412CF-15-57 Rev A. Corrective actions implemented in 2015 by Circor Aerospace to prevent cracking of the check valve housings are indicated by the "TQL" marking.

This recent check valve cracking report indicates that additional oil check valves P/N 209-062-520-001 manufactured by Circor Aerospace (Circle Seal) not having the “TQL” marking may be susceptible to cracking with time in service.

Figure 4. Cracked Engine Oil Check Valve

This Alert Service Bulletin mandates a one-time inspection of the suspected oil check valves for housing dimension measurement. Oil check valves that do not meet the inspection requirements outlined in the Part I of the Accomplishment Instructions of this bulletin will require replacement. Valves that are found serviceable after accomplishment of Part I of this bulletin will not require further inspection or replacement.
