## ALERT SERVICE BULLETIN

**412CF-20-70**

**MODEL AFFECTED:** 412CF

**SUBJECT:** FUEL CHECK VALVE P/N 209-062-607-001,  
INSPECTION AND REPLACEMENT OF.

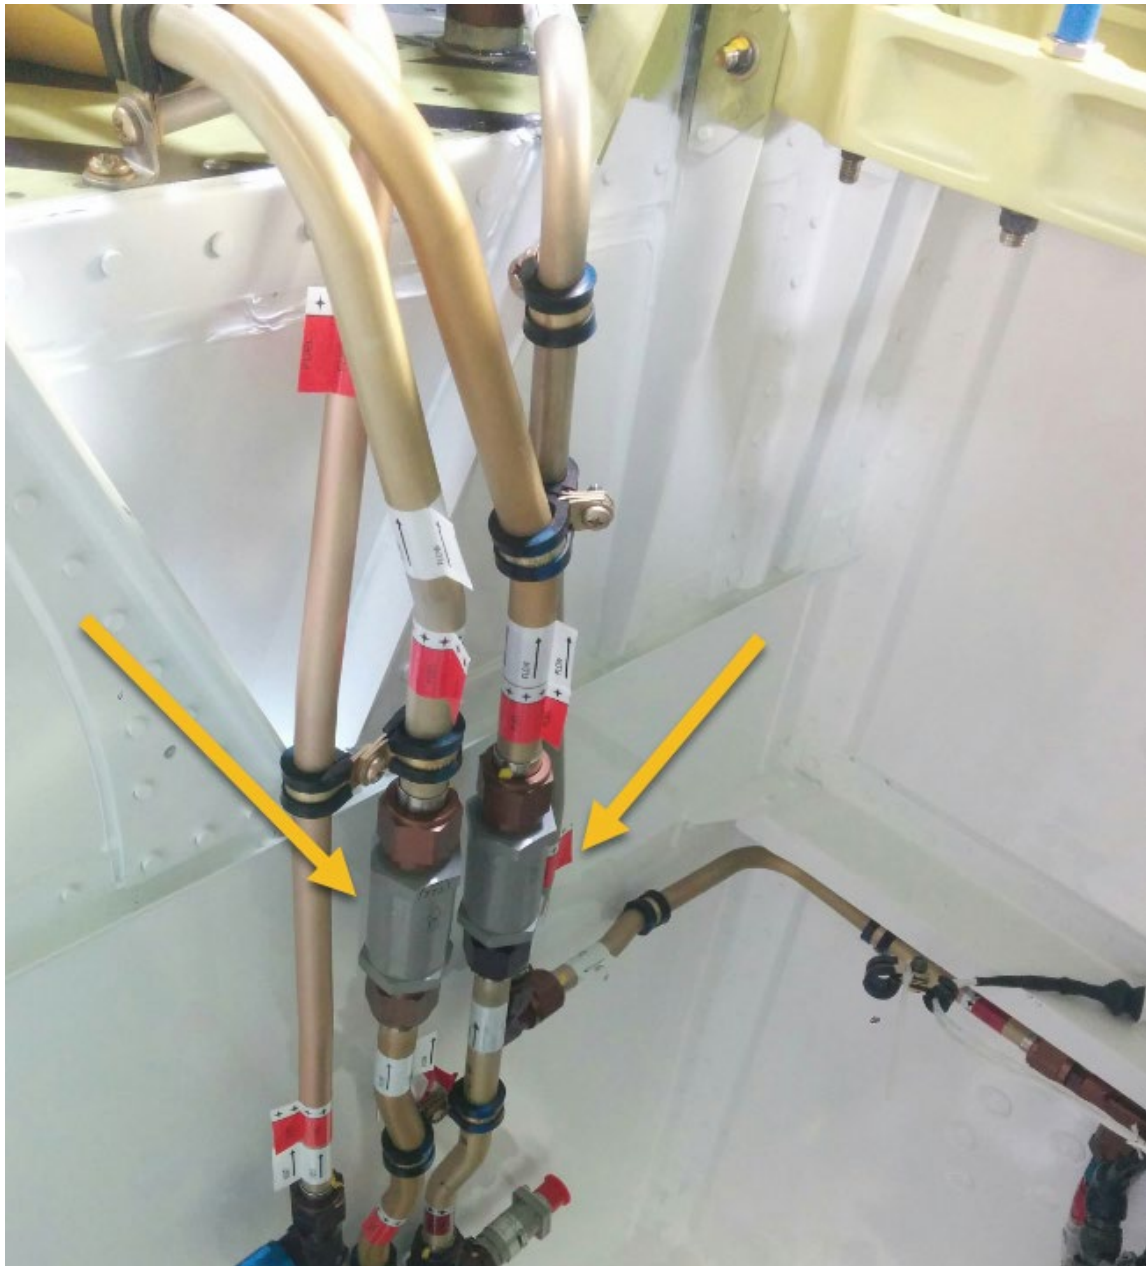
Figure 1. Fuel Check Valves Location

1. Prepare the helicopter for maintenance and gain access to the fuel check valves. The check valves are located in the aft pylon area (Figure 1).

1. Prepare the helicopter for maintenance and gain access to the fuel check valves (Figure 1).
2. Using a strong light source, visually inspect the fuel check valves for general condition and fuel leaks. Inspect for cracks at the inlet end where the threaded fitting is installed (Figure 3).
3. If a crack is found, replace the check valve prior to next flight. Figure 4 shows an example of a cracked check valve.
4. If no cracks or any other defects that would cause the valve to be unserviceable are found, make an entry in the helicopter logbook and historical service records indicating the findings and that Part II will require accomplishment until Part III is accomplished.

1. Prepare the helicopter for maintenance and gain access to the fuel check valves (Figure 1, Details A and B).
2. Refer to the applicable Maintenance Manual and replace defective fuel check valve(s) (C-12-146-000/MF-001, Maintenance Manual, Chapter 28).
3. Make an entry in the helicopter logbook and historical service records indicating compliance with this Alert Service Bulletin.

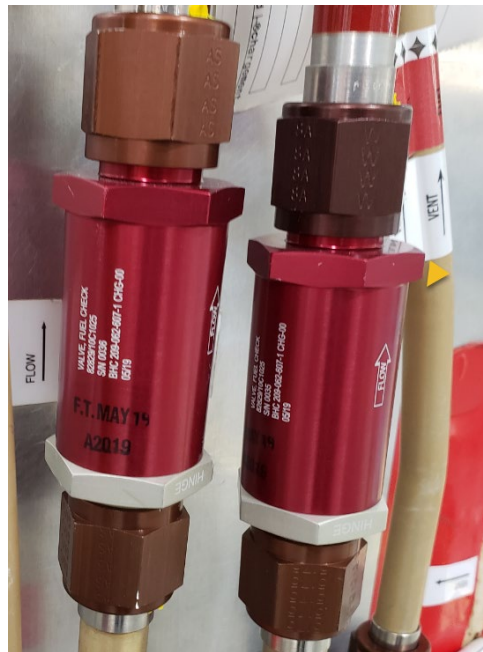
Figure 2. Fuel Check Valves not Affected

It is not necessary to remove the fuel check valve for inspection. Regardless of manufacturing date, any fuel check valves with the "TQL" marking are not affected by this bulletin. Fuel check valves manufactured by other suppliers are also not affected by this bulletin. Fuel check valves with the "CORONA CA" marking and without the "TQL" marking are affected by this bulletin. (Figure 2, Details A and B).

Detail A. Circor Aerospace Fuel Check Valve Marked "TQL"

Detail B. Fuel Check Valves not Manufactured by Circor Aerospace
