ALERT SERVICE BULLETIN

412CF-20-70

MODEL AFFECTED: 412CF

SUBJECT: FUEL CHECK VALVE P/N 209-062-607-001,
INSPECTION AND REPLACEMENT OF.

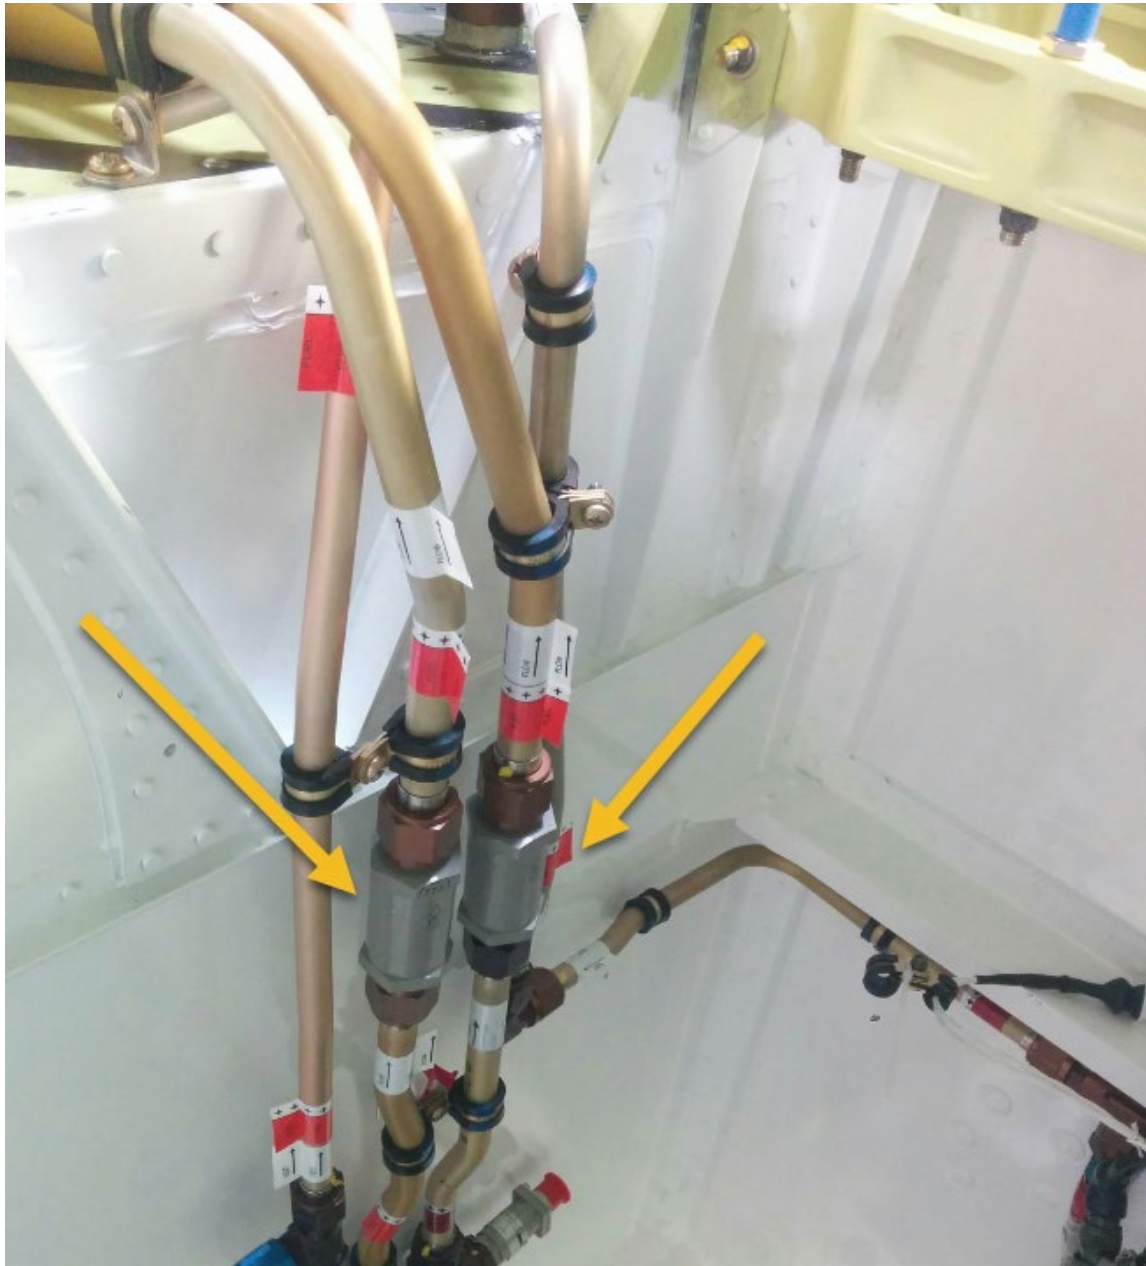
Figure 1. Fuel Check Valves Location

1. Prepare the helicopter for maintenance and gain access to the fuel check valves. The check valves are located in the aft pylon area (Figure 1).

- 1. Prepare the helicopter for maintenance and gain access to the fuel check valves (Figure 1).
- 2. Using a strong light source, visually inspect the fuel check valves for general condition and fuel leaks. Inspect for cracks at the inlet end where the threaded fitting is installed (Figure 3).
- 3. If a crack is found, replace the check valve prior to next flight. Figure 4 shows an example of a cracked check valve.
- 4. If no cracks or any other defects that would cause the valve to be unserviceable are found, make an entry in the helicopter logbook and historical service records indicating the findings and that Part II will require accomplishment until Part III is accomplished.

1. Prepare the helicopter for maintenance and gain access to the fuel check valves (Figure 1, Details A and B).
2. Refer to the applicable Maintenance Manual and replace defective fuel check valve(s) (C-12-146-000/MF-001, Maintenance Manual, Chapter 28).
3. Make an entry in the helicopter logbook and historical service records indicating compliance with this Alert Service Bulletin.

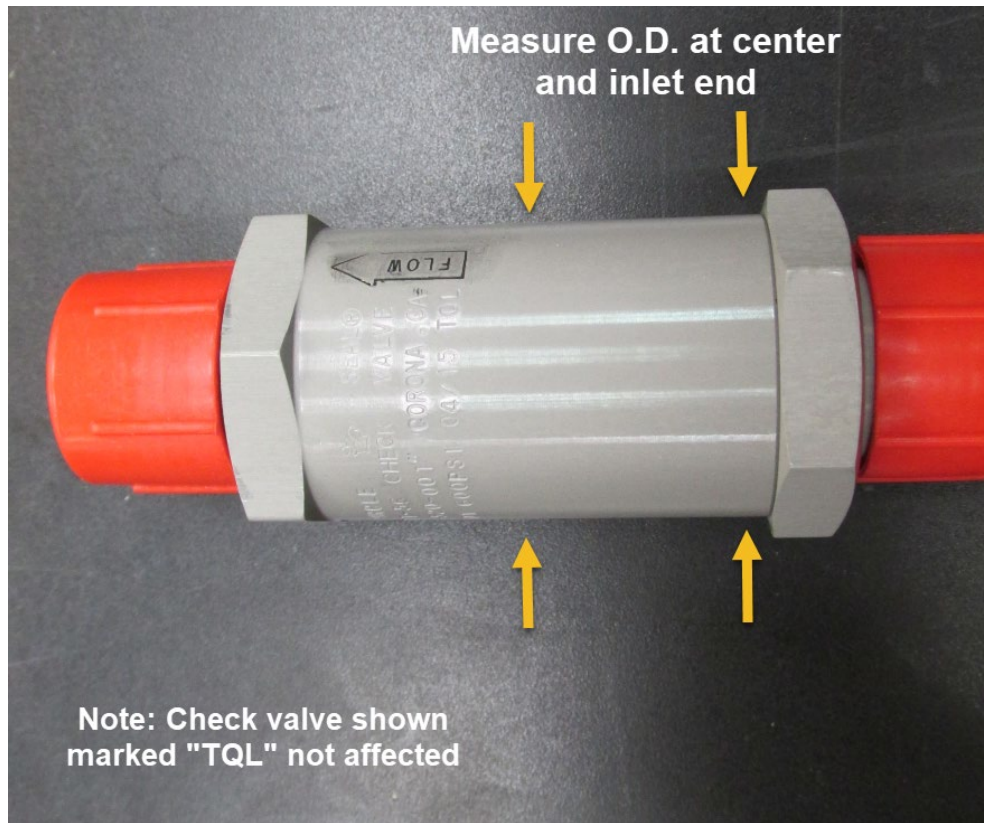
Figure 3. Fuel Check Valve Outside Diameter Measurement

- d. If the dimension measured at the inlet end is greater than 0.003 inch (0.0762 mm) when compared to the measurement at the center, the valve will require replacement. Part III can be accomplished immediately, or Part II can be accomplished until the defective valve can be replaced in accordance with Part III.
- e. If the defective check valve is not replaced immediately, make an entry in the helicopter logbook and historical service records indicating the findings and that Part II must be accomplished every 25 flight hours or 30 days whichever comes first until Part III is accomplished.
